Venture Out at Mesa, Inc.
Mesa, AZ

Report #: 15275-3
Beginning: July 1, 2021
Expires: June 30, 2022

RESERVE STUDY
Update "With-Site-Visit"

April 22, 2022

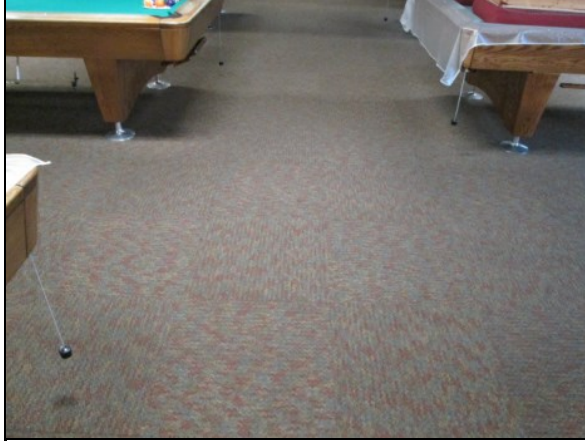
Comments: The carpet receives heavy foot traffic in some areas. Although newer, some wear and visible seams noted.

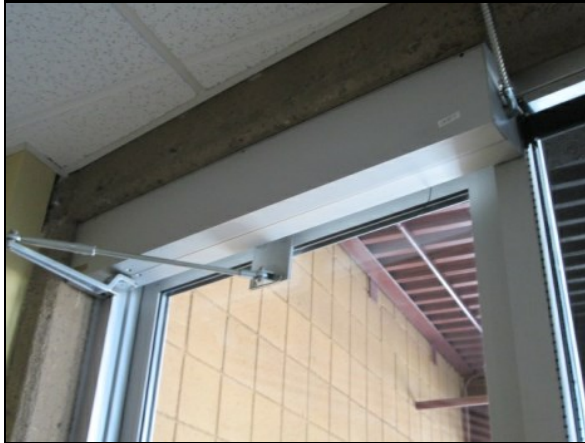
Comments: Handicap door openers are still functional and appear to be in fair condition.

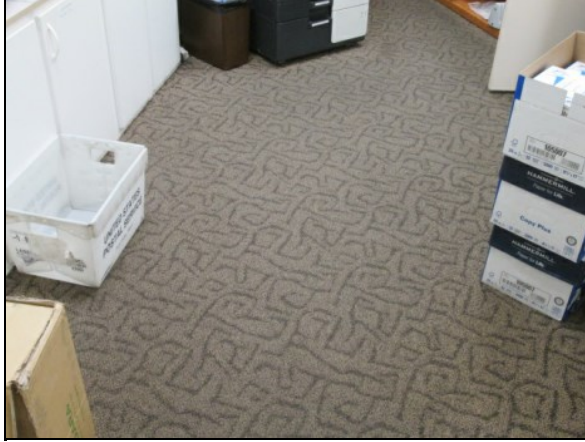
Comments: Carpet is old and worn. It has far exceeded the typical life expectancy and needs to be replaced.

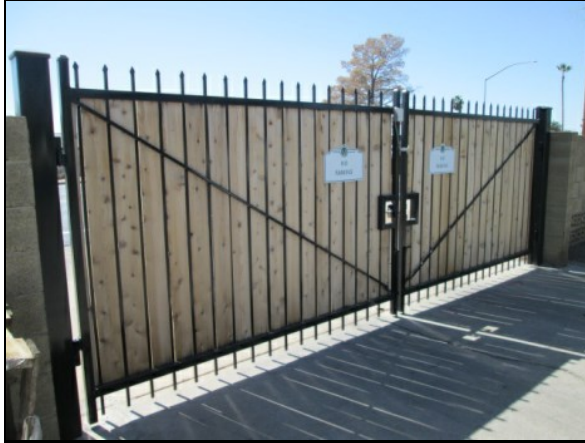
Comments: These gates are newer and are in good condition. They are manually operated gates that receive little to no use. It is unknown why the previous gates were replaced. They should have an extended life span under normal circumstances. Since a replacement record has been established, funding for future replacement has been added.
