VO BALLROOM FLOOR

AD Hoc Committee Report of findings

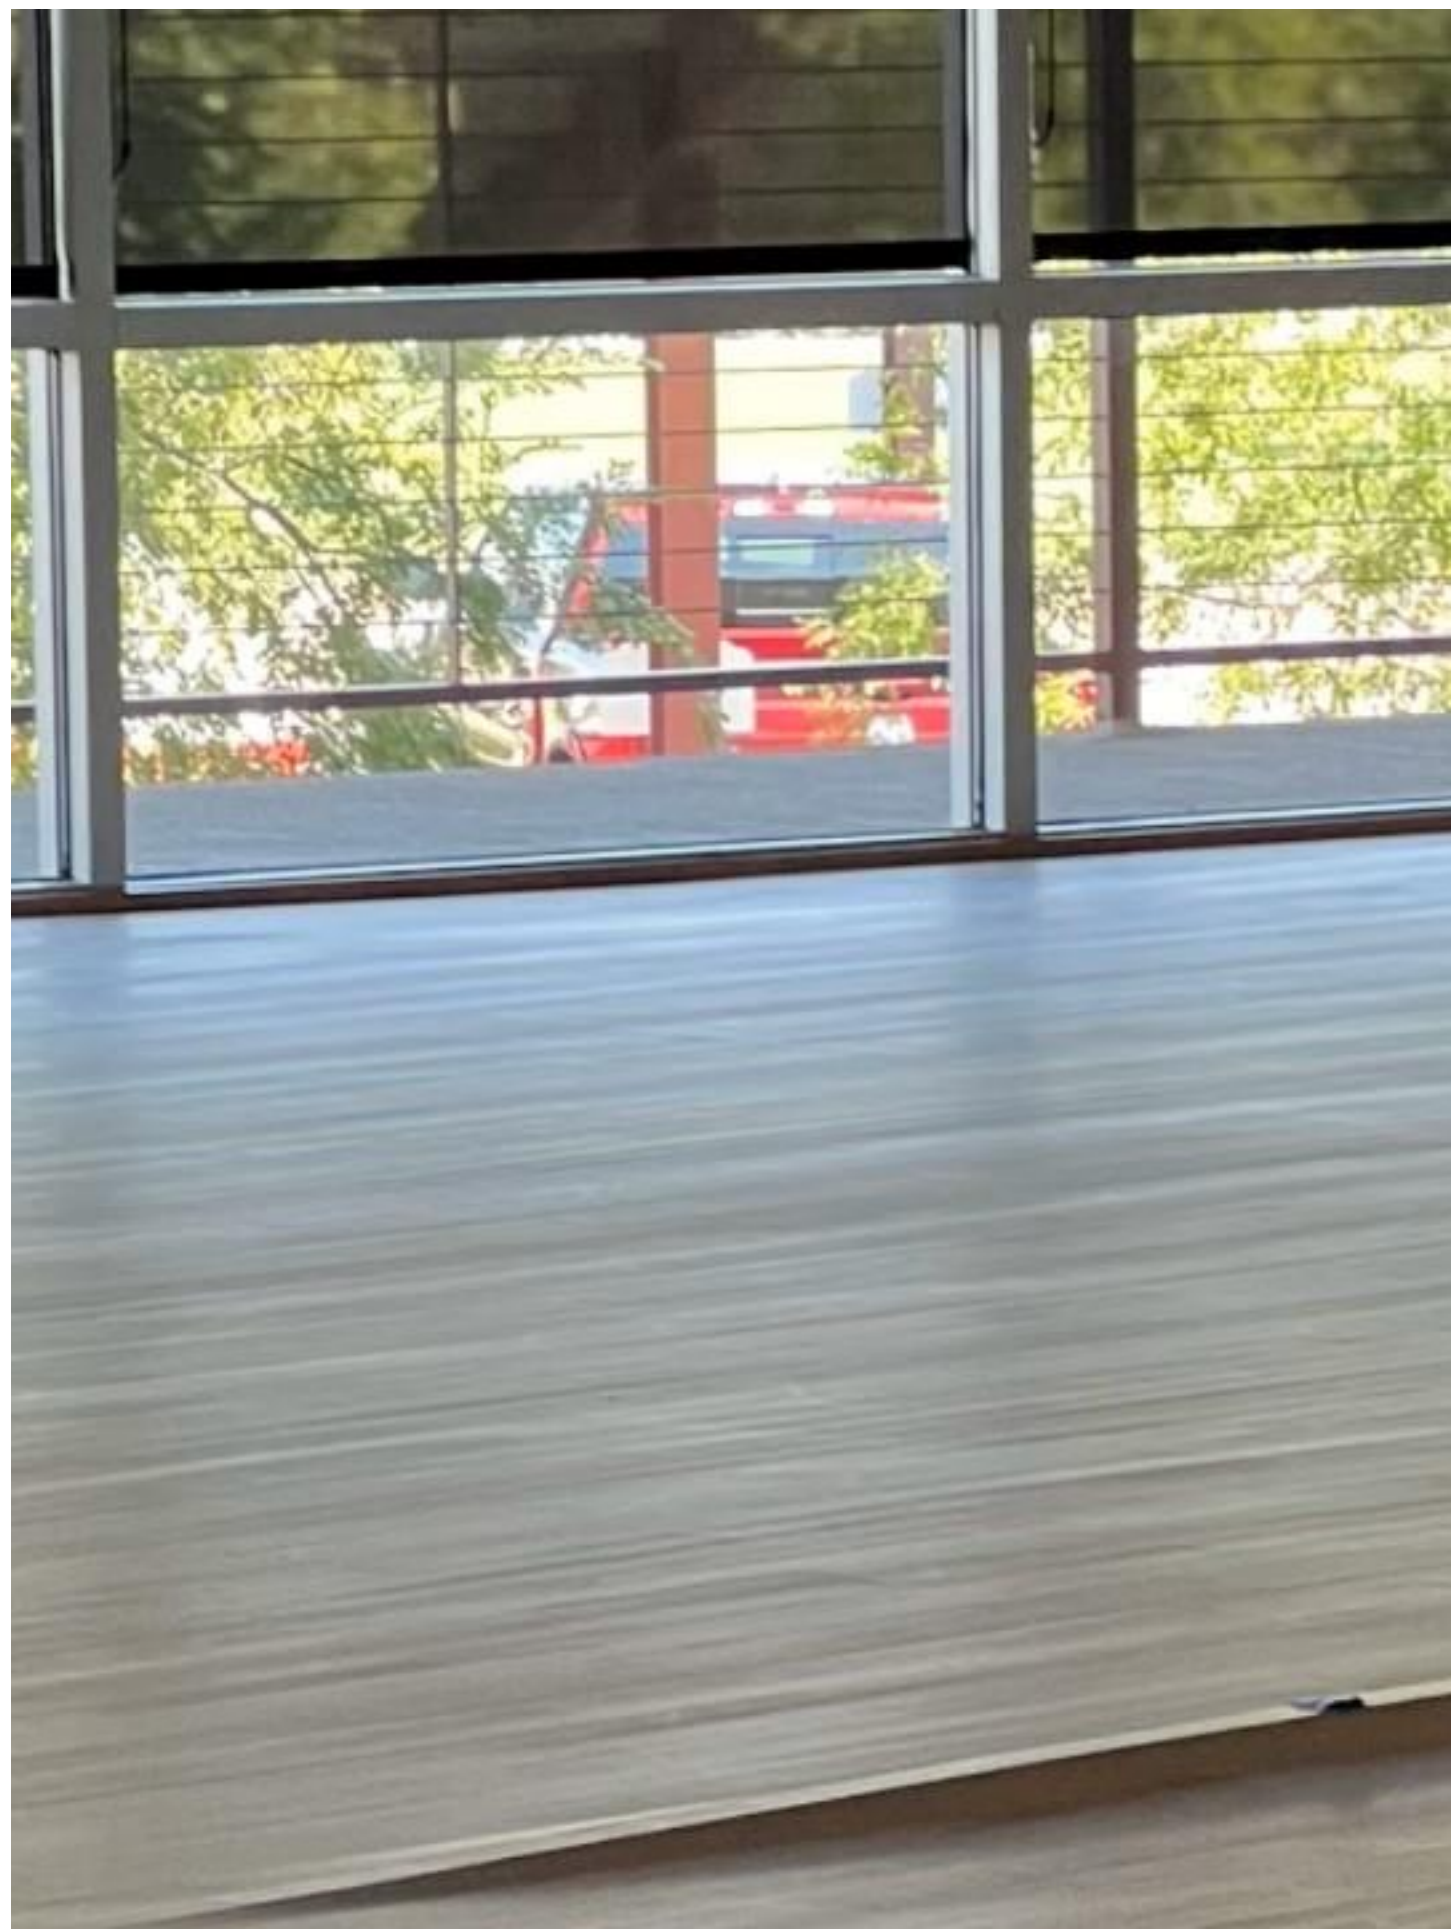
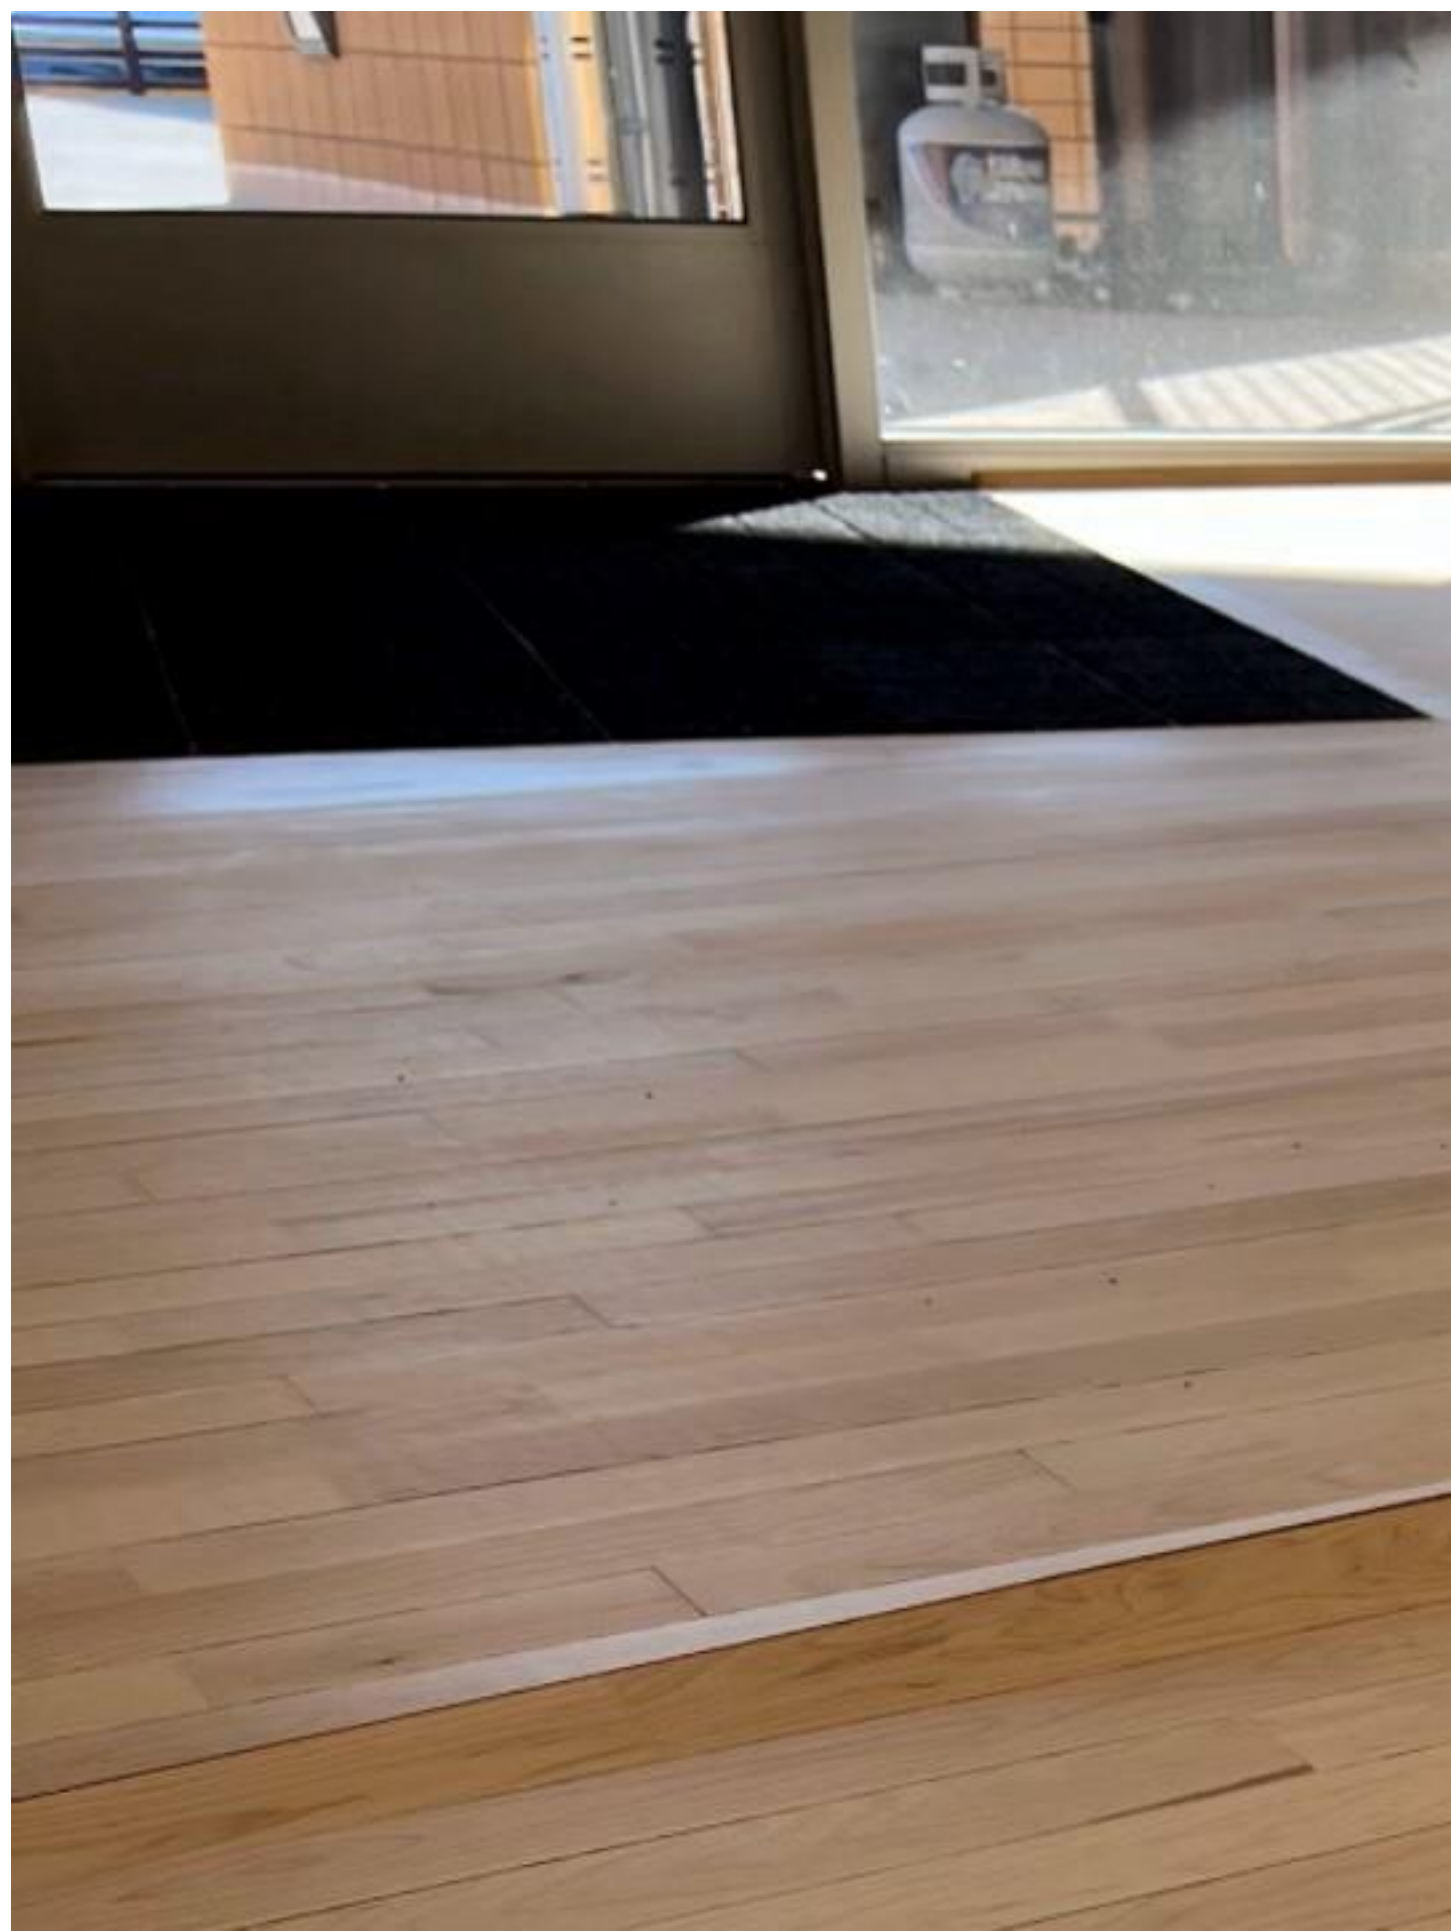
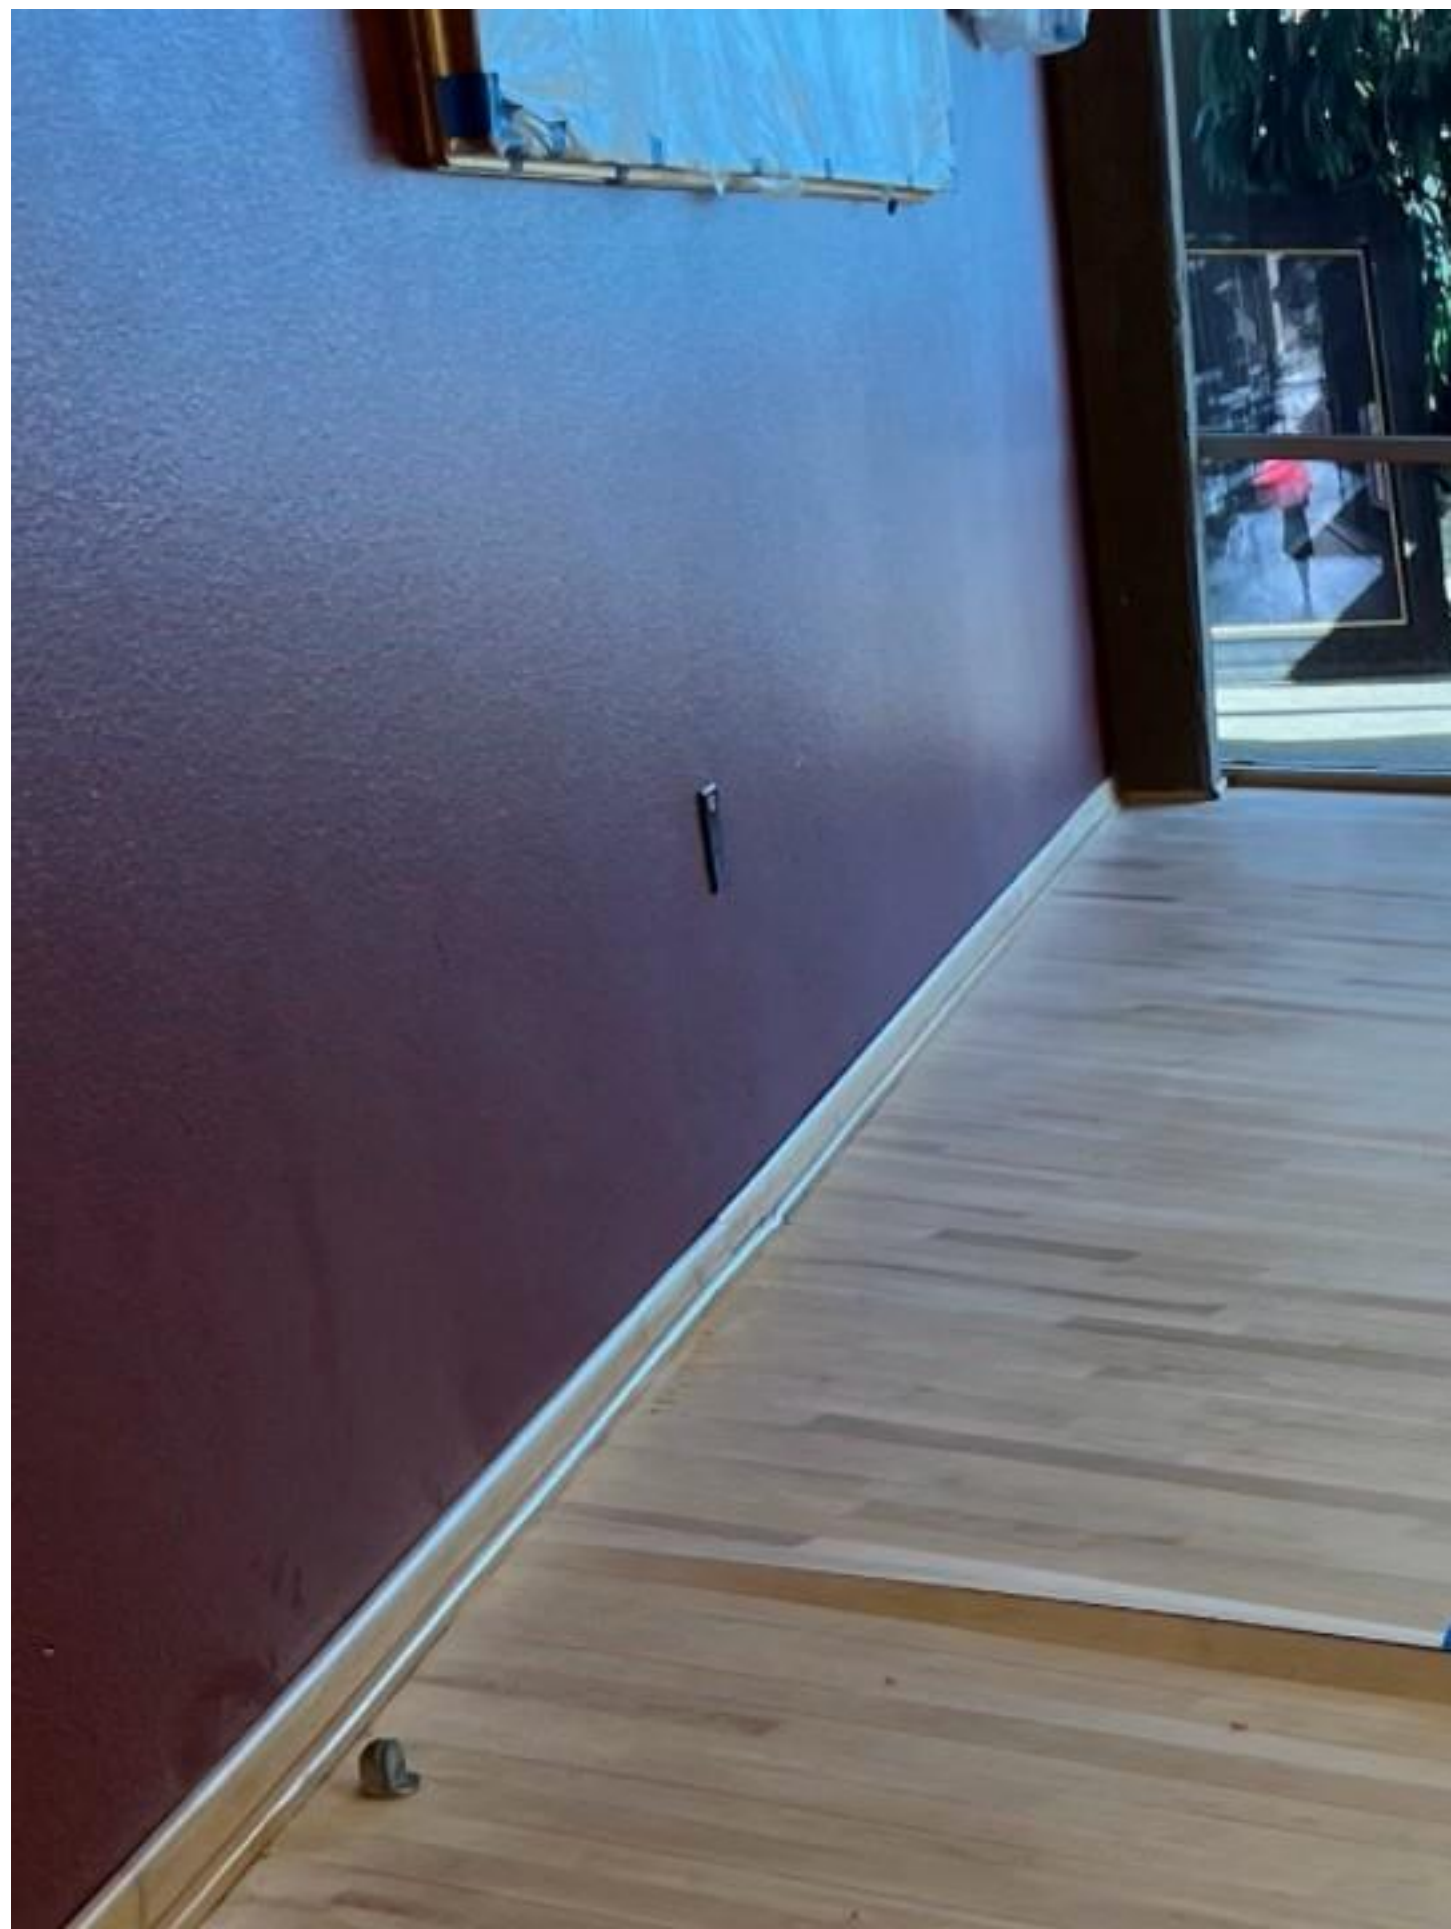
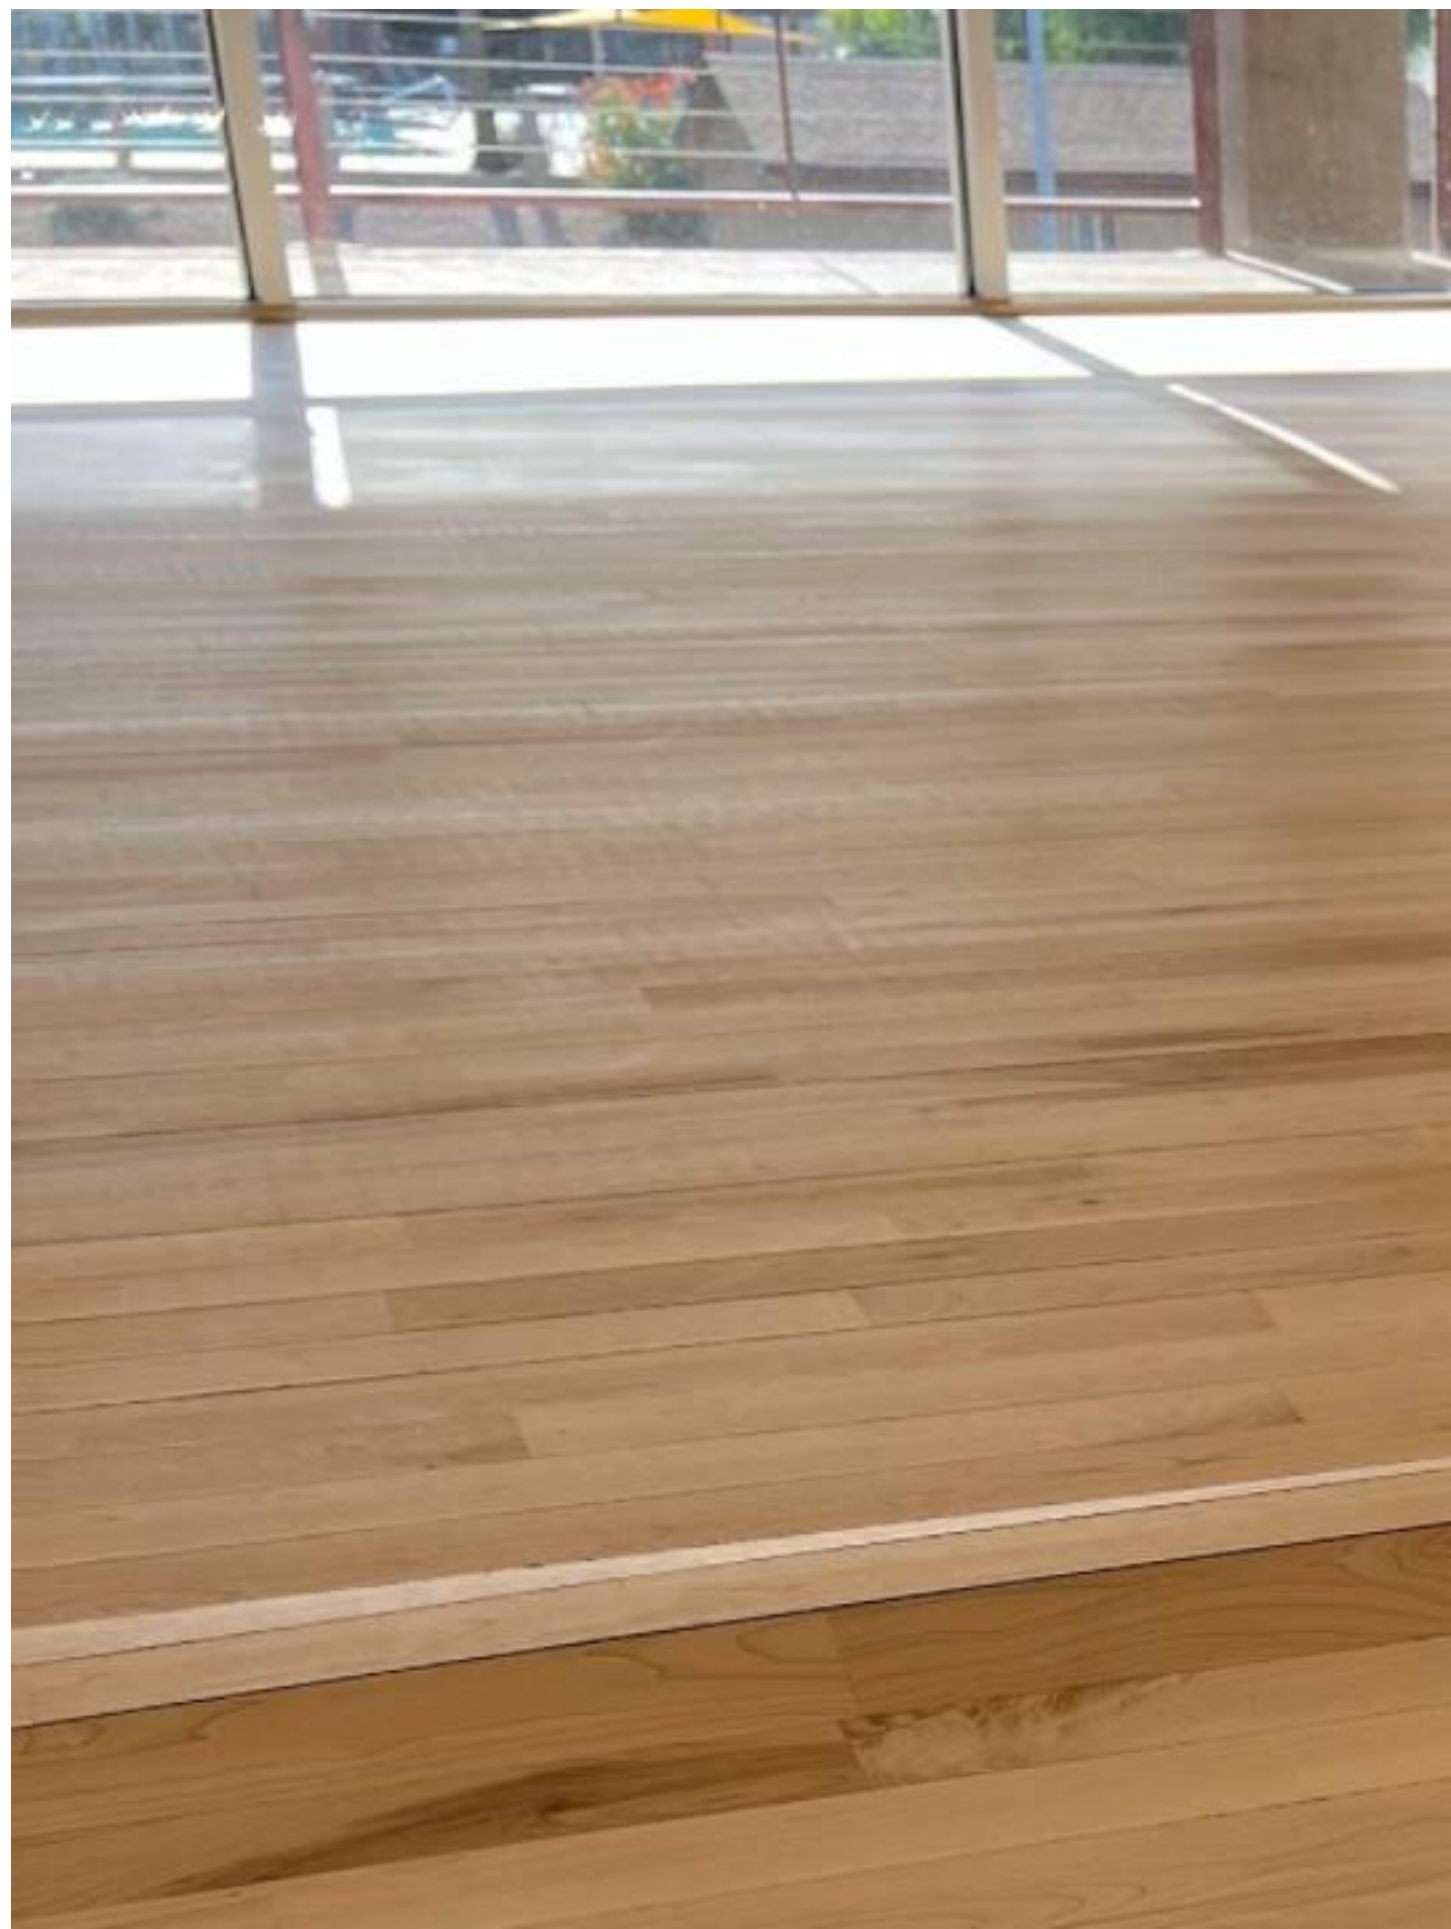
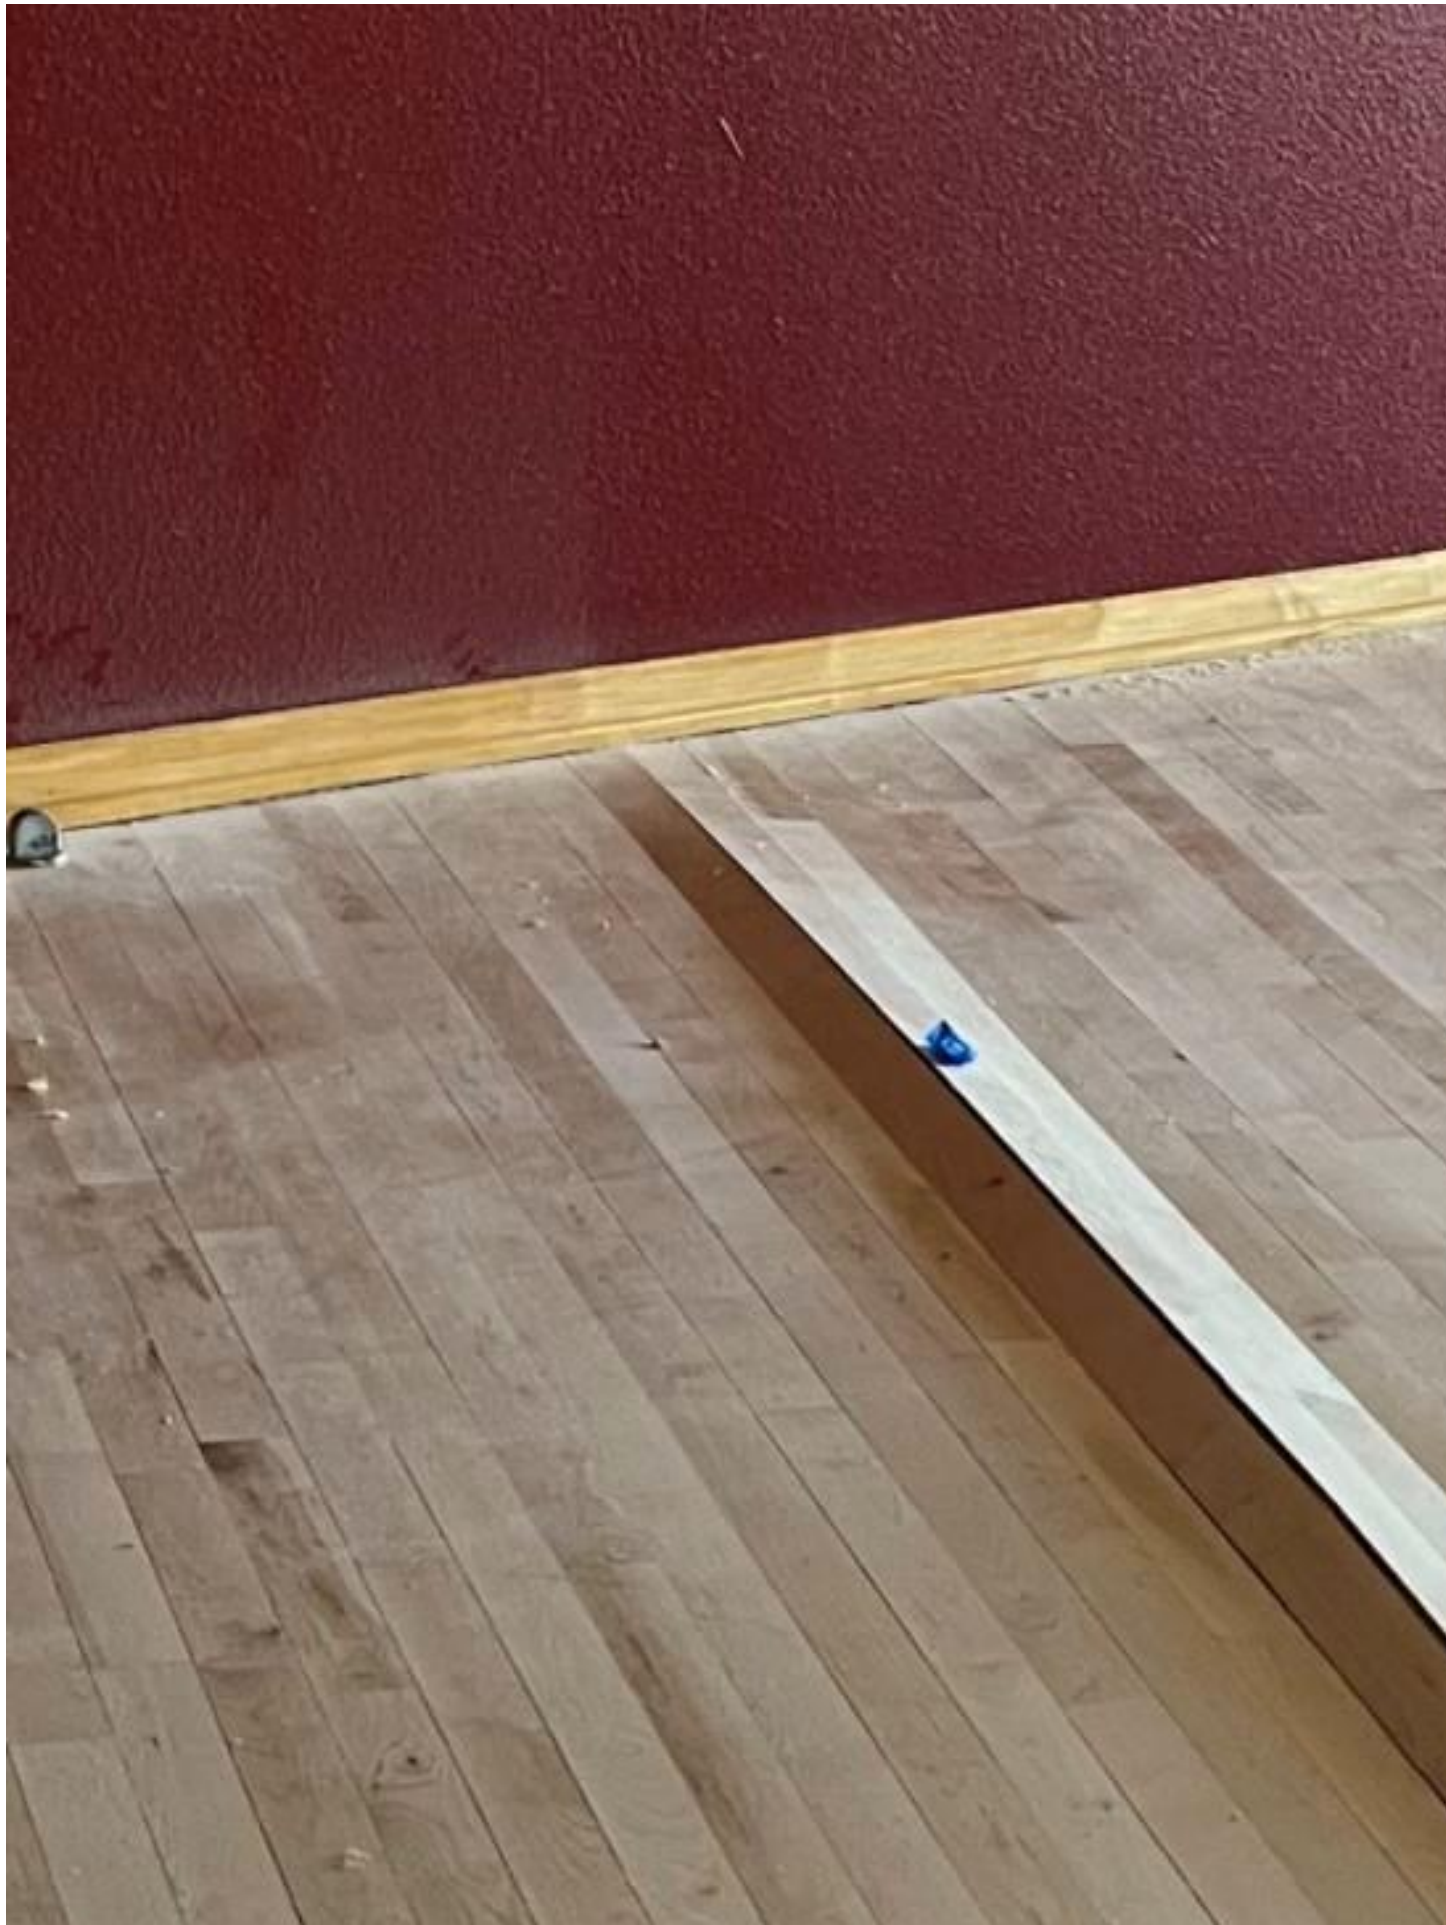
In August 2022, the Ballroom Floor was sanded by Arizona Hardwood and due to lateness of the day was left for finishing in the morning. To allow for ventilation the HVAC system ran through the night. That evening a heavy weather event (monsoon) occurred. As a result, a significant amount of moisture / humidity was drawn into the ballroom by the HVAC system. This added moisture resulted in a significant expansion of the floor. Without proper gapping between the walls and the floor to allow for expansion, the floor buckled in multiple locations throughout the space. This buckling required saw cuts of significant size to allow for the floor to return to its base but was not modified at the perimeter for further expansion.

(The pictures that follow depict the damage that occurred.)

1. Touch up areas that have lifted due to expansion/contraction within the wood flooring.
2. Following an annual inspection of the floor.... Apply a maintenance coat once a year when needed until the floor can be replaced. Work to be done via contractor NOT in-house staff to allow for proper accountability and performance.
3. The recommended sheen is Matte/Satin. (A glossy finish will accentuate the floor imperfections.)
4. Annual budget cost of \$6,000-10,000.
