Venture Out at Mesa, Inc.
Mesa, AZ

Report #: 15275-3
Beginning: July 1, 2021
Expires: June 30, 2022

RESERVE STUDY
Update "With-Site-Visit"

April 22, 2022

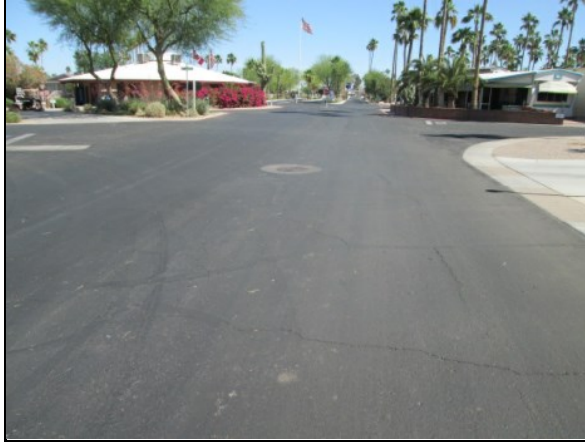
Comments: This asphalt accounts for the main entry and street into the community. It has been repaved in the past, but the actual history is unknown. Still in fair condition. Cracks and patched spots are visible.

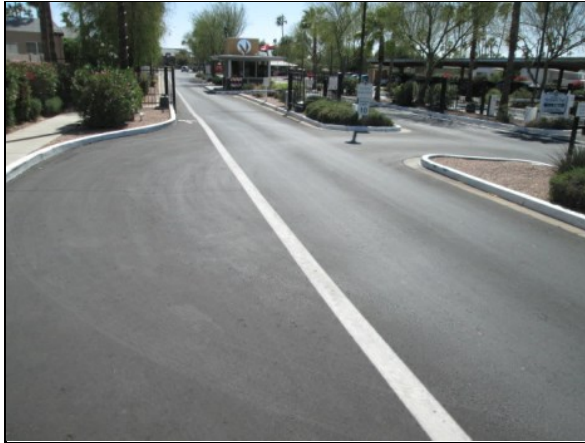
Comments: Still is still intact and in good to fair condition.

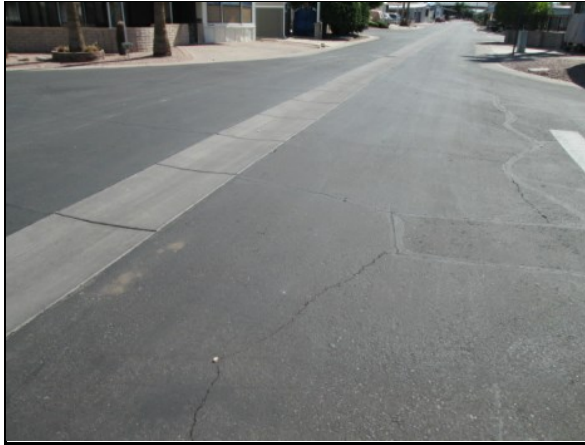
History: Repaved Fairchild & Helio in 2011 for \$109,258. RV Overnights was replaced in 2010-11.

Comments: Fairchild was replaced with a new 3" layer of asphalt due to heavy traffic concerns. Helio received a 2" layer of asphalt. RV Overnights section was repaved as part of the renovations to that area. Surfaces are still smooth and in good condition overall. Some cracking is visible though.

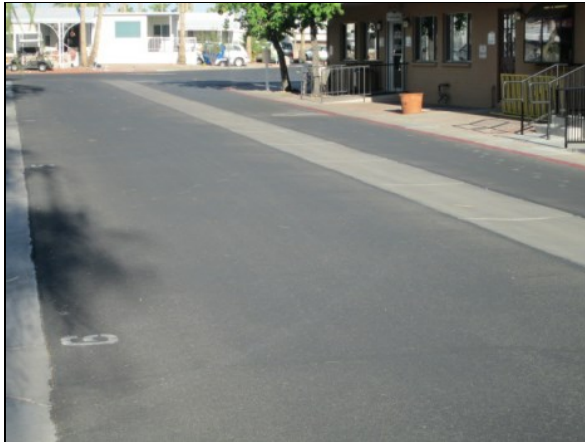
Comments: Conditions vary. These sections of asphalt are scheduled for sealing again in 2023 on the asphalt plan. Helio is not accounted for on the asphalt sealing plan, but it should be included with the other streets listed here.

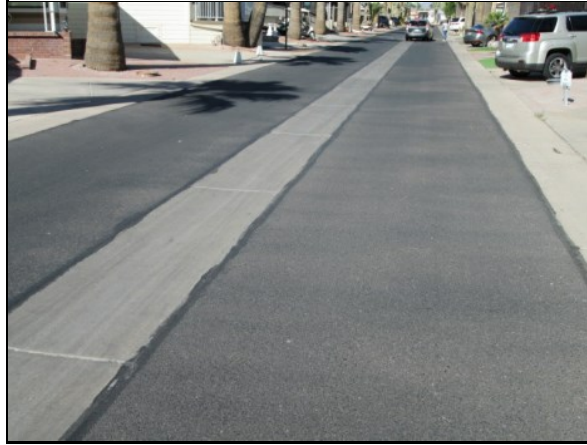
Comments: These streets were repaved with 2.5" of asphalt. Surfaces are still smooth and in good condition. Some small cracks were noted.

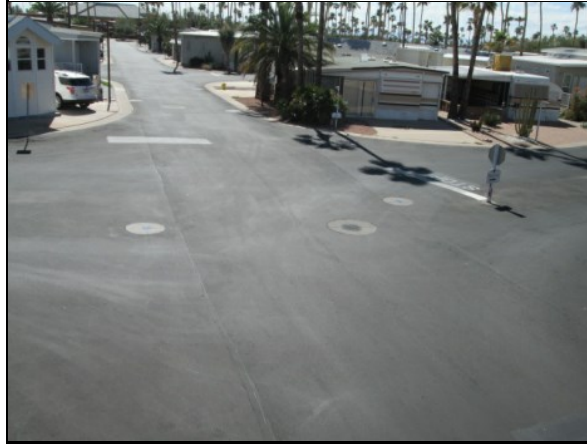
Comments: This asphalt still looks newer and is in good condition.

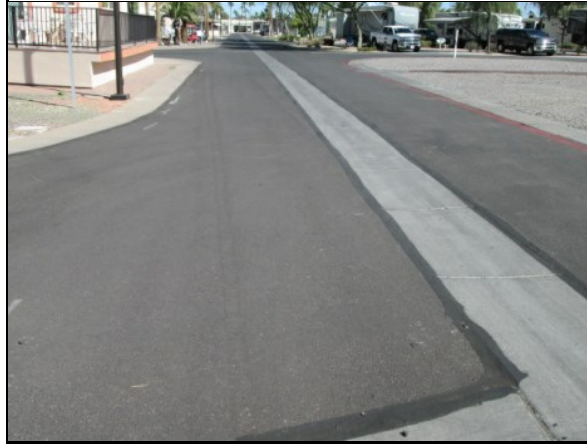
Comments: This asphalt is still near new and in good condition.

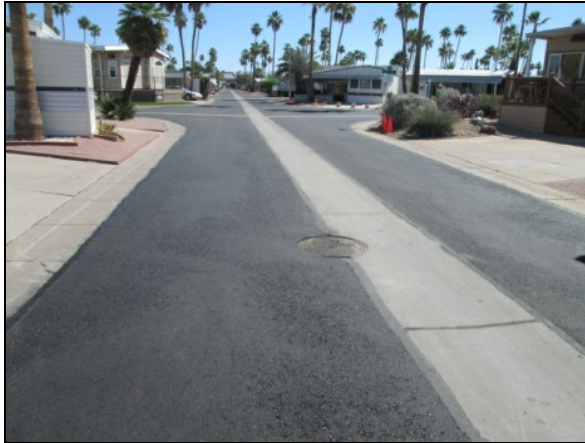
Comments: This asphalt was just recently repaved. It is new and in good condition.

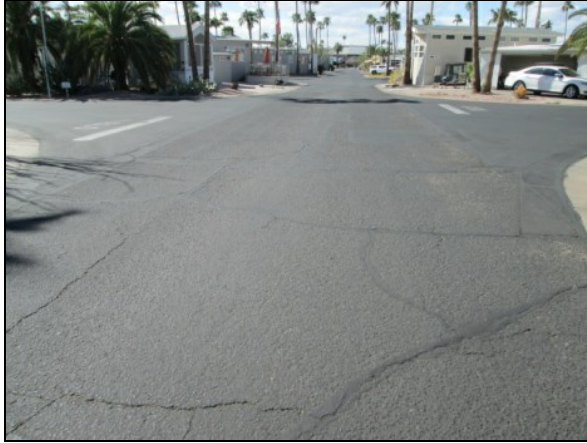
Comments: Conditions vary. Dart is mostly old and rough. invincible has some rough spots and cracks but is not bad. Both streets are scheduled for repaving in 2021-22.

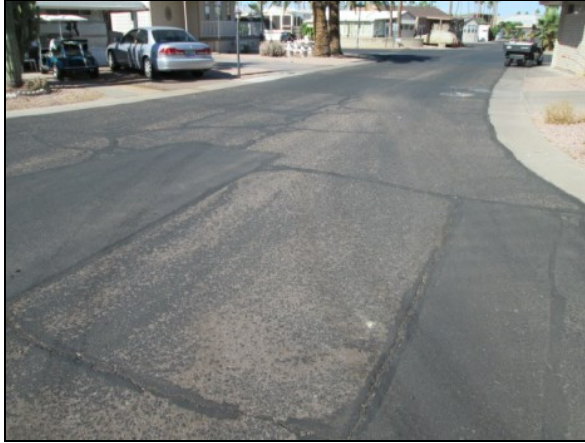
Comments: Conditions vary. A lot of the surface on Cherokee is rough and eroded. Ercoupe has both rough spots and patched spots. Both streets are scheduled for repaving in 2022-23.

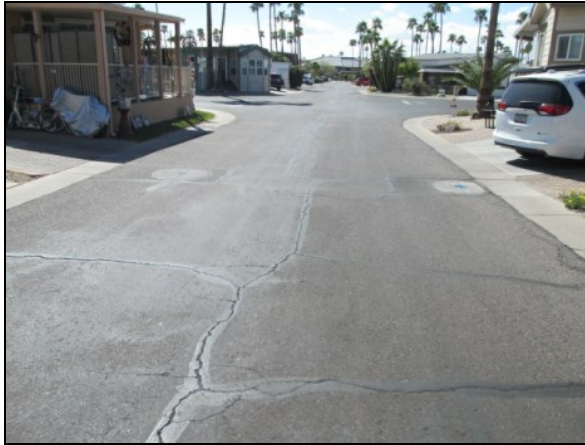
Comments: This component budgets to repave 1/6 of the remaining streets. Conditions vary throughout the community. Some areas exhibit more cracking and deterioration than others. Future updates to this report will more specifically identify and track actual street locations once repaved.

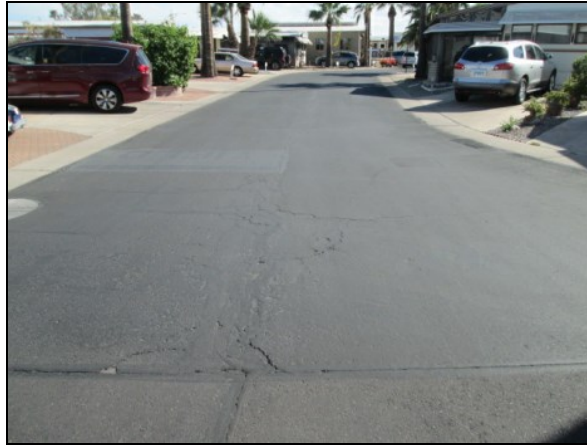
Comments: This component budgets to repave 1/6 of the remaining streets. Conditions vary throughout the community. Some areas exhibit more cracking and deterioration than others. Future updates to this report will more specifically identify and track actual street locations once repaved.

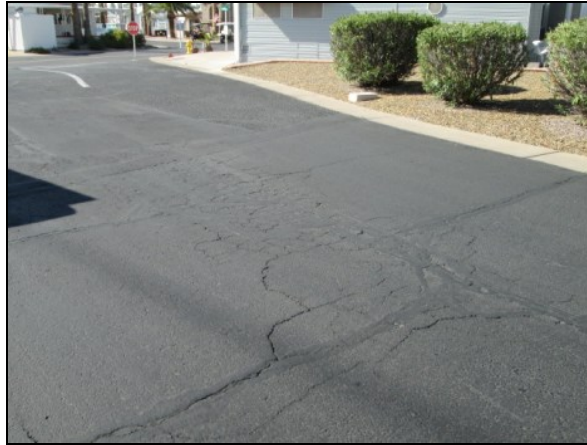
Comments: This component budgets to repave 1/6 of the remaining streets. Conditions vary throughout the community. Some areas exhibit more cracking and deterioration than others. Future updates to this report will more specifically identify and track actual street locations once repaved.

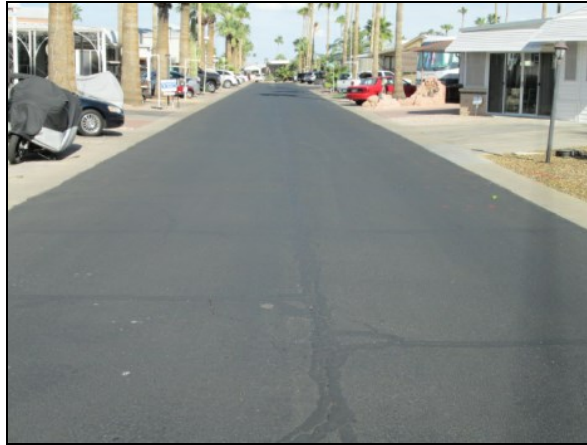
Comments: This component budgets to repave 1/6 of the remaining streets. Conditions vary throughout the community. Some areas exhibit more cracking and deterioration than others. Future updates to this report will more specifically identify and track actual street locations once repaved.

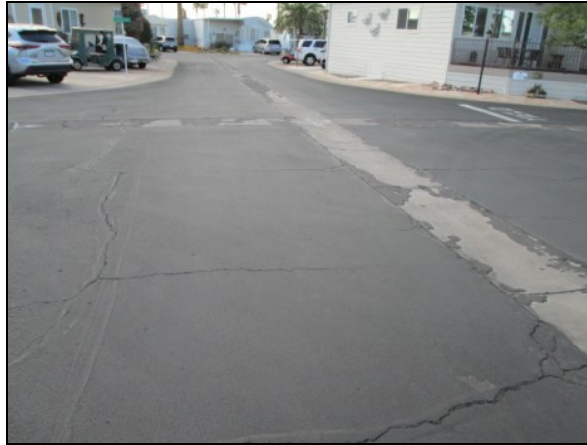
Comments: This component budgets to repave 1/6 of the remaining streets. Conditions vary throughout the community. Some areas exhibit more cracking and deterioration than others. Future updates to this report will more specifically identify and track actual street locations once repaved.

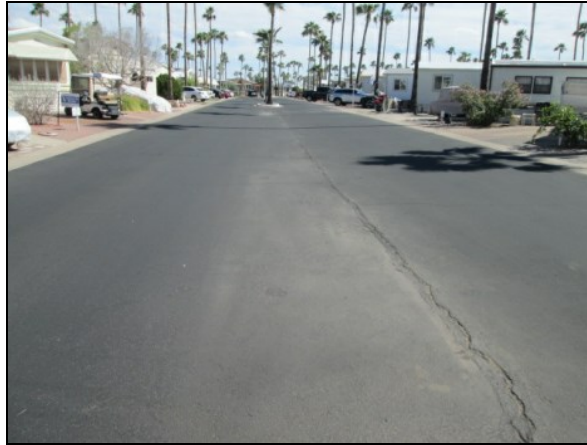
Comments: This component budgets to repave 1/6 of the remaining streets. Conditions vary throughout the community. Some areas exhibit more cracking and deterioration than others. Future updates to this report will more specifically identify and track actual street locations once repaved.

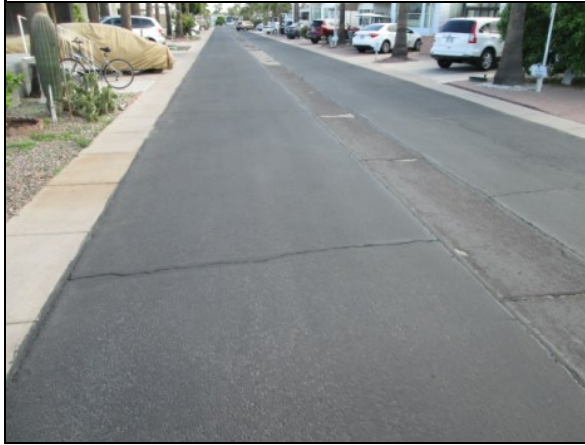
Comp #: 230 Asphalt - Crack Seal

Comments: Asphalt varies in age throughout the community. Some sections exhibit moderate cracking. This component funds an allowance for crack sealing and minor patching work where needed.

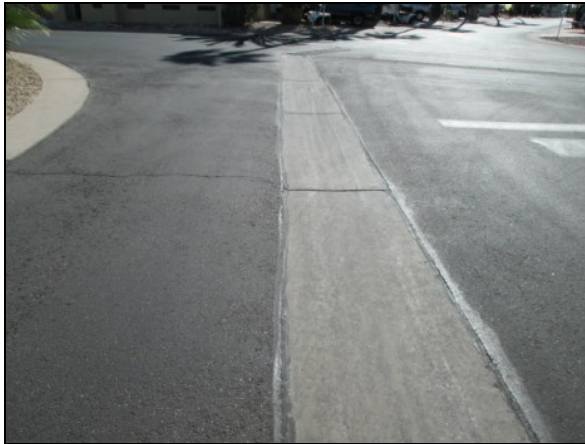
Comp #: 234 Valley Gutters - Replace (A)

History: Replaced in 2011 for \$47,482. Also spent ~\$80,000 prior to 2011.

Comments: There is an extensive amount of concrete valley gutters throughout the community. A portion was replaced in 2010-11, so this component funds long-term replacement again.

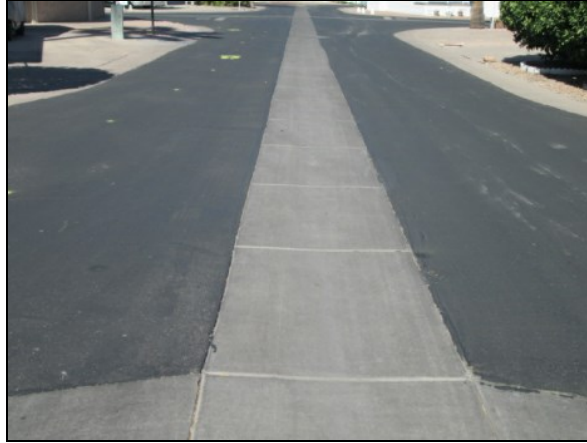
Comp #: 234 Valley Gutters - Replace (B)

History: Replaced in 2016-17 for \$53,480.

Comments: There is an extensive amount of concrete valley gutters throughout the community. A portion was replaced in 2016-17, so this component funds long-term replacement again.

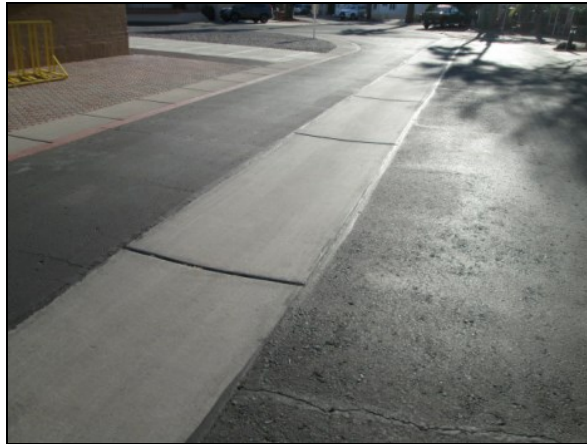
Comp #: 234 Valley Gutters - Replace (C)

History: Replaced in 2019-20 for \$217,981.

Comments: There is an extensive amount of concrete valley gutters throughout the community. A large portion was replaced in 2019-20, so this component funds long-term replacement again.

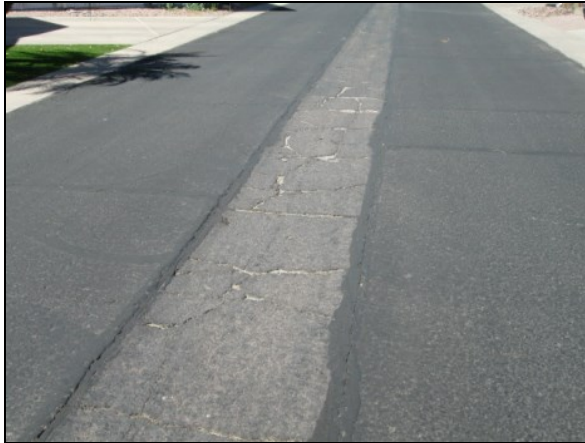
Comp #: 234 Valley Gutters - Replace (D)

Comments: Pavement plan schedules replacement of these valley gutters in 2021.

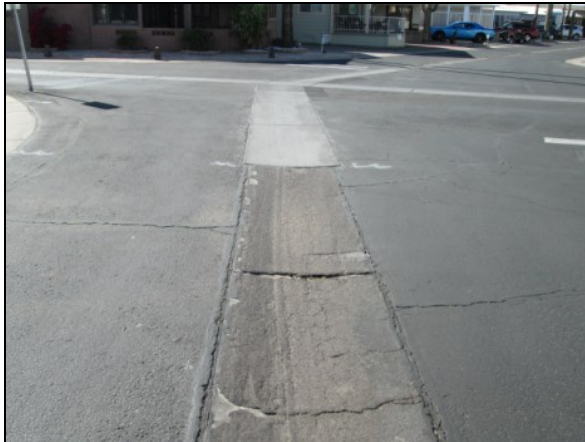
Comp #: 234 Valley Gutters - Replace (E)

Comments: Pavement plan schedules replacement of these valley gutters in 2022.

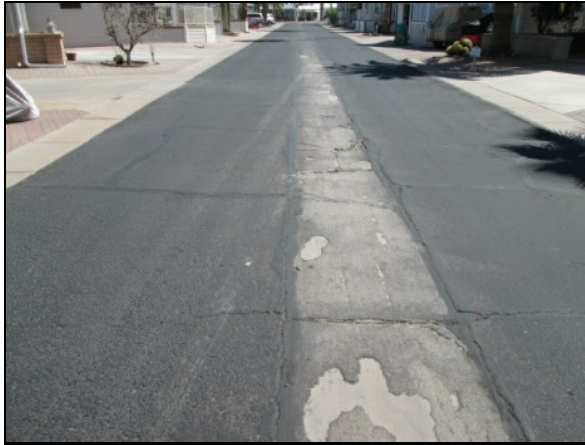
Comp #: 234 Valley Gutters - Replace (F)

Comments: Pavement plan schedules replacement of these valley gutters in 2023.

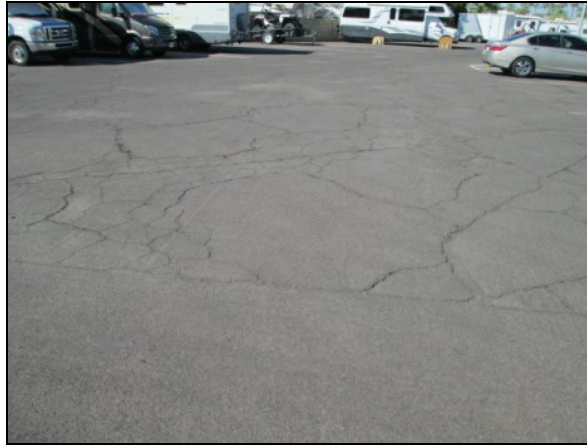
Comments: Pavement is still old and in poor condition. It has not been maintained. Heavy alligating and cracking evident. Some spots are still in decent shape. Repaving is needed, but this area is a lower priority. It is not included in the pavement plan for the next few years.

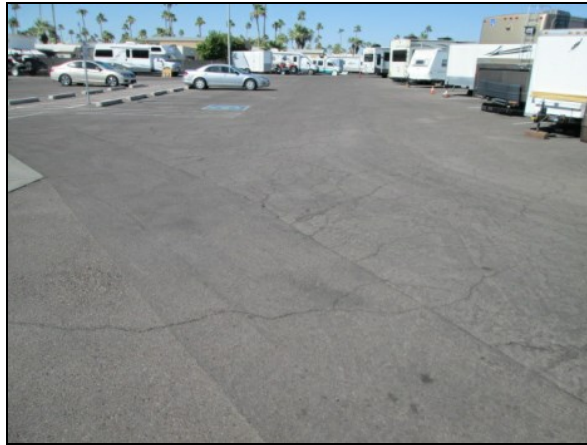
Comp #: 251 Asphalt Parking (SE) - Seal/Repair

History: Last repaired & sealed in 2009-10 for ~\$9,262.

Comments: Seal is completely worn off. This area is not included in the pavement plan. At this point, it does not appear worthwhile sealing until after it has been repaved. Remaining life is scheduled to occur 1-year after repaving. Seal coat asphalt surfaces regularly to prevent premature cracking and deterioration.

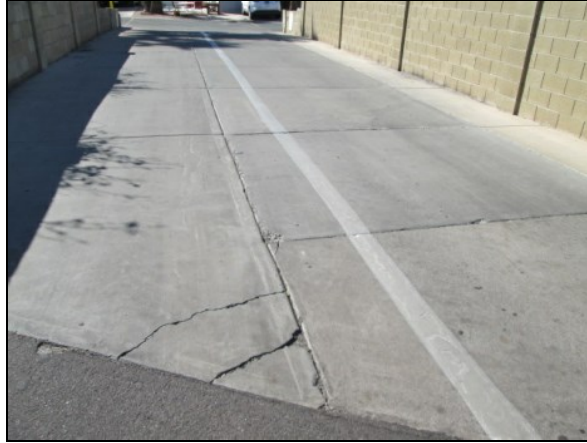
Comp #: 254 Concrete Drive (SE) - Replace

Comments: Concrete driveway is older but still decent. Some sections have been replaced, and others are old. A few cracks noted. Complete replacement should be anticipated eventually. Recommend coordinating with repaving the asphalt, if possible.

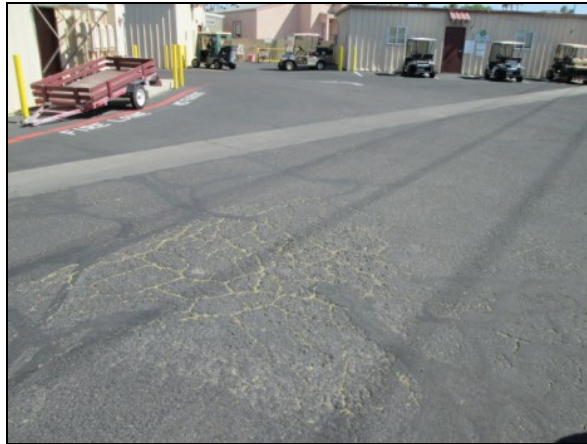
Comments: Moderate cracking as well as alligating visible. Appears older and worn. Repaving is needed soon, but this area is not included in the pavement plan for the next few years.

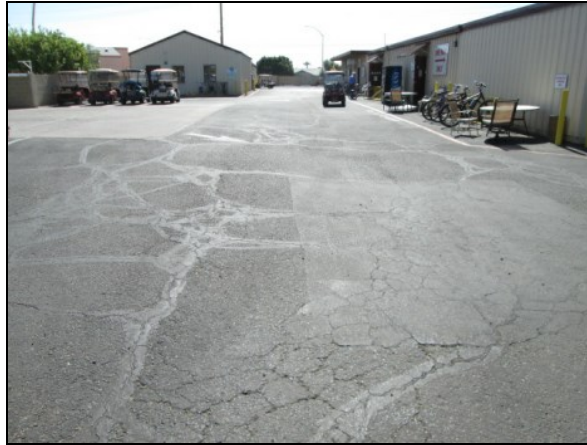
Comp #: 261 Asphalt Parking (HC) - Seal/Repair

Comments: This area is not included in the pavement plan. At this point, it does not appear worthwhile sealing until after it has been repaved. Remaining life is scheduled to occur 1-year after repaving. Seal coat asphalt surfaces regularly to prevent premature cracking and deterioration.

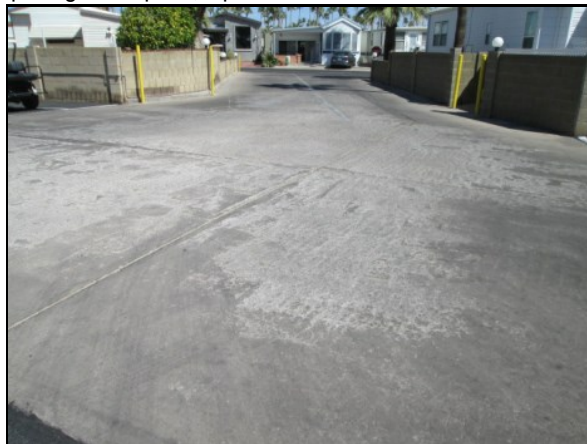
Comp #: 264 Concrete Drive (HC) - Replace

Comments: Concrete appears generally older, rough, and deteriorated. Complete replacement should be expected eventually. Recommend coordinating with repaving the asphalt, if possible.

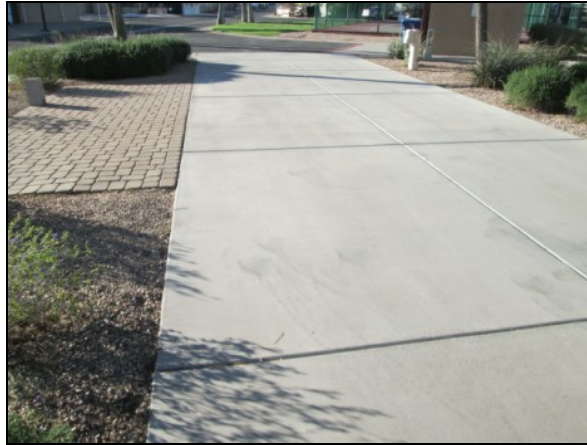
Comp #: 280 RV Spaces - Replace

Comments: RV parking spaces have a combination of concrete (~18,600 sq ft) and concrete pavers (~3,500 sq ft). Good conditions observed. Long life expectancy under normal circumstances. Future replacement should be anticipated to renovate this area again.

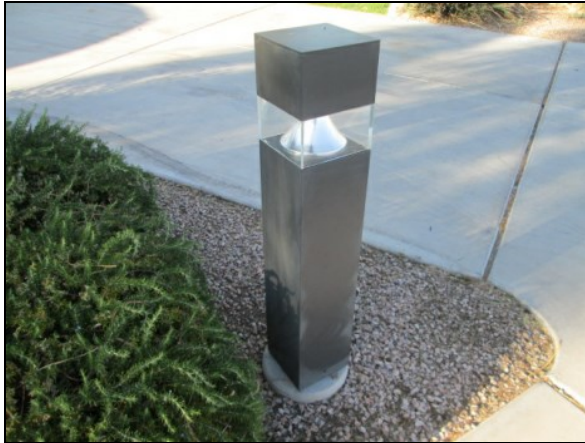
Comp #: 290 Bollard Lights - Replace

Comments: Bollard lights still look good condition. Future replacement should be anticipated.

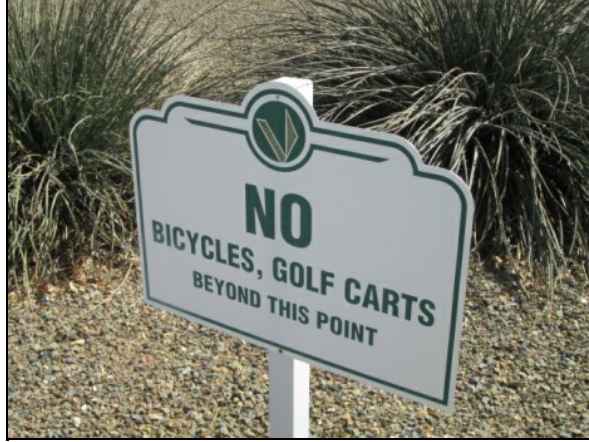
Comp #: 300 Community Signs - Replace

Comments: Total quantity of signs is unknown. This component funds for periodic sign replacement to restore the appearance.

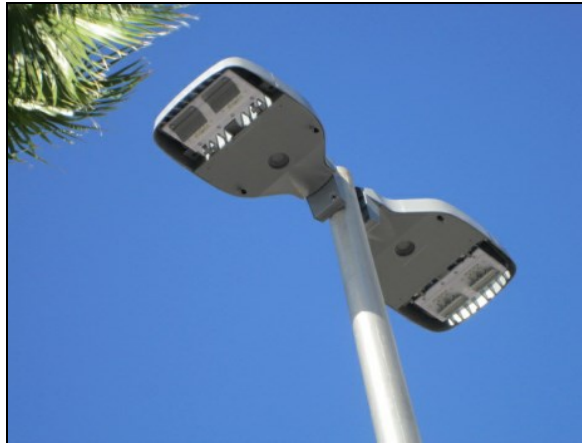
Comp #: 306 Street Lights - Replace (A-LED)

Comments: Street lights with double LED fixtures are mounted in landscape islands on Aztec. All of them were replaced with LED fixtures. Near new and in good condition. Life span varies depending on usage, but the fixtures will not last as long as the poles.

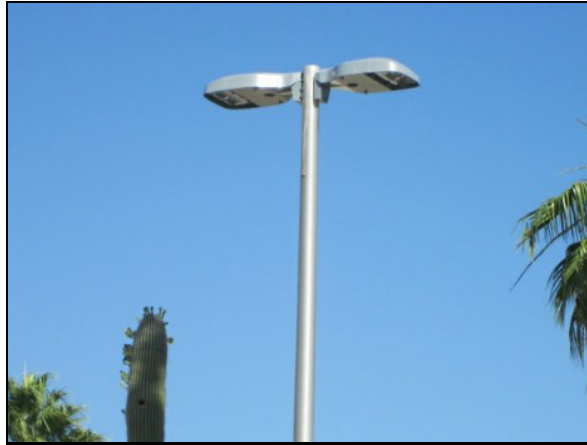
Comp #: 306 Street Lights - Replace (A-Pole)

Comments: The metal light poles will last longer than the light fixtures, but replacement should still be anticipated eventually.

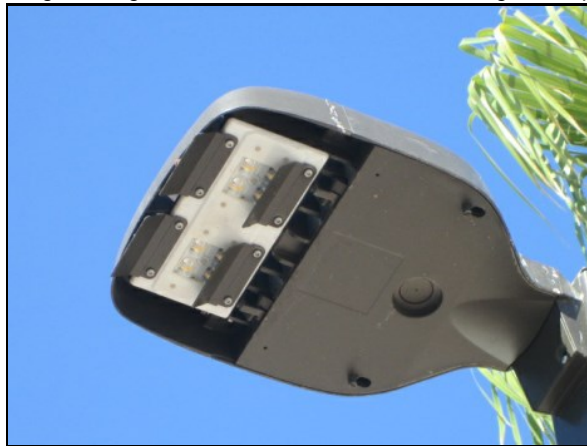
Comp #: 307 Street Lights - Replace (B-LED)

Comments: The small, residential pole lights were replaced with commercial quality poles and LED fixtures. Near new and in good condition. Life span varies depending on usage, but the fixtures will not last as long as the poles.

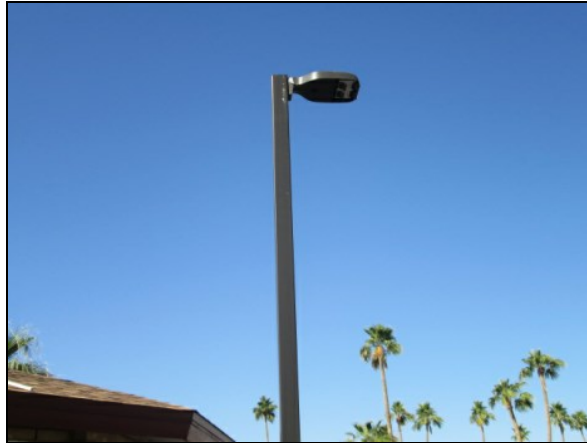
Comp #: 307 Street Lights - Replace (B-Pole)

Comments: The metal light poles will last longer than the light fixtures, but replacement should still be anticipated eventually.

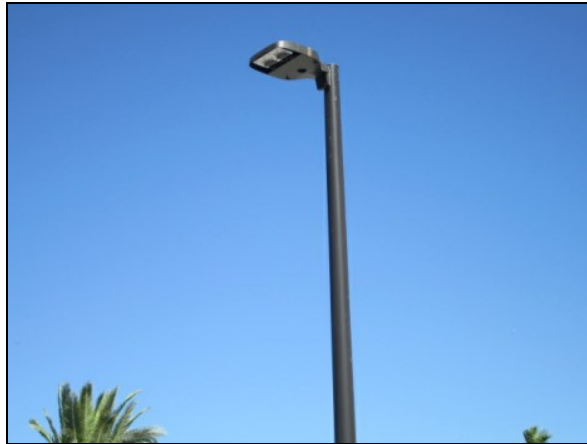
Comp #: 308 Street Lights - Replace (C-LED)

Comments: The small, residential pole lights were replaced with commercial quality poles and LED fixtures. Near new and in good condition. Life span varies depending on usage, but the fixtures will not last as long as the poles.

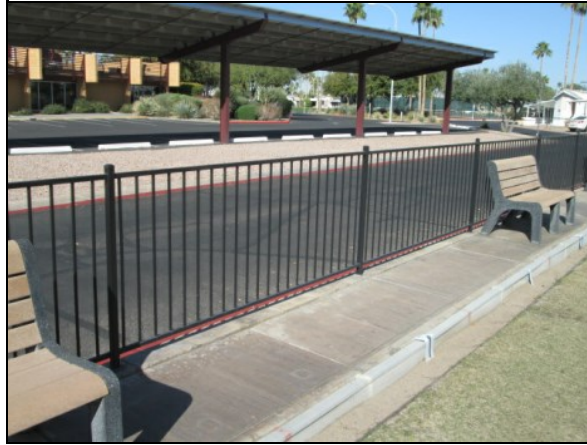
Comments: Paint surfaces vary in condition. Most fences and gates look older and faded. Recommend painting more frequently to maintain the appearance and to inhibit rusting.

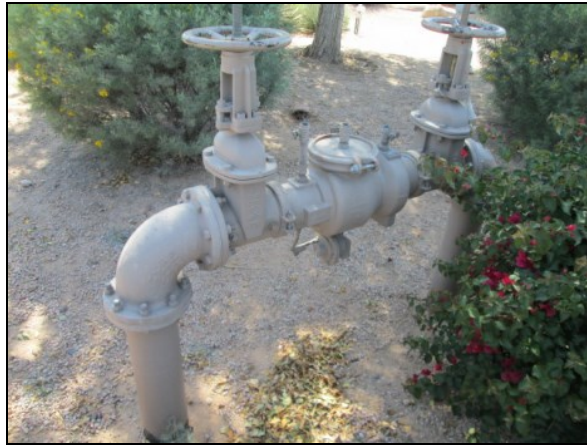
Comp #: 340 Backflow Valves - Replace

Comments: City of Mesa required installation of these backflow pressure reducers. The initial cost was much higher than budgeted replacement due to running new pipe, etc. This component funds to replace the backflow valves, but not all of the underground pipes. Both valves have had reports of leaking and will be repaired soon.

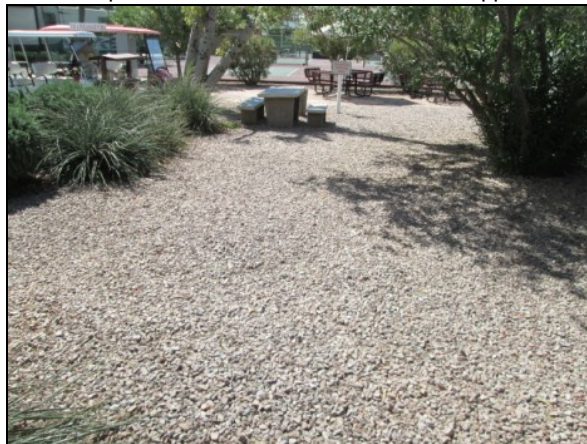
Comments: There is no expectancy to completely replace the granite or replenish the entire community at one-time. Periodic replenishing with a new 1" layer should be planned to maintain and restore the appearance. Most areas still look well covered.

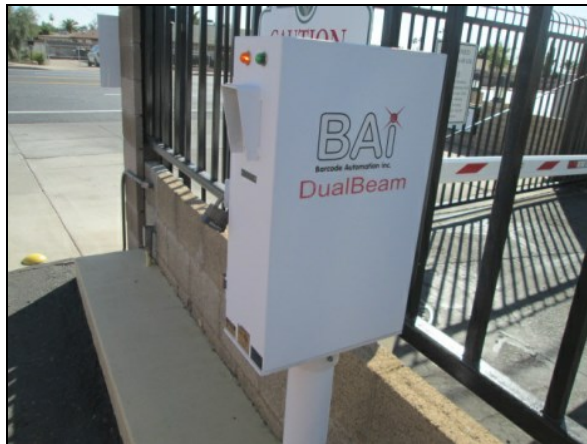
Comp #: 380 Barcode Readers - Replace

Comments: Barcode readers appear to be functional and in fair condition. No problems were observed or reported.

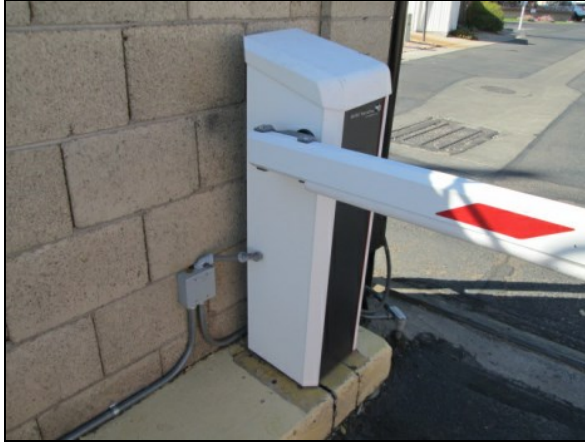
Comp #: 382 Barrier Arm (Entry) - Replace

Comments: This is a newer barrier arm unit. Functional and appears to be in good condition.

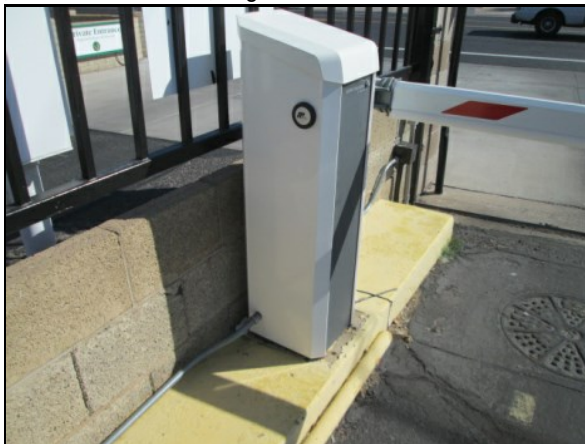
Comp #: 383 Barrier Arm (Exit) - Replace

Comments: This is a higher quality, more expensive barrier arm than was previously installed. Still appears to be in good condition.

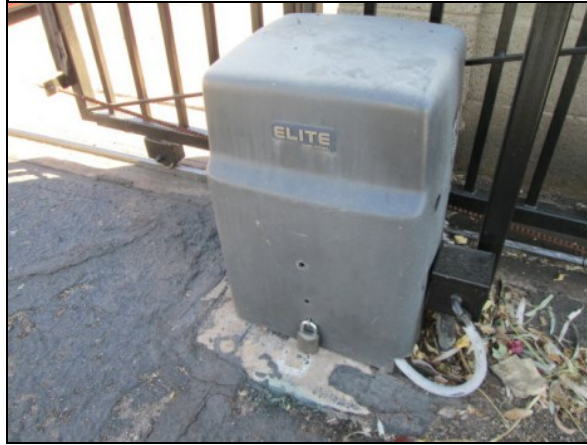
Comp #: 384 Gate Operators - Replace

Comments: These gate operators are still functional. They are getting very old and should be due for replacement soon.

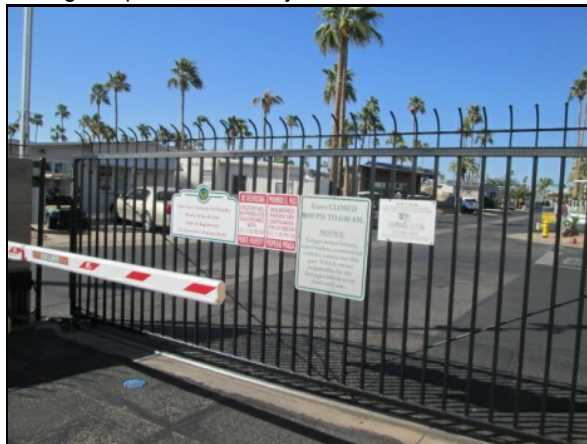
Comp #: 388 Vehicle Gates - Replace

Comments: These rear gates are older but look fine. Vehicle gates have a long life expectancy under normal circumstances. They can often be repaired or rebuilt as needed. Future replacement should be planned to update or modernize the gates. This component accounts for the (2) 22 LF gates plus 22 LF of adjacent fence.

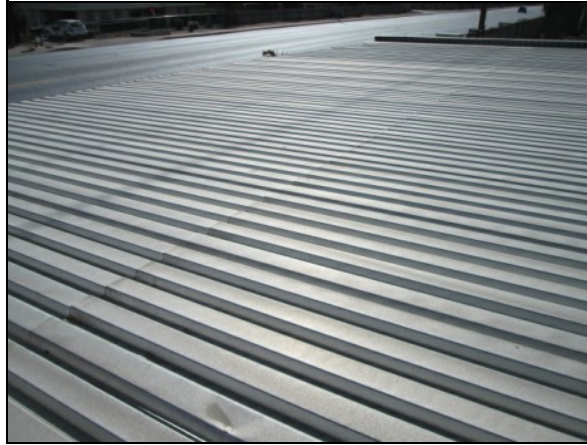
Comp #: 390 Storage Roof - Replace

Comments: Storage building has a metal roof system with low slope, so it looks flat. Age of this roof is unknown, but no problems were reported. Some minor dents noted.

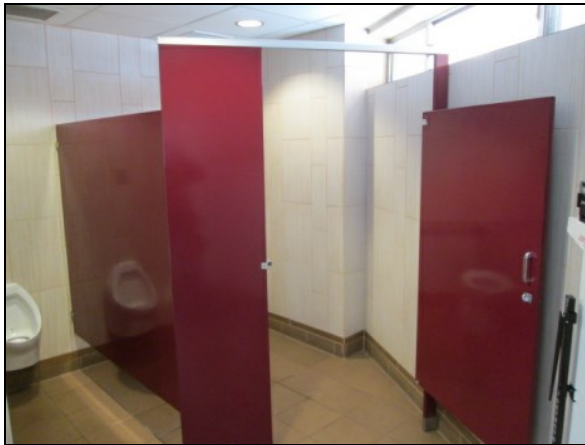
Comments: These restrooms are clean and in good condition. Complete remodel of both restrooms should be expected again in the future. Project includes replacement of the tile surfaces, sinks, counters, toilets, stall doors, hand dryers, etc.

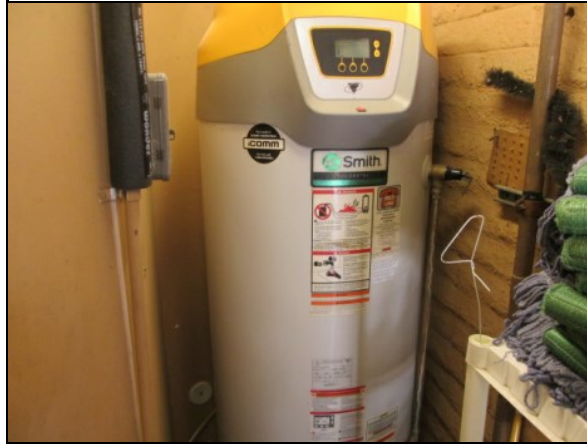
Comp #: 504 Water Heater - Replace

Comments: Water heater is getting older. There is rust around the bottom of the tank. It is likely nearing time for replacement.

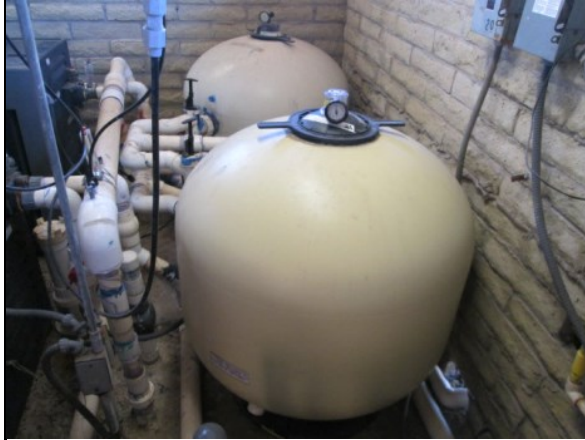
Comp #: 560 Pool Filter #1 - Replace

Comments: Pool filter is old and should be nearing time for replacement.

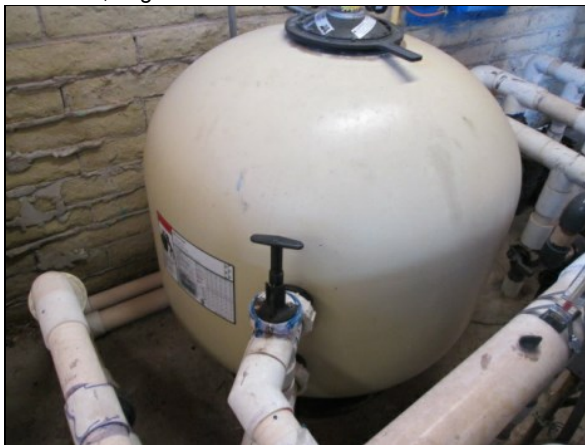
Comp #: 561 Pool Filter #2 - Replace

Comments: This filter is newer and appears to be in good condition.

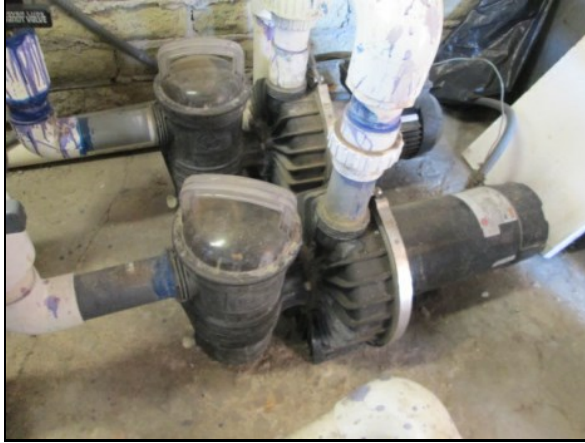
Comp #: 564 Pool Pumps - Replace

Comments: These pumps are getting old. Still functional at the time of inspection. Periodic repair and motor replacement should be addressed as a maintenance issue. This component funds for replacement of the pump and motor assembly.

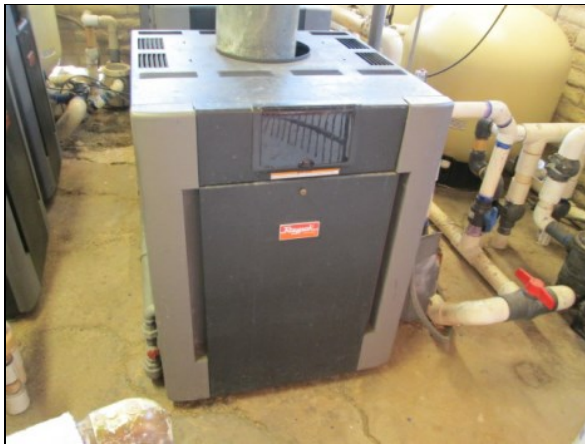
Comp #: 567 Pool Heater #1 - Replace

Comments: Fair condition. Minor corrosion noted, but no visible rusting.

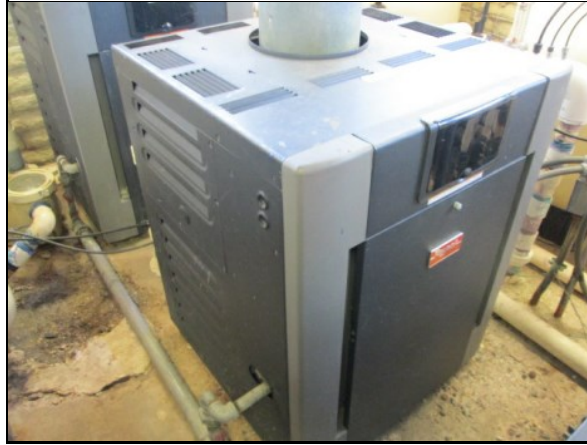
Comp #: 568 Pool Heater #2 - Replace

Comments: Heater appears to be in fair condition.

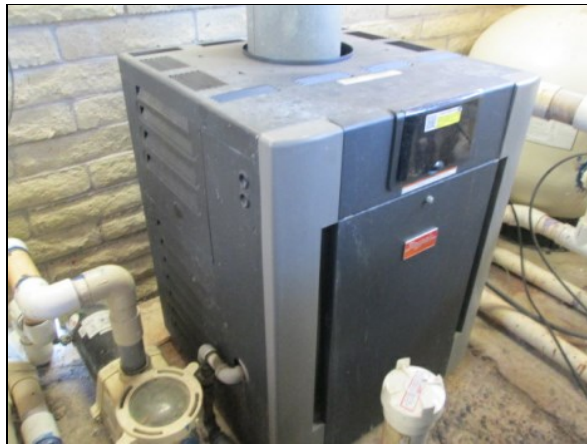
Comp #: 569 Pool Heater #3 - Replace

Comments: Heater is newer and still in good condition.

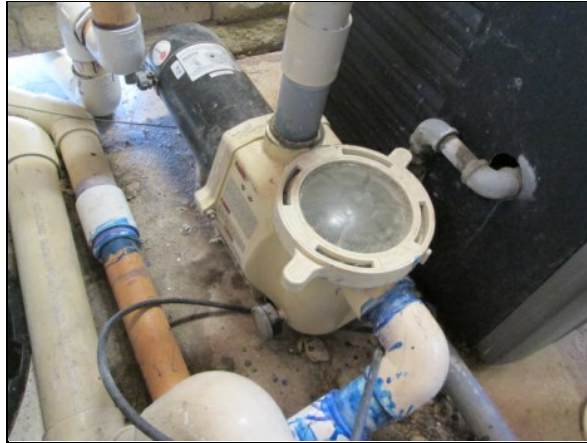
Comp #: 574 Spa Pumps - Replace

History: Replacement is planned in 2022 as part of a pool area renovation. Previously replaced in 2009.
Comments: Pumps are still from 2009. Variable speed motors have all been replaced with regular motors. Pumps look older and should be nearing time for replacement. Periodic repair and motor replacement should be addressed as a maintenance issue. This component funds for replacement of the pump and motor assembly.

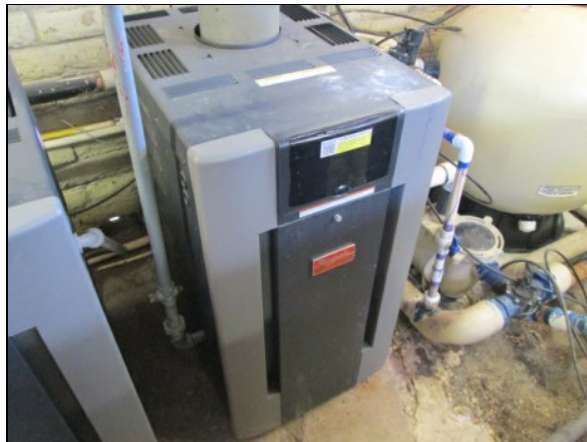
Comp #: 577 Spa Heater (North) - Replace

History: Replacement is planned in 2022 as part of a pool area renovation. Previously replaced in 2018-19 and around 2008-09.
Comments: This heater services the north spa. It still looks newer and is in good condition.
*Model: P-R206A-EN-C, Serial #1812348649

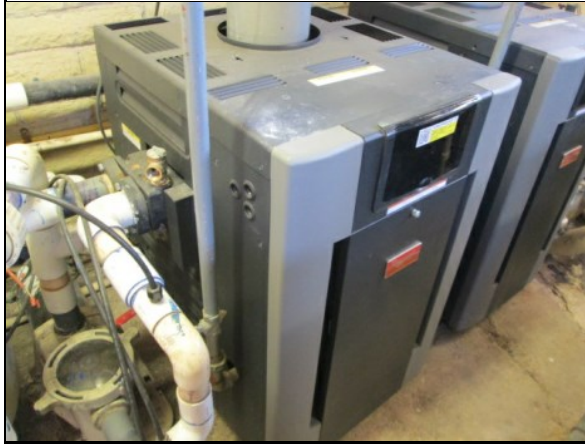
Comp #: 578 Spa Heater (South) - Replace

Comments: This heater services the south spa. It still looks newer and is in good condition.

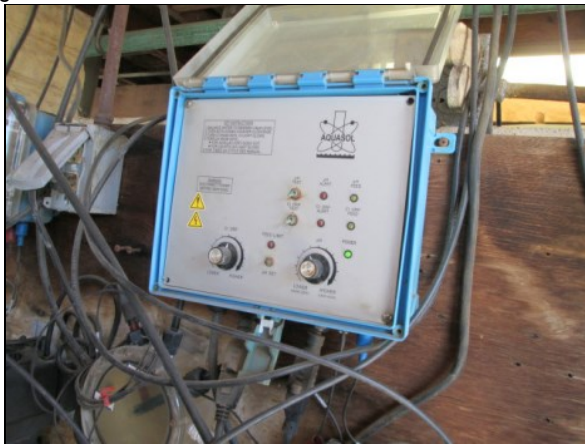
Comp #: 580 Chlorinator (Pool) - Replace

Comments: This chlorinator services the pool. Still intact and appears to be in fair condition. This component funds replacement of the chlorinator system, not just the control panel.

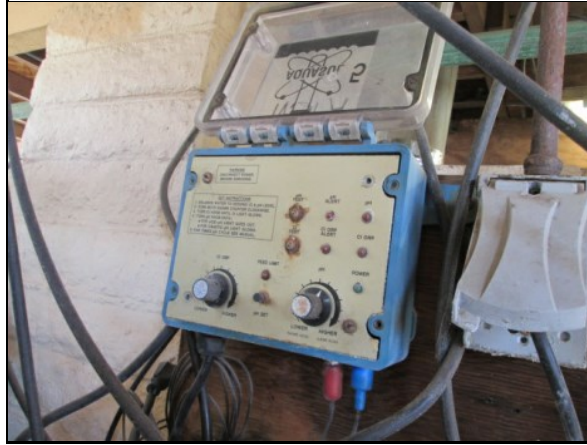
Comp #: 581 Chlorinator (N. Spa) - Replace

Comments: This chlorinator services the north spa. It looks very old and should be replaced in the near future.

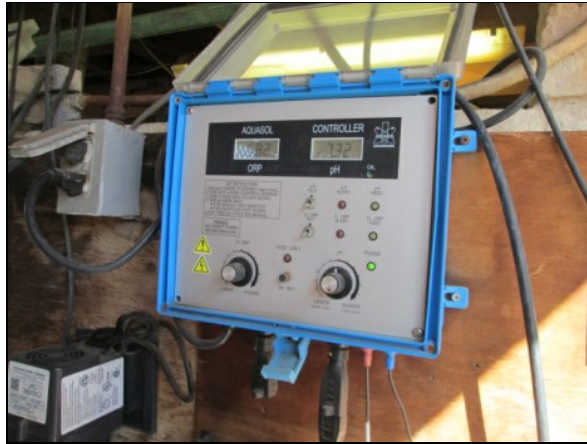
Comp #: 582 Chlorinator (S. Spa) - Replace

Comments: This chlorinator services the south spa. It is newer and appears to be in good condition.

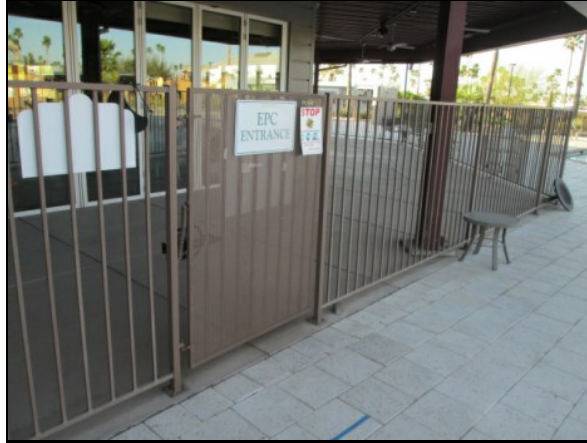
Comp #: 600 Pool Fence - Replace

Comments: Quantity accounts for fencing that ranges from 4' to 7' tall, (4) sets of large, double entry gates, and ~310 LF of single handrails. A lot of the fence and gates were replaced as part of the 2014 renovation project, but some of it was not replaced.

Surfaces look older and rusty in spots. HOA paints the fence as an Operating expense.

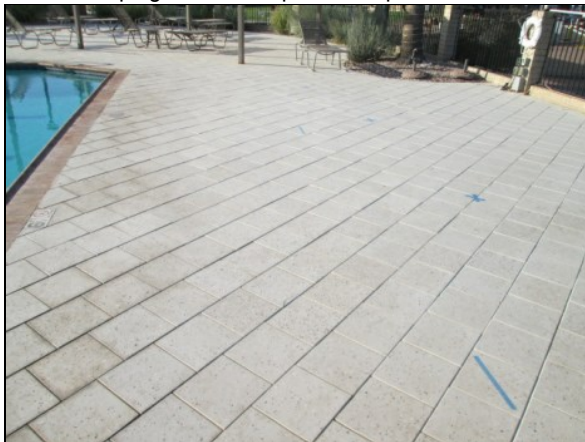
Comp #: 610 Pool Deck - Replace

Comments: The paver deck surface looks good. There are some stains around the pool perimeter and light deterioration on brick coping. This type of deck does not require sealing or maintenance, just cleaning. Long life expectancy, but future replacement should still be planned. Quantity includes coping around the pool and spas.

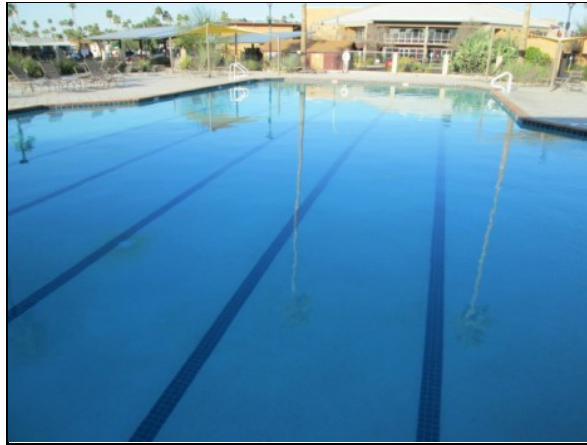
Comments: Pool has a pebble finish with waterline tile. It is 6.5' deep on one end and 4' deep on the other. Surface looked a little dirty or stained.

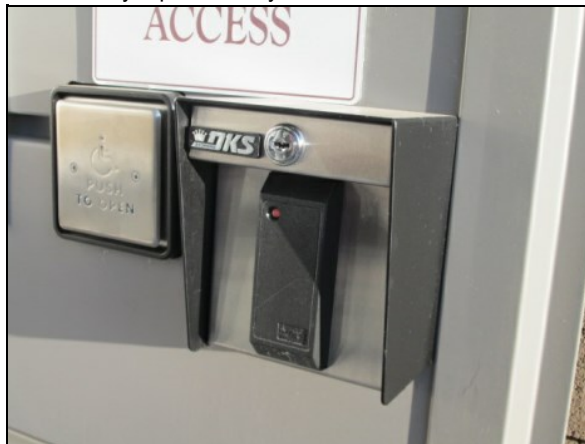
Comp #: 651 Keycard System - Replace

Comments: A keycard system was added for the EPC clubhouse and pool area. Repair and replace parts as a maintenance expense. This component funds to eventually replace the system.

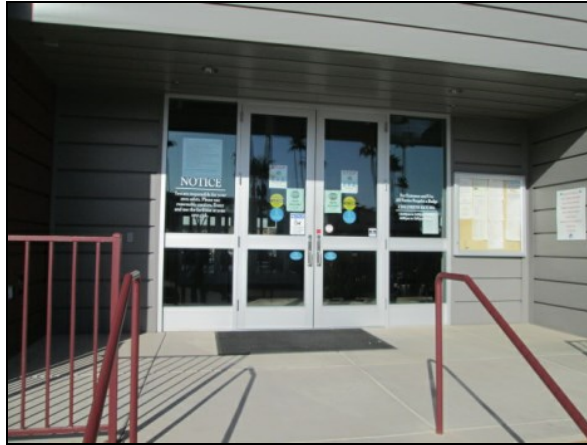
Comp #: 652 Doors - Replace

Comments: Quantity includes (4) commercial quality, storefront style aluminum & glass, (16) aluminum & glass folding/retracting doors, and (7) steel closet-style doors. Long life expectancy. It is prudent to plan for eventual replacement. Individual replacements should be treated as an Operating expense.

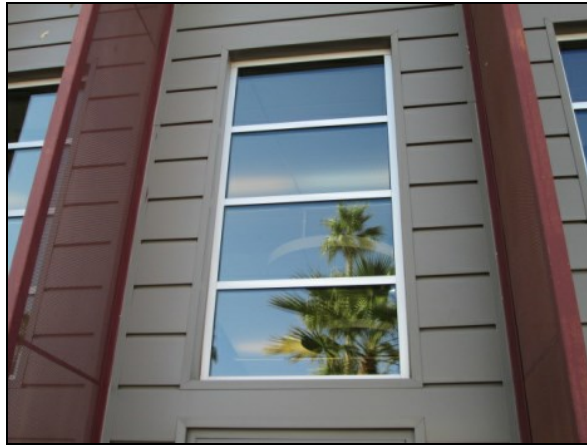
Comp #: 653 Windows - Replace

Comments: There are (16) commercial/storefront quality window sections with a surface area of ~630 sq ft, plus another (31) glass block windows with a surface area of ~305 sq ft. Long life expectancy under normal circumstances. It is prudent to plan for replacement eventually. Individual replacements should be treated as an Operating expense.

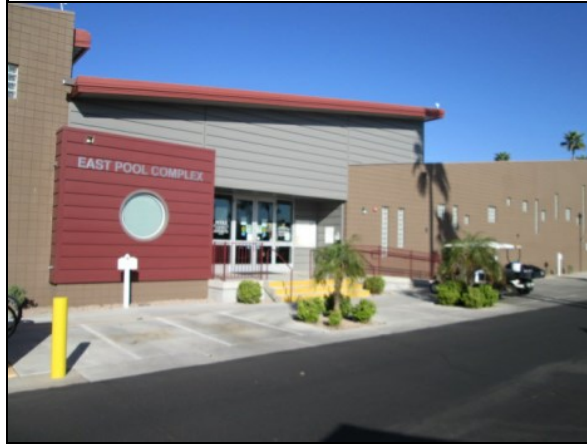
Comments: This component funds to refurbish the building exterior by repairing and painting. Exterior walls include ~7,000 sq ft of painted block and 6,000 sq ft of painted metal trim & ceilings. Surfaces still look well painted and fairly uniform.

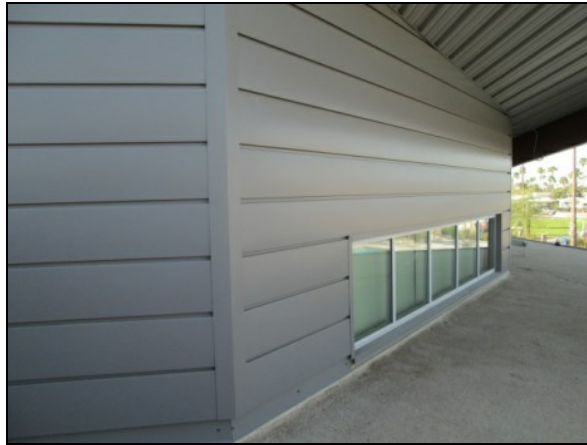
Comp #: 655 Metal Siding - Paint/Replace

Comments: Metal siding installed on this building has a baked-on finish. There is no expectancy to paint or replace the siding. If replacement becomes an issue in the future, then funding can be added to the Reserve Study.

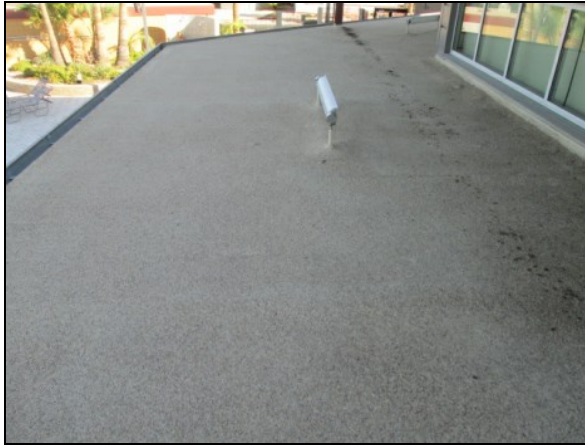
Comp #: 657 Foam Roof - Replace

Comments: The flat roofs on these buildings have a foam system. No visible cracks or blisters. Good conditions observed. Life span is based on re-coating the roof periodically as required. Combined cost with the re-coat component accounts for the total estimated replacement budget.

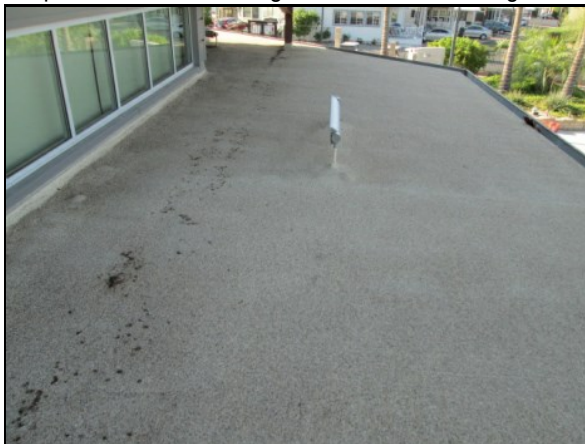
Comments: Foam roof system should have a 10-year initial warranty. This roof should be re-coated at the end of 10-years and then every 5-years thereafter until replacement is needed again. Surfaces still look good. No deterioration, cracks or bubbling.
