Venture Out at Mesa, Inc.
Mesa, AZ

Report #: 15275-3
Beginning: July 1, 2021
Expires: June 30, 2022

RESERVE STUDY
Update "With-Site-Visit"

April 22, 2022

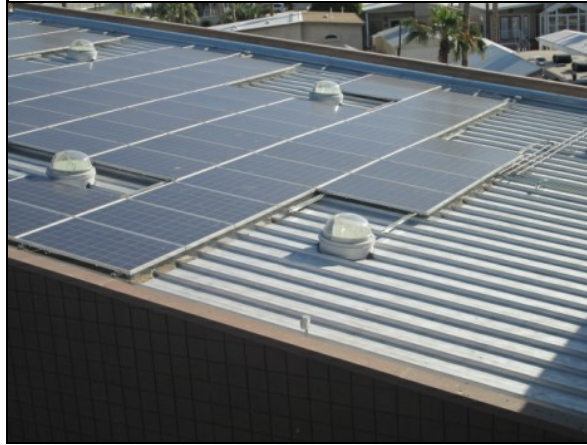
Comp #: 660 Metal Roof - Replace

Comments: This is a standing seam steel roof system. Long life expectancy under normal circumstances. Because this is a roof system, replacement should be planned eventually, even if just for aesthetic purposes.

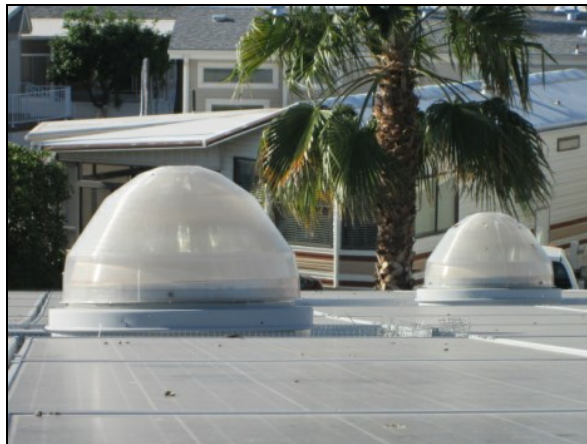
Comp #: 661 Skylights - Replace

Comments: These are round, 2' diameter, dome shaped skylights. Brand is Solar Tube. Good conditions observed. Replacement should be anticipated eventually.

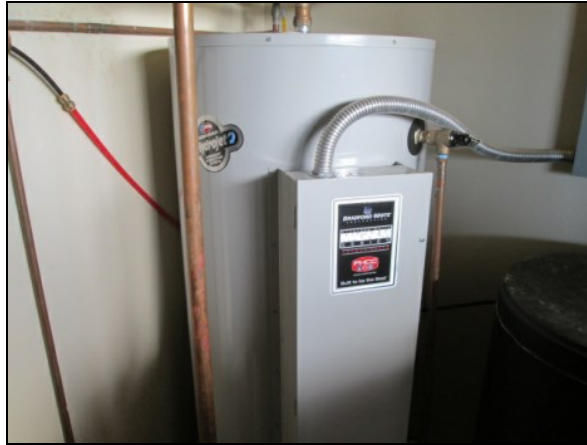
Comp #: 664 Water Heater - Replace

Comments: This is an electric, 119-gallon water heater. It is near new and in good condition. Due to high use, a lower life span is anticipated.

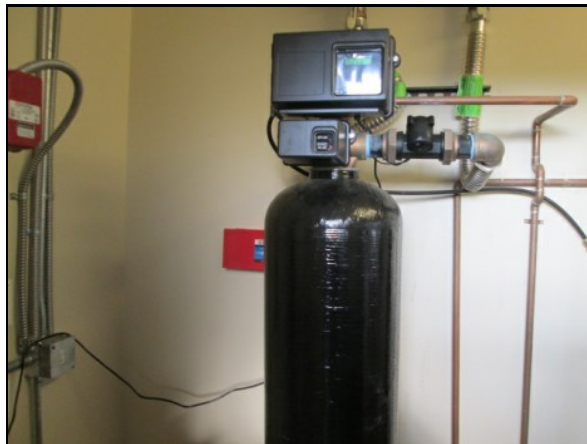
Comp #: 665 Water Softener - Replace

Comments: This softener was installed at some point after our site inspection during 2015. Appears to be in good condition.

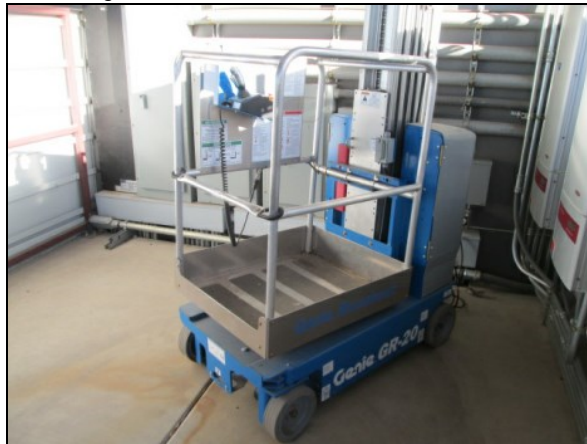
Comp #: 668 Personnel Lift - Replace

Location: EPC Clubhouse - Building Exterior: Storage area with Solar Inverters (south side of the building)
Funded?: Yes.
History: Purchased in 2016 for \$14,841.
Comments: Single person scissor lift used to access high locations. Expected to be in good condition.
*Model: GR-20, Serial #GR16P-43398, Mfg date 5/13/2016

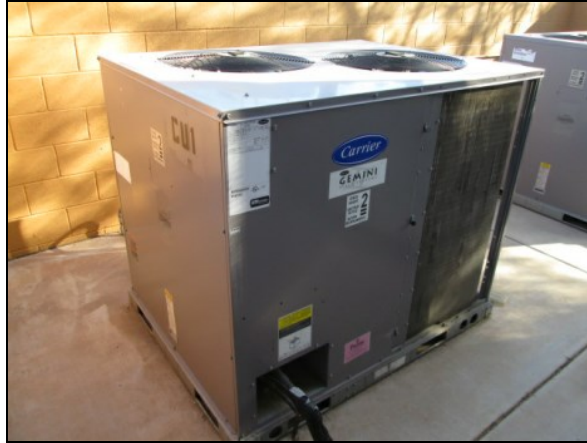
Comp #: 670 HVAC Unit (CU1) - Replace**Quantity: (1) Carrier, 10-Ton**

Comments: This is a split HVAC system. Replacement cost includes both the exterior condensing unit and the interior air handler.
Still appears to be in good shape.

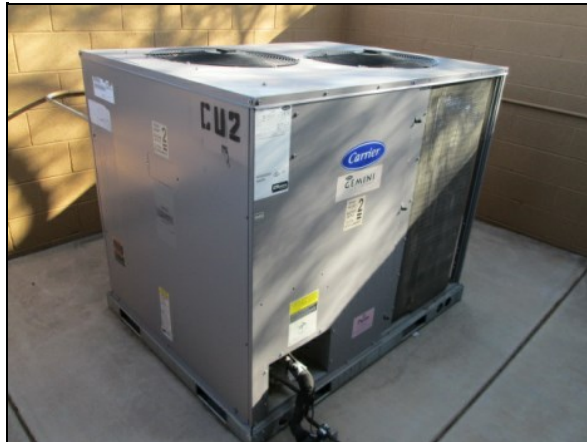
Comp #: 670 HVAC Unit (CU2) - Replace**Quantity: (1) Carrier, 10-Ton**

Comments: This is a split HVAC system. Replacement cost includes both the exterior condensing unit and the interior air handler.
Still appears to be in good shape.

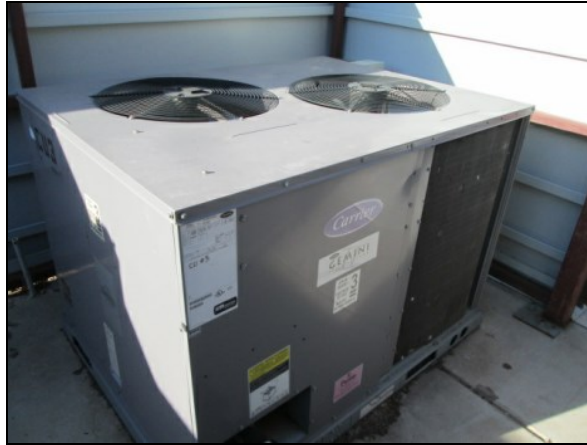
Comp #: 670 HVAC Unit (CU3) - Replace

Comments: This is a split HVAC system. Replacement cost includes both the exterior condensing unit and the interior air handler. Still appears to be in good shape.

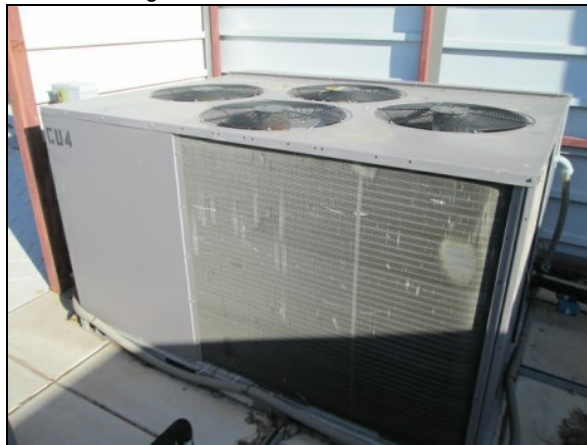
Comp #: 670 HVAC Unit (CU4) - Replace

Comments: This is a split HVAC system. Replacement cost includes both the exterior condensing unit and the interior air handler. Still appears to be in good shape.

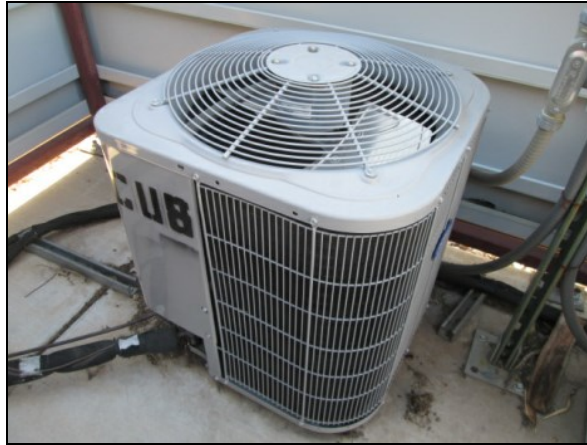
Comp #: 670 HVAC Unit (CU5) - Replace

Comments: This is a split HVAC system. Replacement cost includes both the exterior condensing unit and the interior air handler. Still appears to be in good shape.

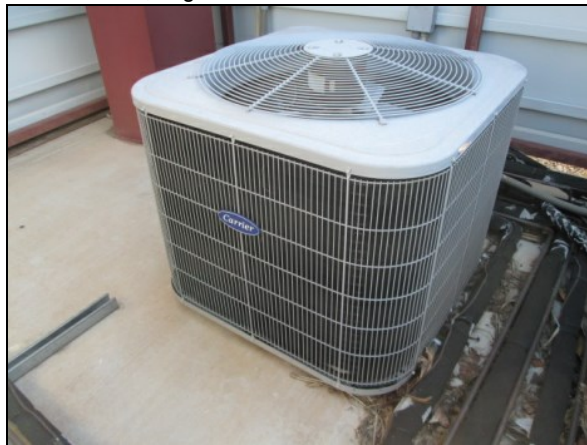
Comp #: 670 HVAC Unit (CU6) - Replace

Comments: This is a split HVAC system. Replacement cost includes both the exterior condensing unit and the interior air handler. Still appears to be in good shape.

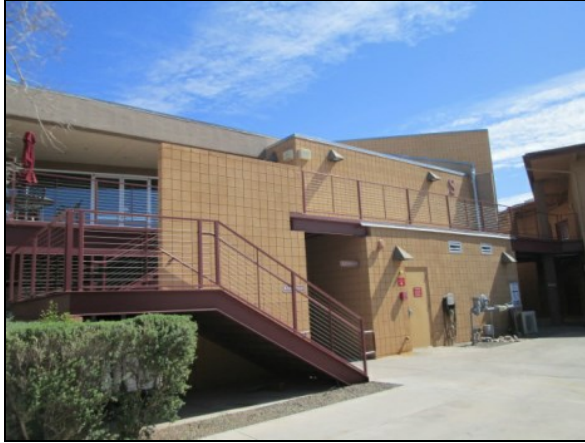
Comments: This component funds to refurbish the building exterior by repairing and painting. Exterior walls are a mixture of stucco and block surfaces. Block surfaces with higher sun exposure look faded and discolored, plus some peeling was noted.

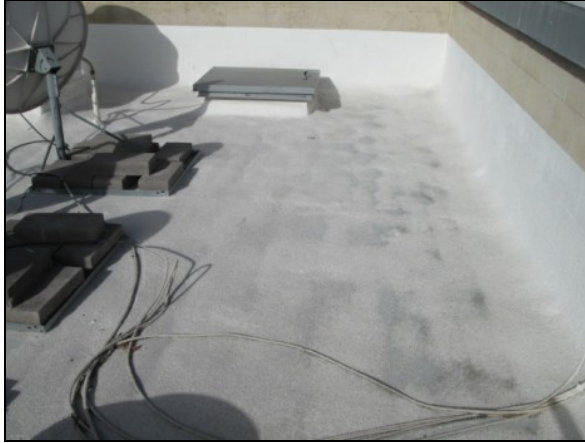
Comp #: 716 Foam Roof - Replace

Comments: This roof still looks good overall. Several repairs were visible in the past. Life span is based on re-coating the roof periodically as required. Combined cost with the re-coat component accounts for the total estimated replacement budget.

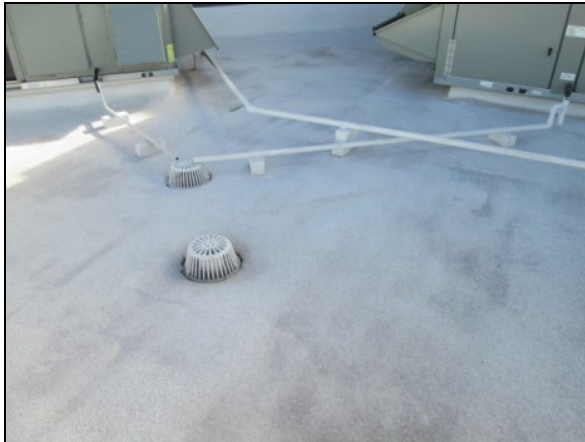
Comments: Both upper and lower roofs look good. There are no bubbles, cracks, or exposed foam visible. This component budgets to re-coat at the end of the initial 10-year warranty and then every 5-years thereafter until replacement is needed.

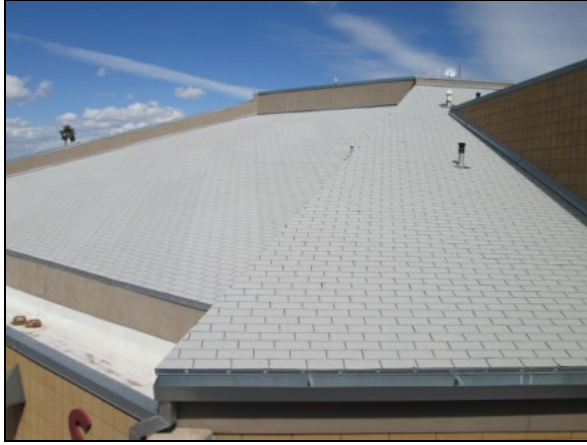
Comp #: 718 Shingle Roof - Replace

Comments: Shingle roof appears to be in fair condition. Some granule loss and minor curling noted in spots. No significant issues observed, and no problems were reported.

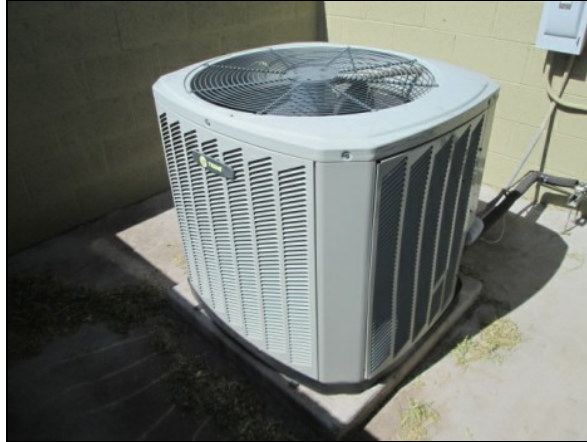
Comp #: 720 HVAC #1 - Replace

History: Replaced only the condenser in 2016 for \$3,601. Installed during 2005-06.

Comments: This is a split system HVAC. Replacement cost includes both the exterior condensing unit and the interior air handler.

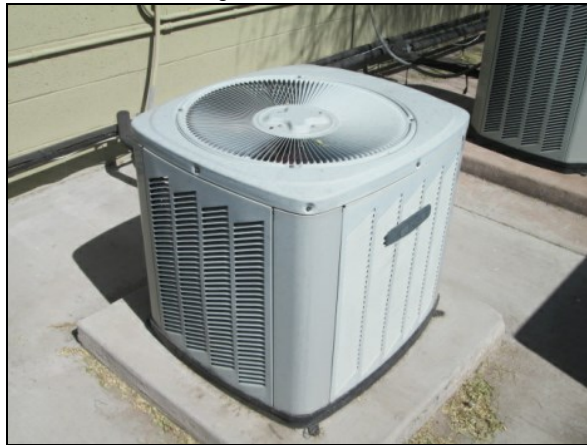
Comp #: 721 HVAC #2 - Replace

Comments: This is a split system HVAC. Replacement cost includes both the exterior condensing unit and the interior air handler. Unit looks aged and weathered.

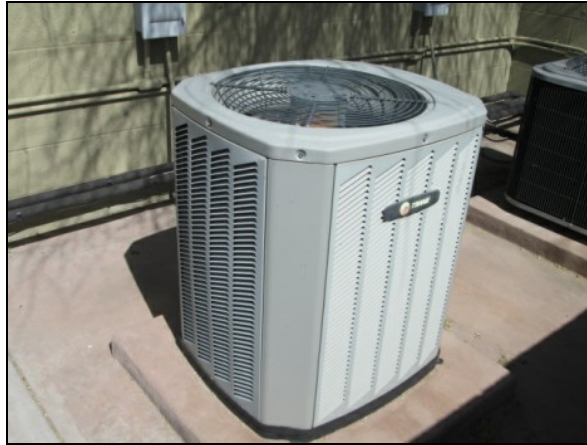
Comp #: 722 HVAC #3 - Replace

History: Replaced in 2013. Previously installed in 2005-06.

Comments: This is a split system HVAC. Replacement cost includes both the exterior condensing unit and the interior air handler. Still in good condition.

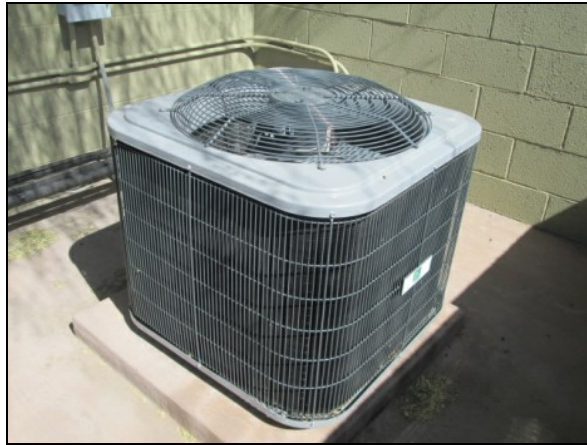
Comp #: 723 HVAC #4 - Replace

History: Replaced in 2019-20. Previously installed in 2005-06.

Comments: This is a split system HVAC. Replacement cost includes both the exterior condensing unit and the interior air handler. Still in good condition.

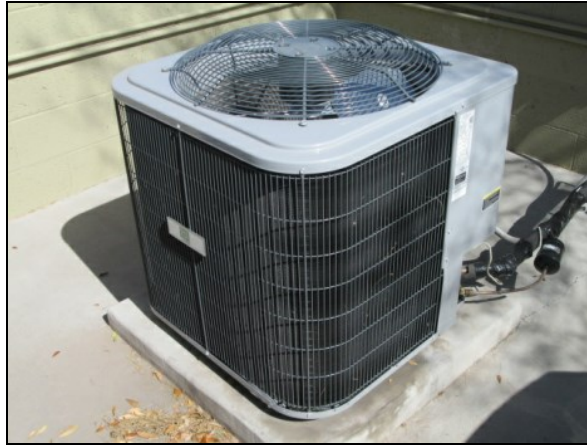
Comp #: 724 HVAC #5 - Replace

History: Replaced in 2019-20. Previously installed in 2005-06.

Comments: This is a split system HVAC that services the Billiards Room. Replacement cost includes both the exterior condensing unit and the interior air handler. Still in good condition.

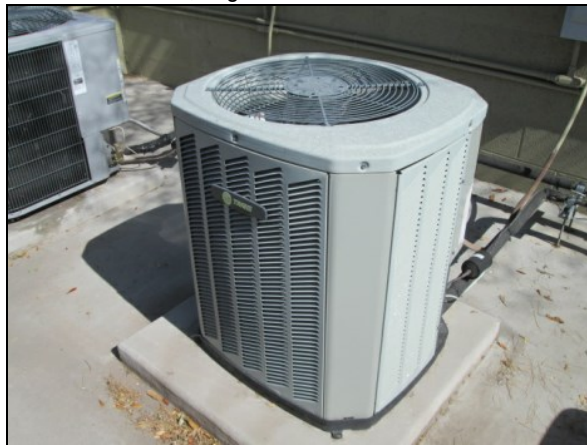
Comp #: 725 HVAC #6 - Replace

History: Replaced 7/2014 for \$2,850. Previously installed in 2005-06.

Comments: This is a split system HVAC that services the Post Office. The 2014 replacement project only included the condenser, so future replacement will need to include the air handler too. Still looks fine and is expected to be in fair condition.

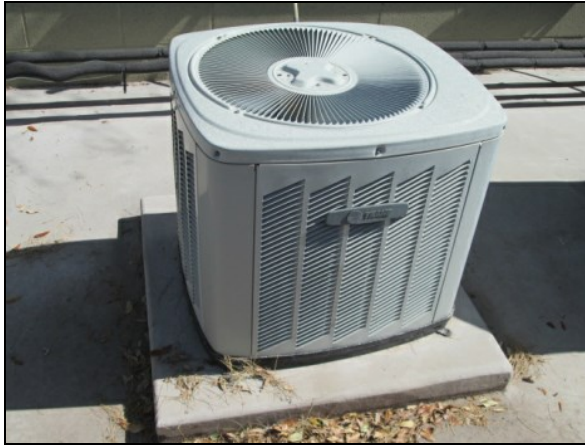
Comp #: 726 HVAC #7 - Replace

Comments: This is a split system HVAC that services the Post Office. Replacement cost includes both the exterior condensing unit and the interior air handler. Looks aged and weathered.

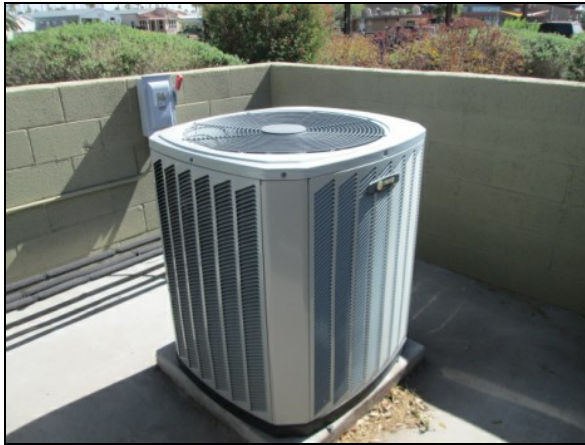
Comp #: 727 HVAC #8 - Replace

History: Replaced in 2016 for \$4,181. Previously installed in 2005-06.

Comments: This is a split system HVAC that services the Billiards Room. Replacement cost includes both the exterior condensing unit and the interior air handler. Still intact and in fair condition.

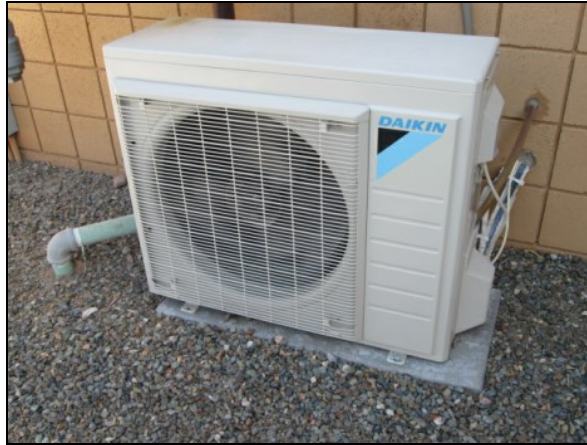
Comp #: 728 HVAC #9 - Replace

History: Replaced in 2017-18 for \$3,400. Previously installed 7/2013 for \$2,500.

Comments: This mini-split HVAC was added for the Dish Network equipment room. Still looks new and is expected to be in good condition.

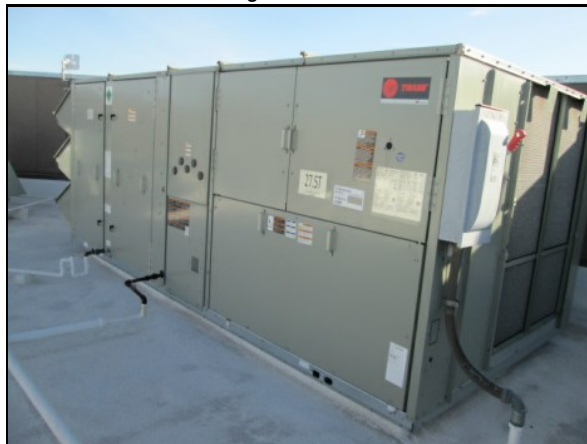
Comp #: 729 HVAC AHU1 - Replace

History: Replaced in 2019-20. Previously installed in 2005-06.

Comments: This is a large, packaged rooftop air conditioner with electric cooling and gas heat. Good condition.

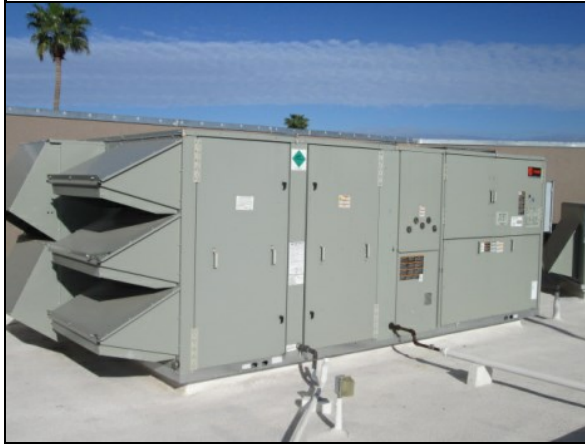
Comp #: 730 HVAC AHU2 - Replace

History: Replaced in 2019-20. Previously installed in 2005-06.

Comments: This is a large, packaged rooftop air condition with electric cooling and gas heat. Good condition.

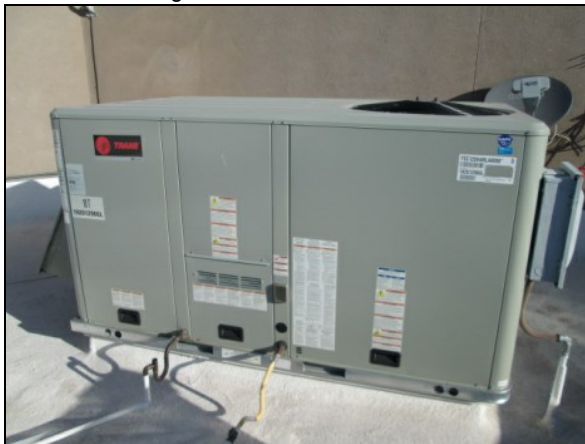
Comp #: 731 HVAC AHU3 - Replace

History: Replaced in 2019-20. Previously installed in 2005-06.

Comments: This is a packaged HVAC system. Still looks newer and is expected to be in good condition.

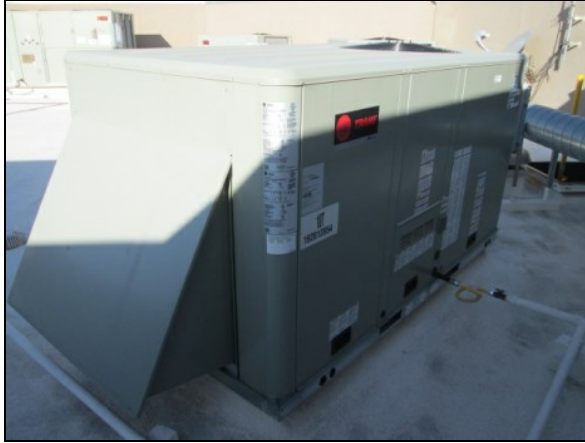
Comp #: 732 HVAC AHU4 - Replace

History: Replaced in 2019-20. Previously installed in 2005-06.

Comments: This is a packaged HVAC system. Still looks newer and is expected to be in good condition.

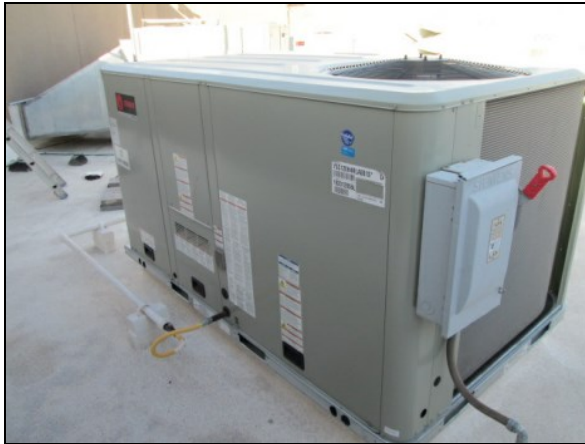
Comp #: 733 HVAC AHU5 - Replace

History: Replaced in 2019-20. Previously installed in 2005-06.

Comments: This is a packaged HVAC system. Still looks newer and is expected to be in good condition.

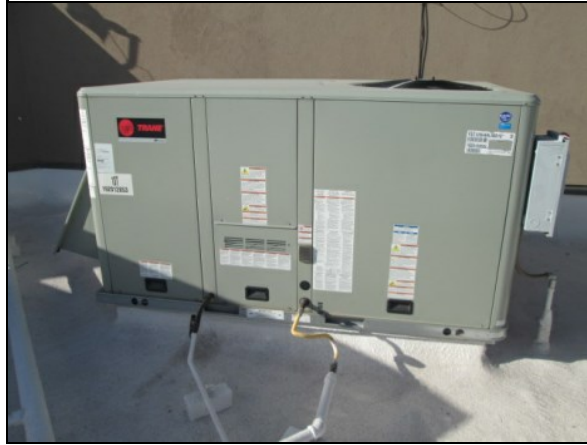
Comp #: 734 HVAC AHU6 - Replace

History: Replaced in 2019-20. Previously installed in 2005-06.

Comments: This is a packaged HVAC system. Still looks newer and is expected to be in good condition.

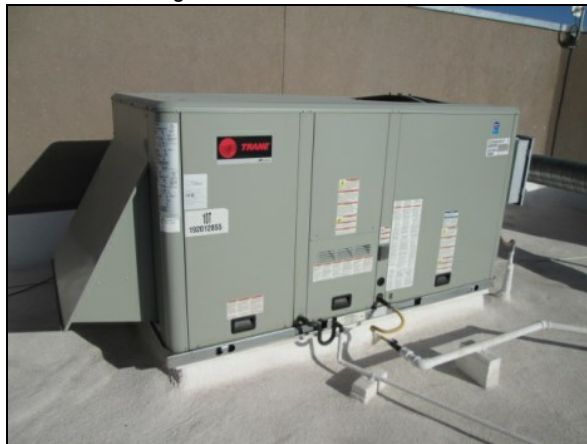
Comp #: 735 HVAC AHU7 - Replace

History: Replaced in 2020. Previously installed in 2005-06.

Comments: This is a packaged HVAC system. Still looks newer and is expected to be in good condition.

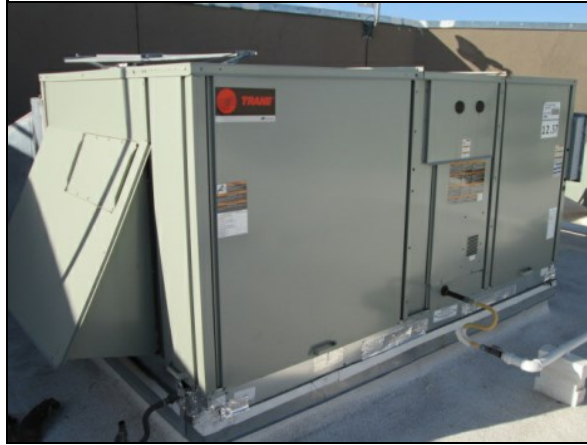
Comp #: 736 HVAC AHU8 - Replace

History: Replaced in 2019-20. Previously installed in 2005-06.

Comments: This is a packaged HVAC system. Still looks newer and is expected to be in good condition.

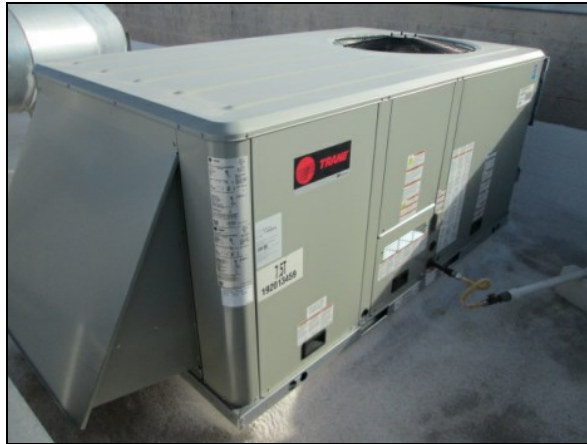
Comp #: 737 HVAC AHU9 - Replace

History: Replaced in 2019-20. Previously installed in 2005-06.

Comments: This is a packaged HVAC system. Still looks newer and is expected to be in good condition.

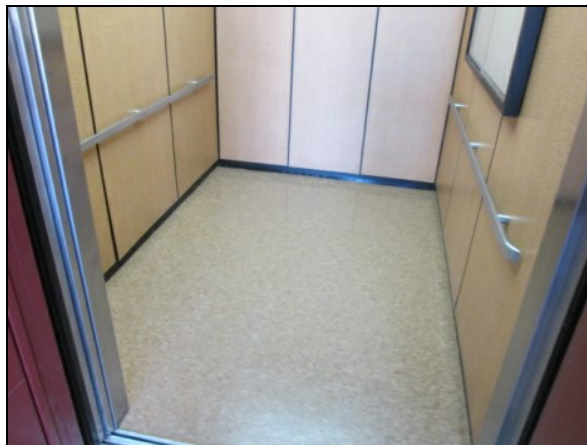
History: Installed in 1997, but it was repaired in 2005-06 for the new Community Center.

Comments: Still appears to be in good working condition. Modernization involves replacement of the controller, door equipment, and push button fixtures.

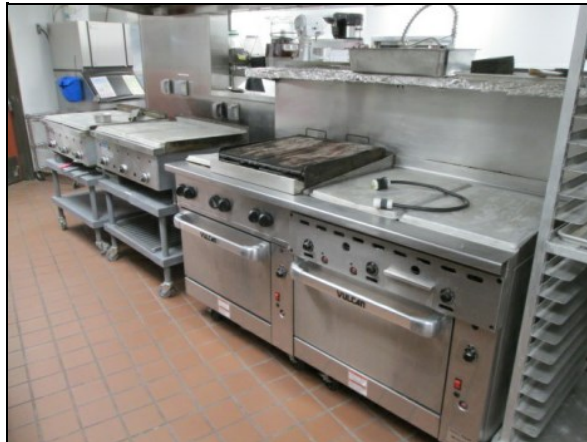
Comp #: 784 Hood & Ansul Systems - Replace

Comments: There are (2) Vent-Matic exhaust hoods and (2) Piranha fire suppression systems. Tanks need to be hydro tested every 12-years and that would be a maintenance expense. Replacement funding has been included at the HOA's request.

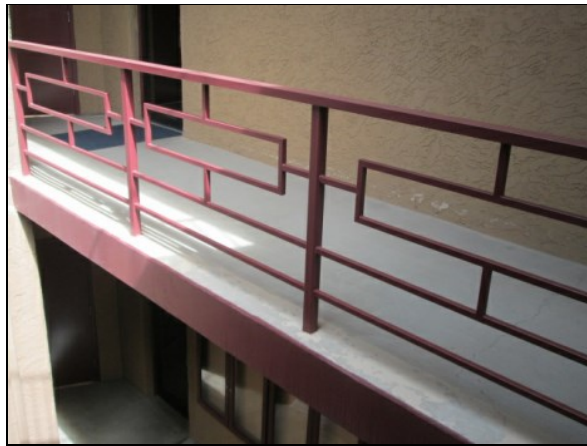
Comments: Exterior has been repainted since 2007, but we do not know when. Paint is still in fair condition. Some faded spots were visible. Repair and repaint periodically to maintain appearance and protect surfaces. Cycle with the Community Center Clubhouse, if possible.

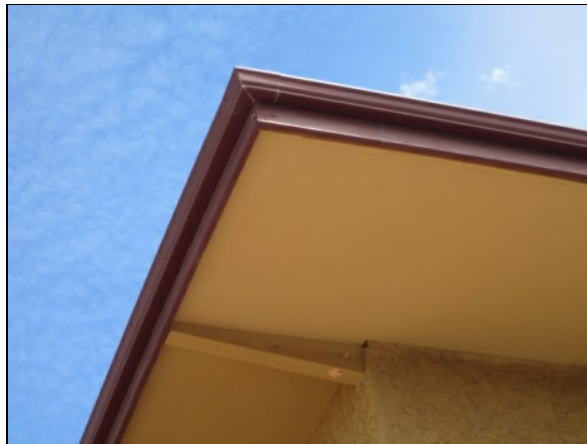
Comp #: 810 Foam Roof - Replace

History: Replaced in 2009 for \$31,706. Previous age was unknown.

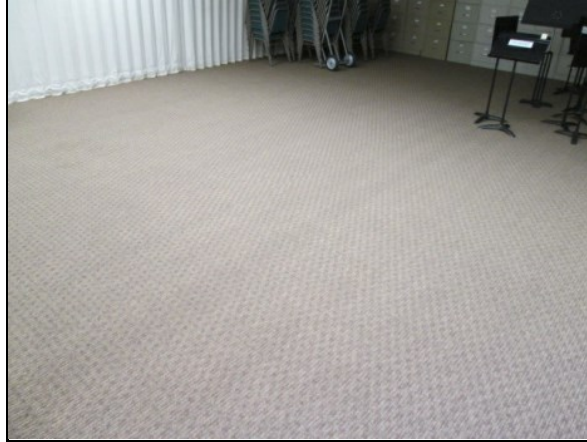
Comp #: 830 Carpet Floor - Replace

Comments: Carpet looks old but is still in fair condition. Some marks and stains visible. Replacement should be considered in the near future.

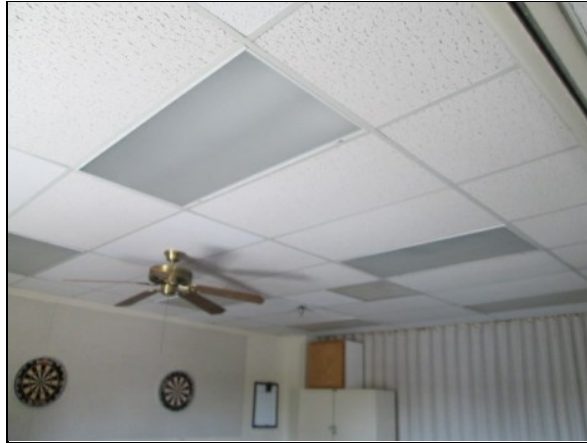
Comp #: 834 Ceiling Tiles - Replace

Comments: All rooms in this building have suspended ceilings. These ceiling tiles have a long life expectancy under normal circumstances. They do look older, but replacement is not a priority at the time. Many of them have been replaced as needed, so they are miss-matched. We recommend planning long-term replacement to eventually update and restore the appearance.

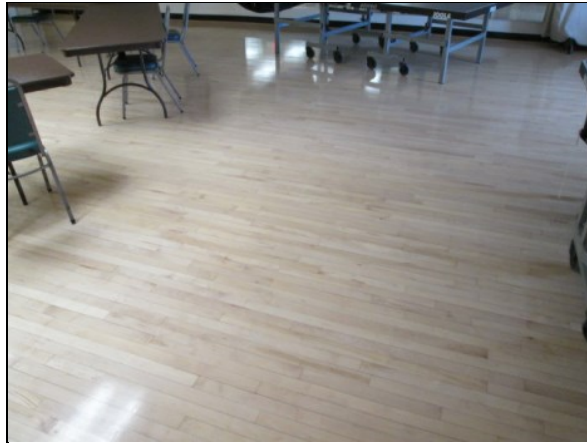
Comp #: 840 Ballroom Floor - Replace

Comments: Floor still appears to be in good condition. Long life expectancy if well maintained.

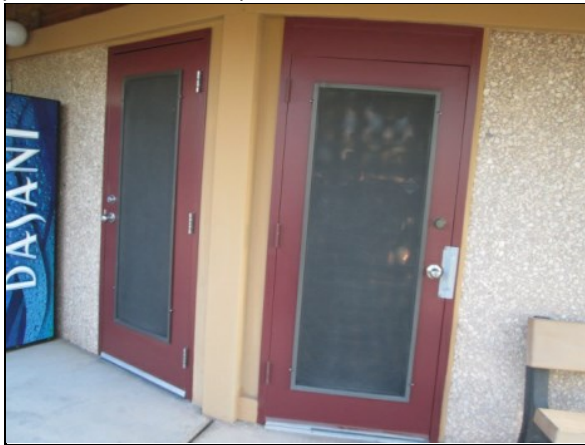
Comp #: 852 Doors - Replace

Comments: Quantity includes (5) commercial quality, storefront style aluminum & glass doors and (5) steel closet-style doors (2 have glass centers). These are older doors, but actual age is unknown. Still appear to be in fair condition. Long life expectancy. It is prudent to plan for eventual replacement. Individual replacements should be treated as an Operating expense.

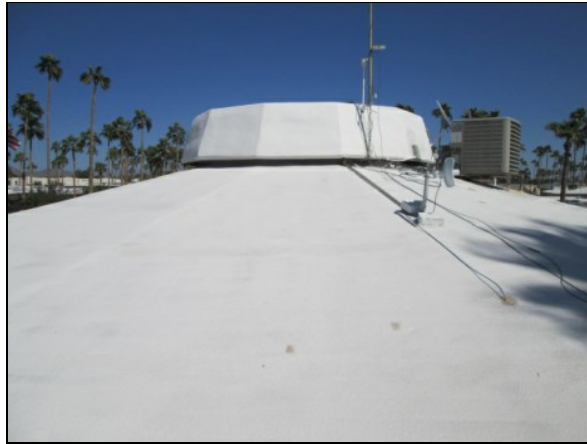
Comp #: 860 Foam Roof - Replace

Comments: This roof is sloped, so it will not get standing water like a typical flat roof. Roof looks older and exhibits some wear, but it does not appear to need replacing yet as long as it is coated soon. Life span is based on re-coating the roof periodically as required. Combined cost with the re-coat component accounts for the total estimated replacement budget.

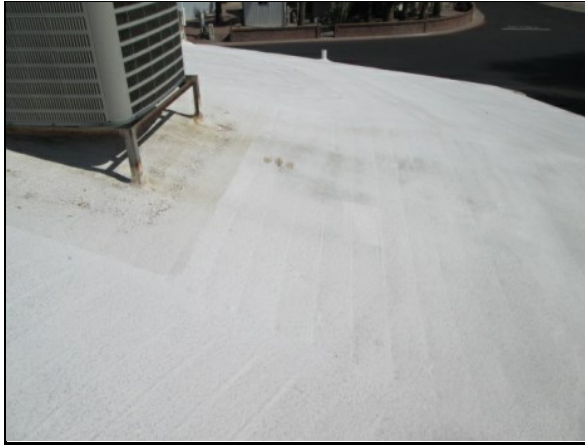
Comments: The 10-year initial warranty on this roof expired in 2010. It should have been re-coated at the end of 10-years. Timing of when this roof was last coated is unknown. There is visible wear on the roof, plus some exposed foam under the HVAC unit. This component budgets to re-coat every 5-years thereafter until replacement is needed.

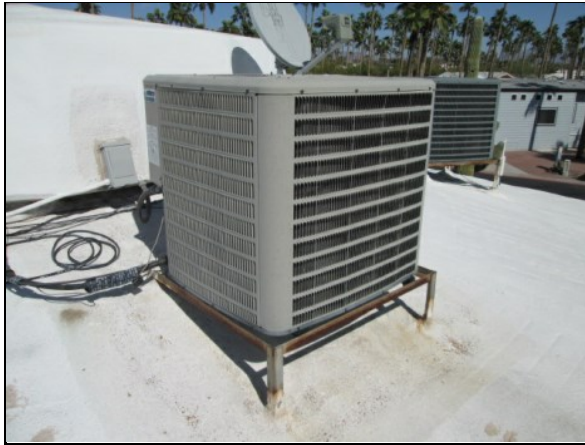
Comp #: 862 HVAC #1 - Replace

Comments: This is a split HVAC system. It looks weather but still in fair condition. Replacement includes both the exterior condensing unit and the interior air handler.

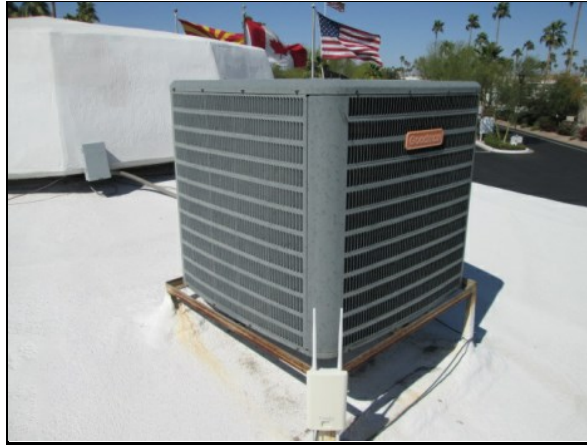
Comp #: 863 HVAC #2 - Replace

Comments: This is a split HVAC system. The 2009 cost is/was high for this type of system, so it may have included additional work we are not aware of. Still functional but looking older. Expected to be nearing time for replacement.

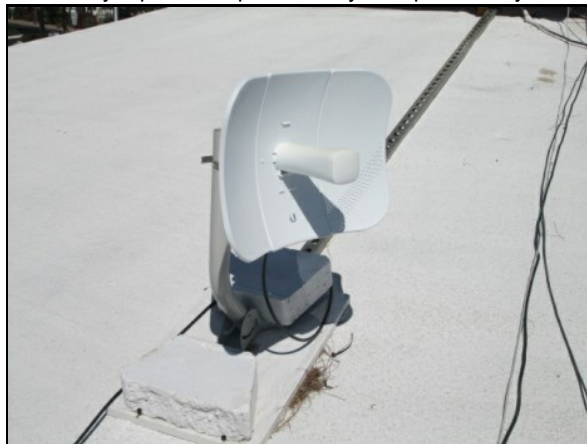
Comp #: 864 Wi-Fi System - Replace

Comments: This system provides Wi-Fi access throughout the community. Treat repairs and individual replacements as a maintenance expense. Expect to eventually replace or update the system periodically.

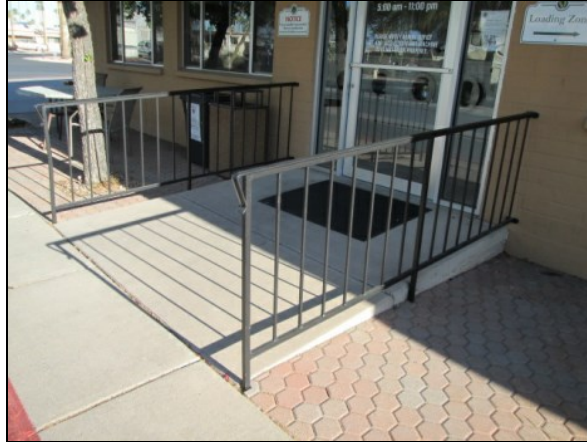
Comp #: 900 Metal Handrails - Replace

Comments: Handrails are mounted at stairs and ramps to the room doors. They appear securely mounted and in overall fair condition. No severe rusting or signs of instability noted. Repairs and painting will be treated as an Operating expense.

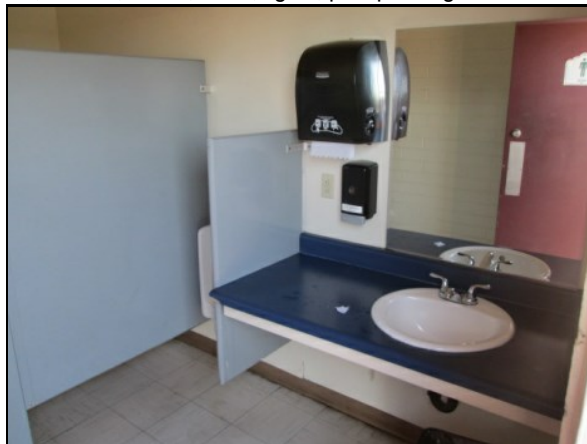
Comments: These restrooms are old but still functional. Recommend remodeling in the near future. This component funds to replace vinyl floor, counters & sinks, mirrors, toilets, stalls, lights, plus painting.

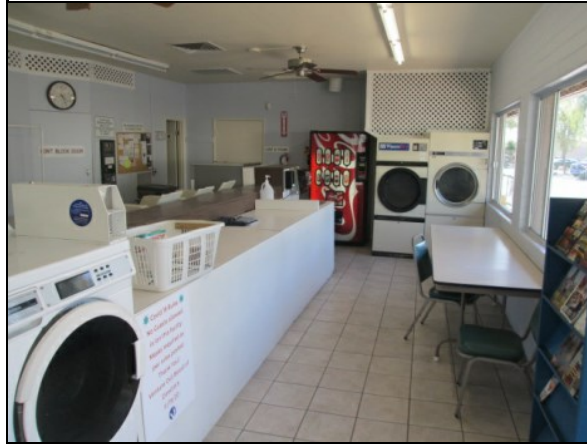
Comments: Interior is older but still in fair condition. Remodeling is not a priority at this time, but it should be planned eventually. This component funds to replace the tile floor, cabinetry, ceiling fans, lights, restroom vanity and toilet, plus painting.

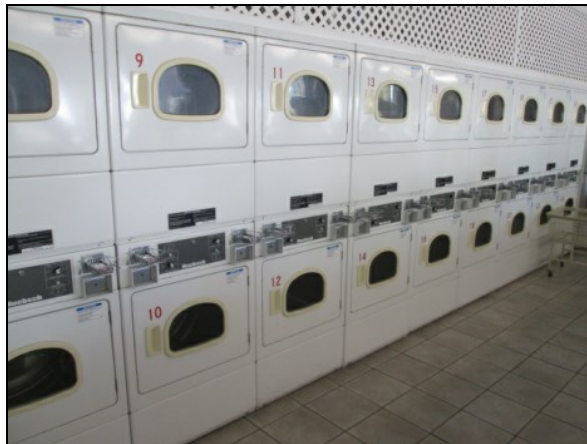
Comp #: 920 Laundry Dryers - Replace (A)

Comments: These dryers are getting old. Still functional, and there are no plans currently to replace. HOA reports these machines are receiving lower use as many residents have installed their own laundry machines. Therefore, this component now funds to replace just half of these dryers.

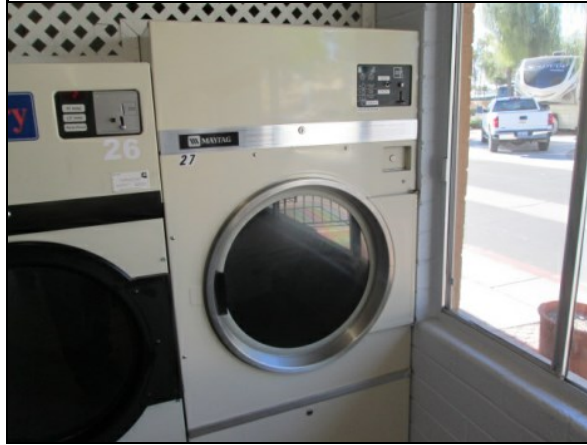
Comp #: 921 Laundry Dryers - Replace (B)

Comments: This is a larger commercial dryer. It is very old but believed to be functional. Based on age, replacement should be anticipated in the near future.

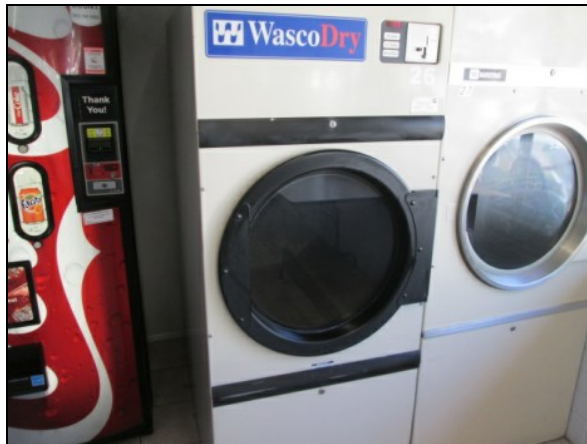
Comp #: 922 Laundry Dryers - Replace (C)

Comments: This dryer receives a lot of use. It is getting old but reportedly still functional. Expected to be nearing time for replacement.

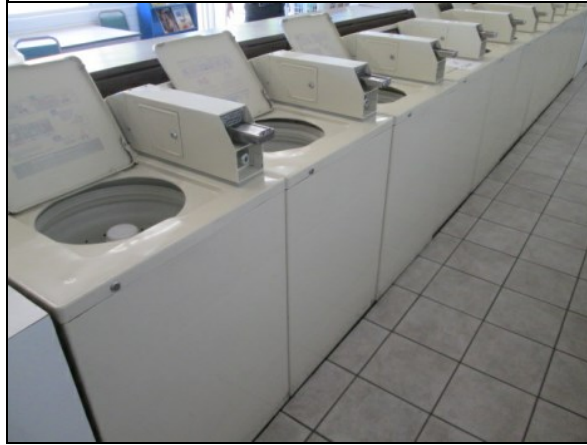
Comp #: 930 Laundry Washers - Replace (A)

Comments: These washers are still functional but quite old. Expected to be nearing time for replacement.

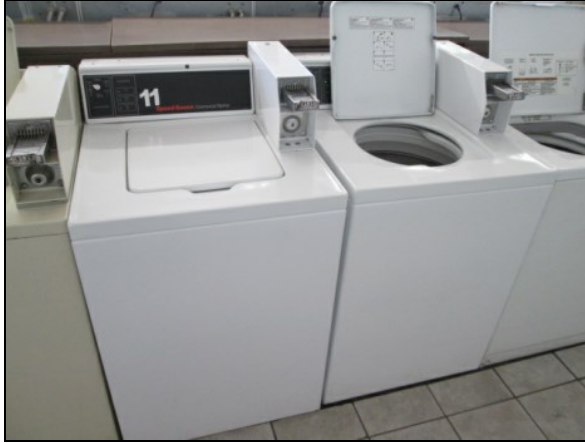
Comp #: 930 Laundry Washers - Replace (C)

Comments: These washers are labeled #10 & #11. They are newer and in good condition.

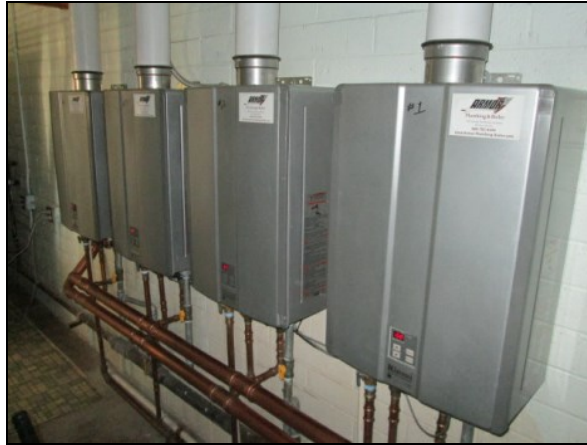
Comp #: 940 Water Heaters - Replace

Comments: These are tankless water heaters. They circulate water constantly, so there is no need for a storage tank. No visible leaks or rust. They appear to be in good condition.

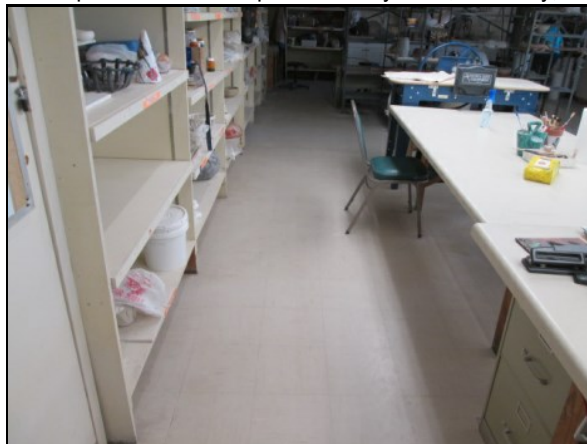
Comments: Ceramics room is mainly a workshop type of location. It is old but clean. Remodeling is not a priority at this time, but it should be planned eventually. This component funds to replace the vinyl floor, cabinetry, and lights, plus painting.

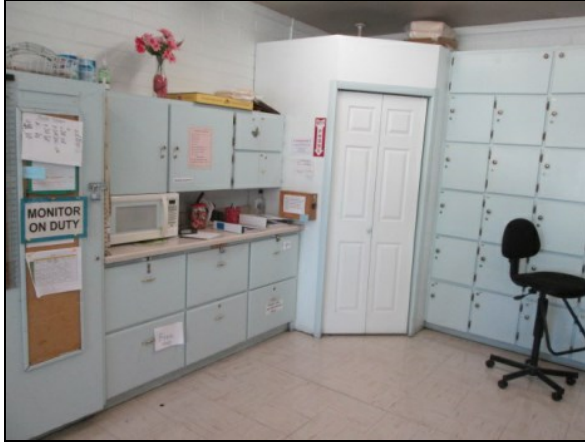
Comments: This room looks older and dated, but clean. Remodeling is not a priority at this time, but it should be planned eventually. This component funds to replace the vinyl floor, cabinetry, ceiling fans, and lights, plus painting.

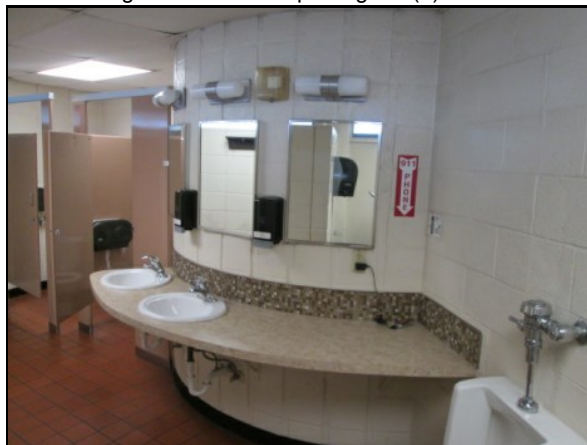
Comments: Looking aged and dated, but still in overall fair condition. Ceiling tiles look old and should be replaced soon. This component funds to replace the tile floors & walls, ceiling tiles, light fixtures, counters, sinks, mirrors, toilets & stalls, shower faucets & doors, and wood benches. Funding also includes replacing the (2) restroom doors and (16) windows.

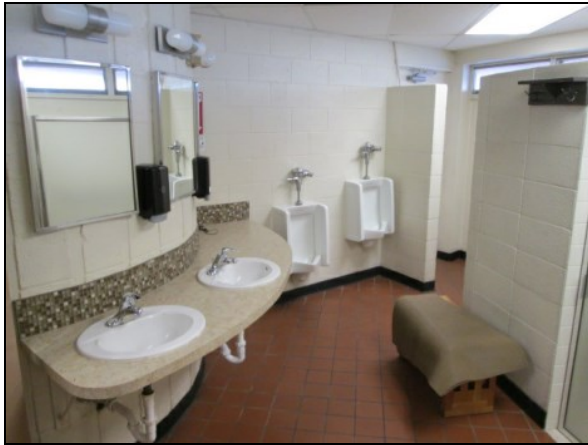
Comments: Looking aged and dated, but still in overall fair condition. Ceiling tiles look old and should be replaced soon. This component funds to replace the tile floors & walls, ceiling tiles, light fixtures, counters, sinks, mirrors, toilets & stalls, shower faucets & doors, and wood benches. Funding also includes replacing the (2) restroom doors and (16) windows.

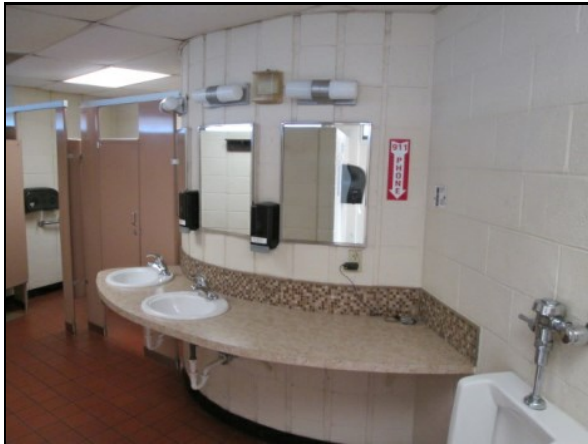
Comments: Looking aged and dated, but still in overall fair condition. Ceiling tiles look old and should be replaced soon. This component funds to replace the tile floors & walls, ceiling tiles, light fixtures, counters, sinks, mirrors, toilets & stalls, shower faucets & doors, and wood benches. Funding also includes replacing the (2) restroom doors and (16) windows.

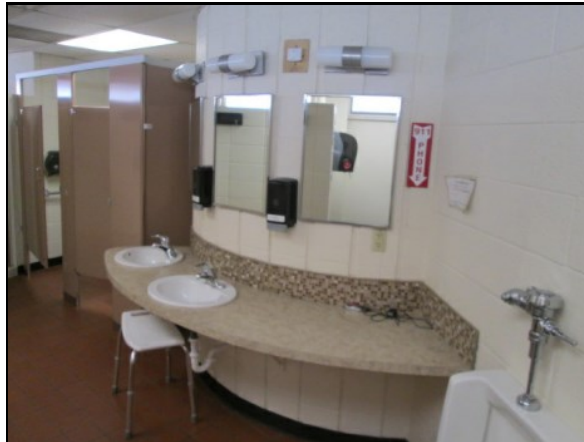
Comments: Looking aged and dated, but still in overall fair condition. Ceiling tiles look old and should be replaced soon. This component funds to replace the tile floors & walls, ceiling tiles, light fixtures, counters, sinks, mirrors, toilets & stalls, shower faucets & doors, and wood benches. Funding also includes replacing the (2) restroom doors and (16) windows.

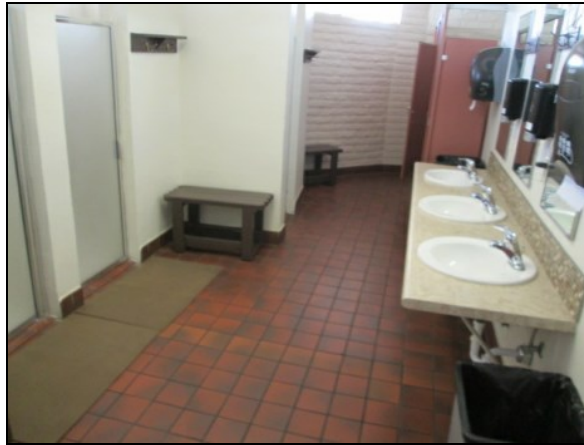
Comments: Restrooms are older and dated, but they are still clean and good shape for their age. Ceiling tiles look old; some are stained and warped. This component funds to replace the tile floors & walls, ceiling tiles, light fixtures, counters, sinks, mirrors, toilets & stalls, shower faucets & doors, and wood benches. Funding also includes replacing the (2) restroom doors and (12) windows.

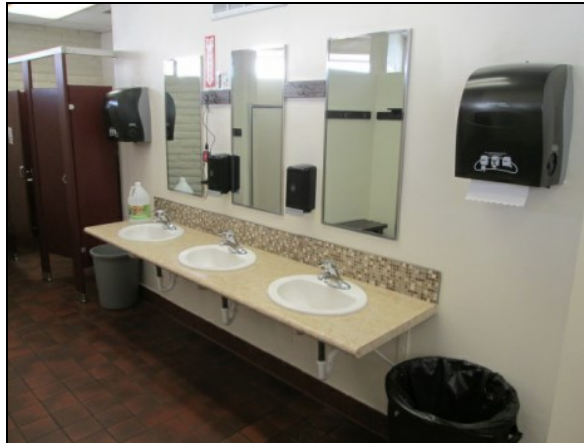
Comments: Restrooms are older and dated, but they are still clean and good shape for their age. Ceiling tiles look old; some are stained and warped. This component funds to replace the tile floors & walls, ceiling tiles, light fixtures, counters, sinks, mirrors, toilets & stalls, shower faucets & doors, and wood benches. Funding also includes replacing the (2) restroom doors and (12) windows.

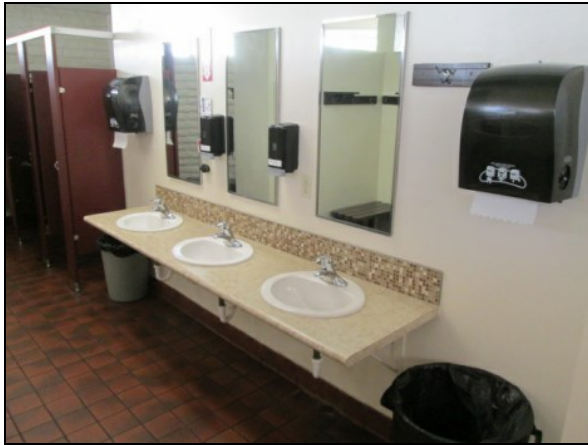
Comments: Restrooms are older and dated, but they are still clean and good shape for their age. Ceiling tiles look old; some are stained and warped. This component funds to replace the tile floors & walls, ceiling tiles, light fixtures, counters, sinks, mirrors, toilets & stalls, shower faucets & doors, and wood benches. Funding also includes replacing the (2) restroom doors and (12) windows.

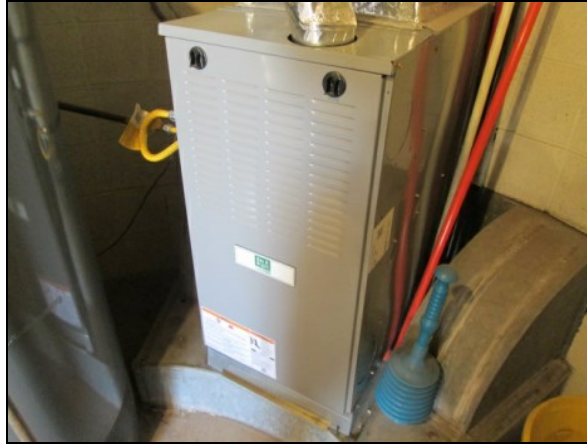
Comp #: 1042 Furnaces - Replace

History: Replaced at BH 4 in 12/2019 for \$2,400. Replaced at BH2 in 11/2018 for \$2,415. BH 1 & 3 are very old.

Funded?: No. There is no expectancy to replace all of the furnaces at the same time. Individual costs are below the Reserve expense threshold. Recommend replacing as needed with Operating funds.

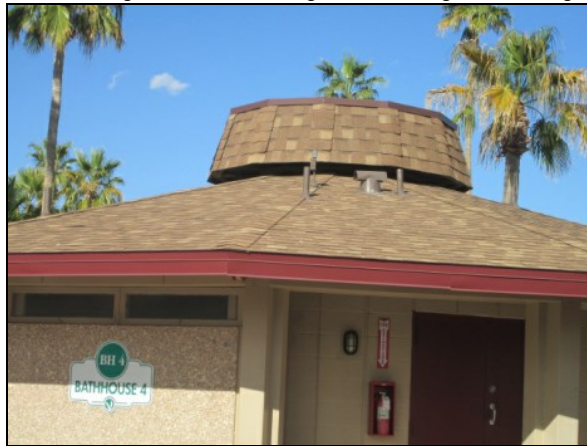
Comp #: 1050 Shingle Roofs - Replace

History: Replaced in 2019-20 for \$35,858. Previously replaced in 1997 & 2000.

Comments: Roofs were replaced at different times in the past, but this recent replacement accounted for all of them as one project. Shingle roofs still look newer and in good condition. Slight wear along some shingle edges.

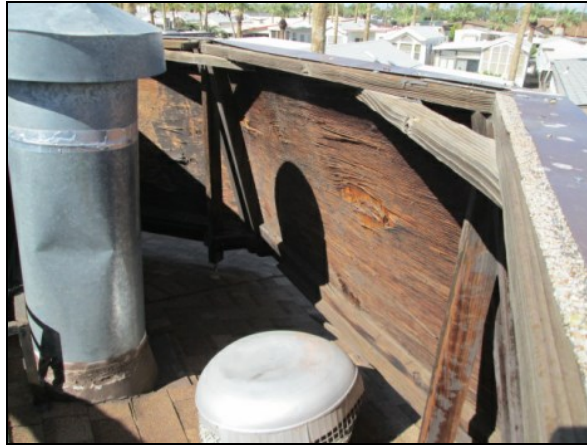
Comp #: 1060 HVAC Screens - Replace

Comments: Bathhouse roofs have a wood wall that hides the HVAC units. Exterior portion of the wall has asphalt shingles (replaced with the bathhouse roofs). The interior portion of the wall is plywood with wood supports. Screens are very old, but they have new roofing material on the exterior. Recommend replacing in conjunction with the next roof project, if they last that long.

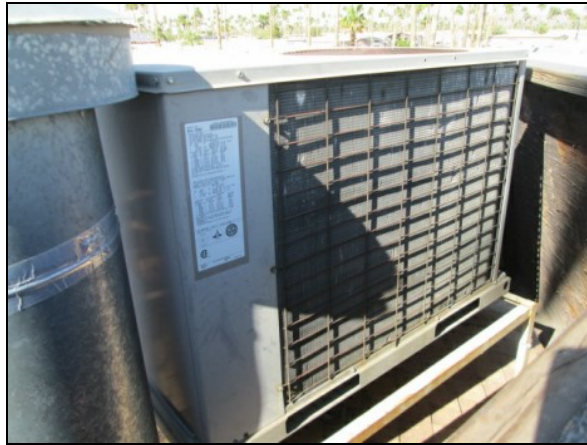
Comp #: 1070 HVAC #5M - Replace

Comments: This packaged HVAC unit is looking old. Functional with no issues reported. It should be nearing time for replacement.
