Venture Out at Mesa, Inc.
Mesa, AZ

Report #: 15275-3
Beginning: July 1, 2021
Expires: June 30, 2022

RESERVE STUDY
Update "With-Site-Visit"

April 22, 2022

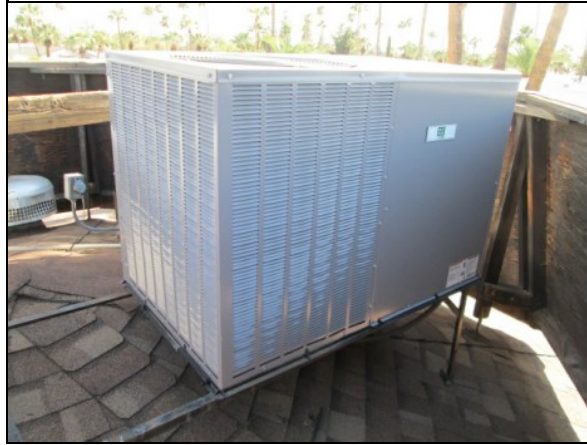
Comp #: 1071 HVAC #5W - Replace

History: Replaced 9/2020 for \$4,600. Previously replaced around 2004.

Comments: This is a packaged HVAC unit. It is newer and appears to be in good condition.

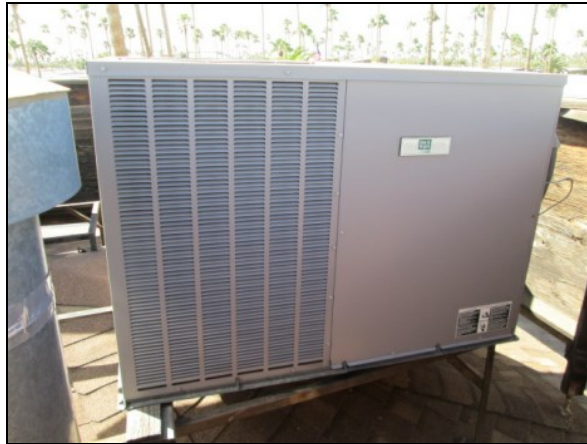
Comp #: 1072 HVAC #6M - Replace

History: Replaced 2/2012. Previously replaced around 1996.

Comments: This is a packaged HVAC unit. It still looks to be in fair condition. No problems have been reported.

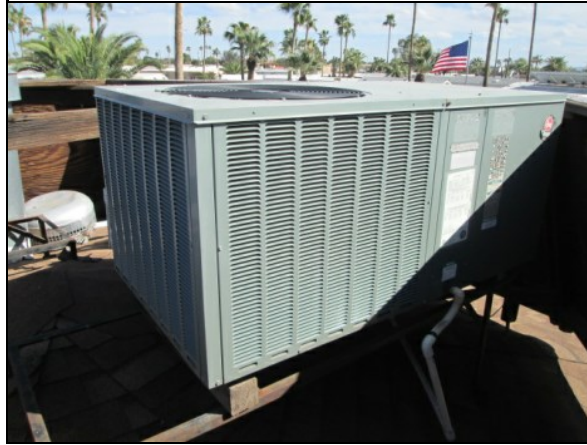
Comp #: 1073 HVAC #6W - Replace

History: Replaced in 2006 for \$3,874. Previous age was unknown.

Comments: This is a packaged HVAC unit. It is getting older, but still appears to be in fair condition.

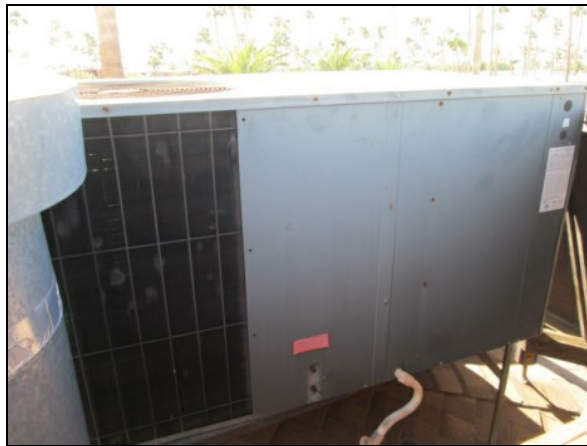
Comp #: 1074 HVAC #7M - Replace

History: Replaced in 2005. Previous age was unknown.

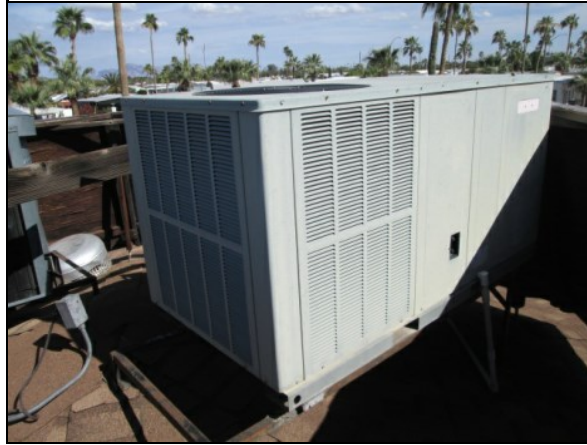
Comp #: 1075 HVAC #7W - Replace

History: Replaced in 2007 for \$3,995. Previous age was unknown.

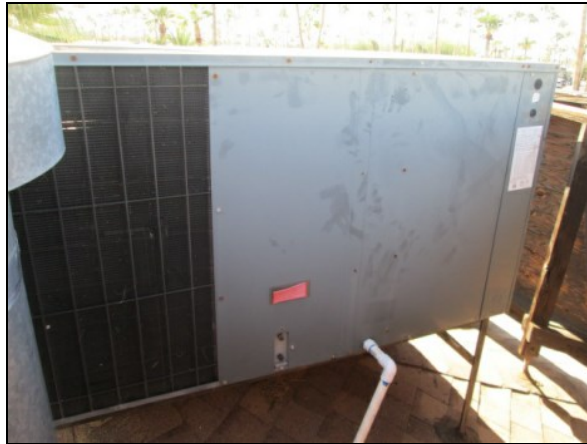
Comp #: 1076 HVAC #8M - Replace

History: Replaced in 2005. Previous age was unknown.

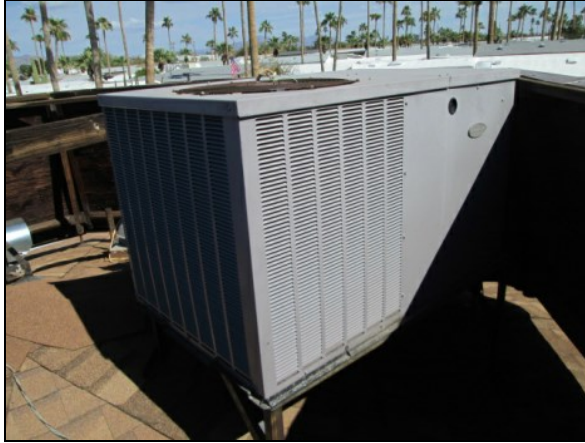
Comp #: 1077 HVAC #8W - Replace

History: Replaced in 2002. Previous age was unknown.

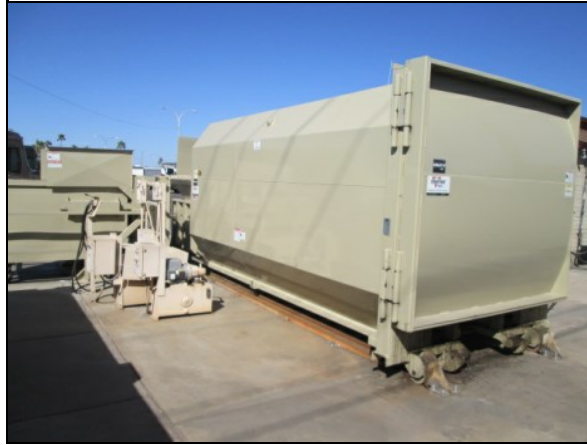
Comp #: 1210 Trash Compactor - Replace

History: Replaced in 2020-21. Previously purchased in 2004 for \$34,902.

Comments: Trash compactor is newer and in good condition.

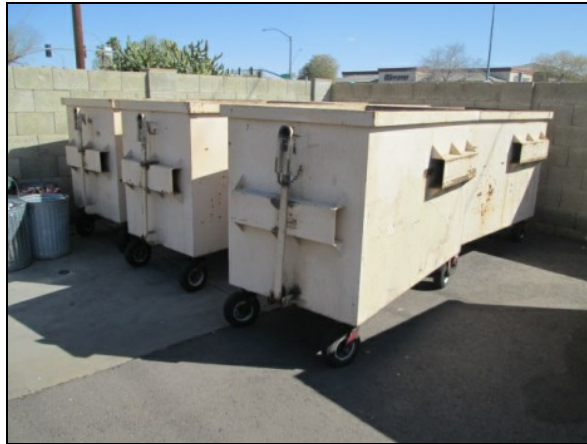
Comp #: 1211 Trash Carts - Replace

Comments: These carts are towed around the community to collect trash and delivery it to the compactor. They are old and beat-up. Replacement is expected in the near future.

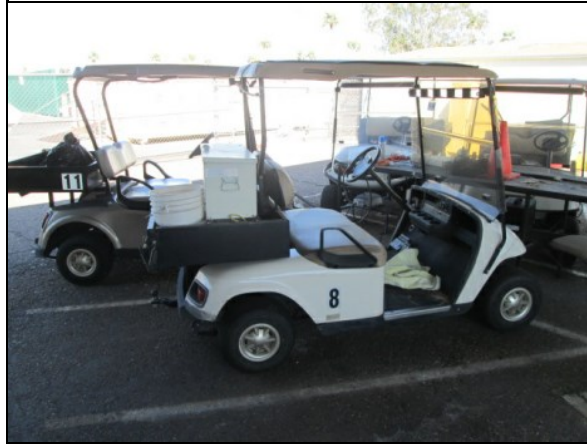
Comp #: 1213 Maintenance Carts - Replace

History: Several carts replaced in 2021.

Comments: Most of these golf carts were purchased used and vary in age. There is no expectancy to replace all of them at the same time. Expect to replace one or two annually.

Funded?: No. HOA treats replacement as an Operating expense, so no Reserve funding has been allocated.

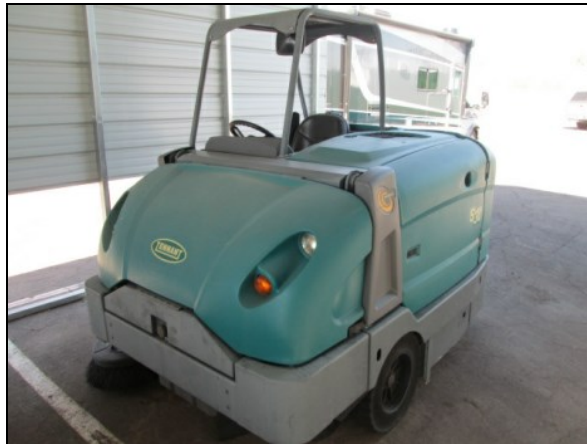
Comp #: 1217 Street Sweeper - Replace

History: Replaced in 2012-13 for \$41,747. Previously purchased 6/1995 for \$26,721.

Comments: Sweeper still looks good. It has a plastic body/exterior, and no cracks or damage was noted.

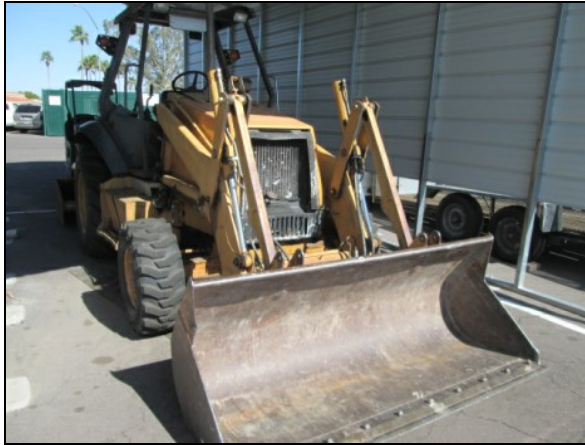
Comp #: 1218 Tractor - Replace

Comments: Tractor appears older and aged. Moderate use and weathering evident. Future replacement cost is based on purchasing another used tractor.

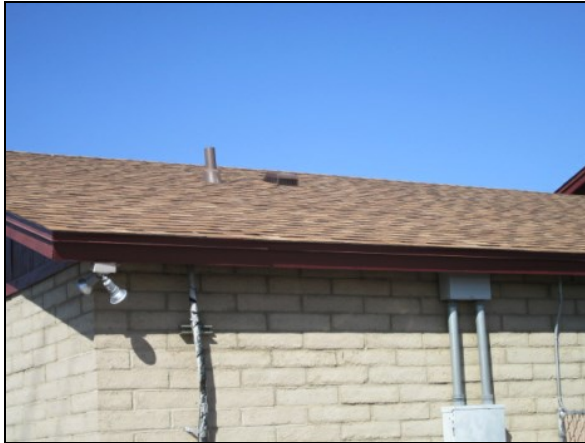
Comp #: 1228 Shingle Roof - Replace

History: Replaced 5/2020 for \$9,580. Previously replaced in 2000-01.

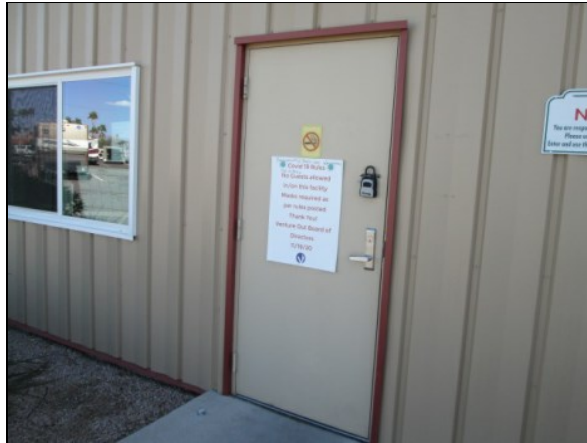
Comp #: 1261 Doors - Replace

Comments: Still appear to be in good condition. Long life expectancy. It is prudent to plan for eventual replacement. Individual replacements should be treated as an Operating expense.

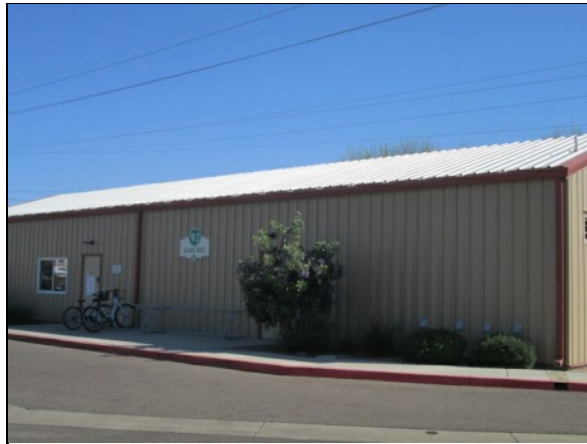
Comp #: 1266 Metal Roof - Replace

Comments: Metal roof is still in good condition. Long life expectancy, but future replacement should still be anticipated eventually, even if just for aesthetic purposes.

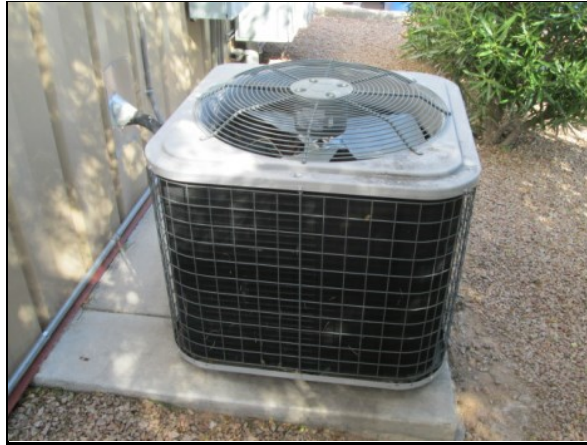
Comp #: 1270 HVAC #1 - Replace

Comments: This is a split HVAC system. Replacement cost includes both the exterior condensing unit and the interior air handler. Still appears to be in fair condition.

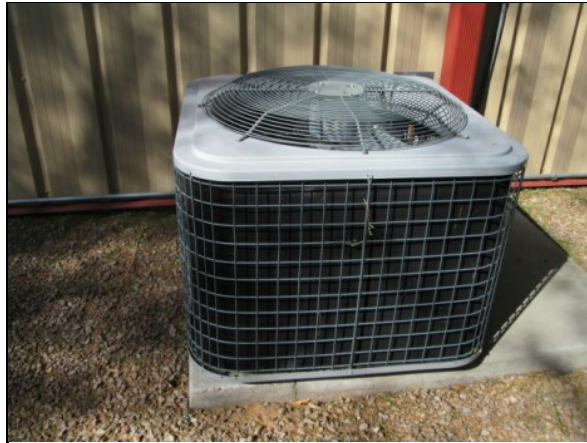
Comp #: 1271 HVAC #2 - Replace

Comments: This is a split HVAC system. Replacement cost includes both the exterior condensing unit and the interior air handler. Still appears to be in fair condition.

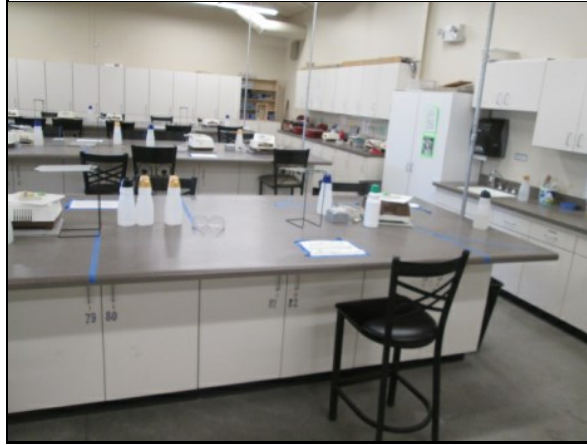
Comments: This building still looks good. No issues or problems reported. This component funds to replace cabinetry, ~(28) assorted light fixtures, tile surfaces & fixtures in the restrooms, plus painting.

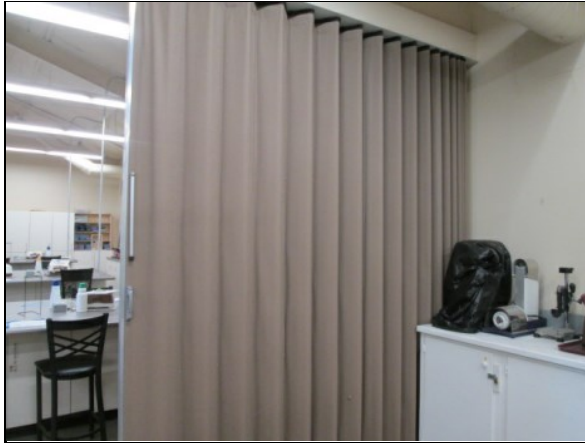
Comp #: 1280 Room Divider - Replace

Comments: This is a vinyl, accordion style room divider. Some minor wear. This divider reportedly receives a lot of use.

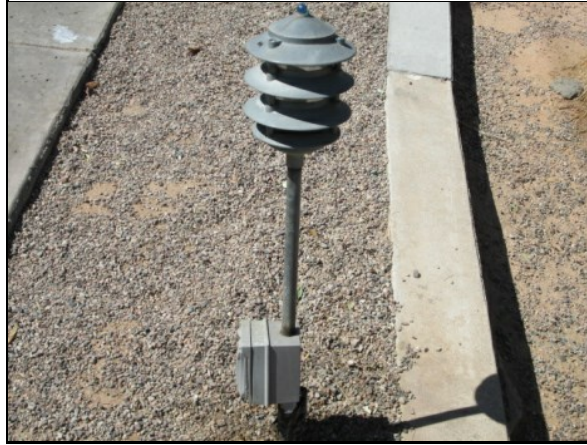
Comp #: 1311 Pet Walk Lights - Replace

Comments: Landscaping lighting is installed along the walking path. Fixtures are getting older and are nearing time for replacement.

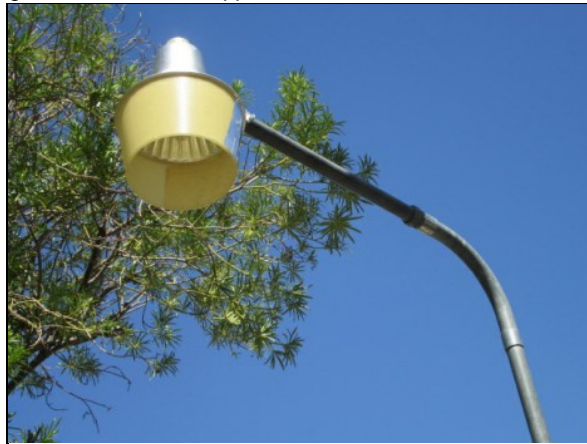
Comp #: 1312 Pet Walk Lights - Replace

Comments: These are taller pole lights along the walking path. They look very old and dated. Recommend planning to replace periodically to improve the lighting and to restore the appearance.

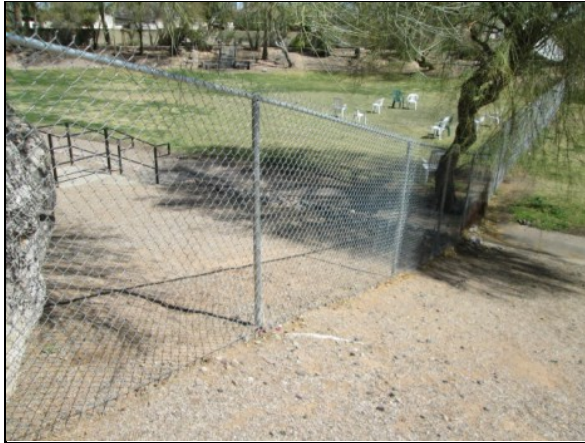
Comp #: 1314 Pet Walk Fence (2008) - Replace

Comments: Fence still appears to be in good shape overall. Future replacement should be expected.

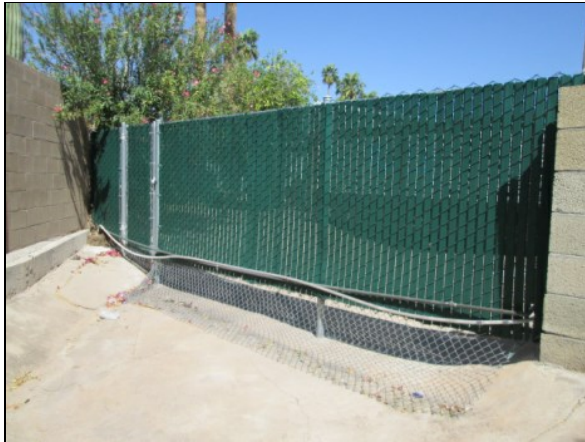
Comp #: 1315 Pet Walk Fence (2014) - Replace

Comments: This is a fence section with a single gate. Privacy slates are installed. Still looks to be in good condition and is stable.

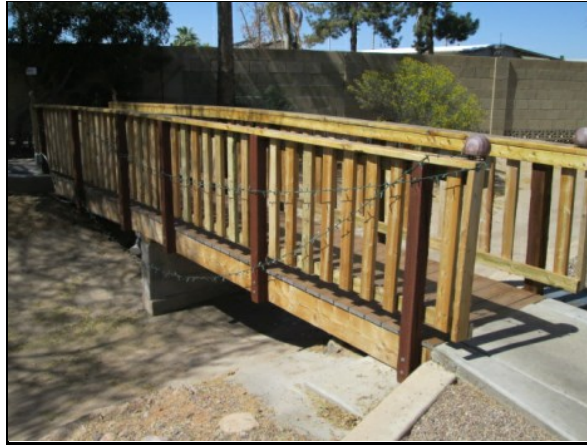
Comp #: 1320 Pet Walk Bridge - Replace

Comments: This is a wood footbridge mounted over the wash section. It was recently rebuilt/replaced with new wood frame and rails. Walking portion is constructed with Trex (or similar product). Repair as a maintenance expense when needed. This component funds to replace the entire structure eventually.

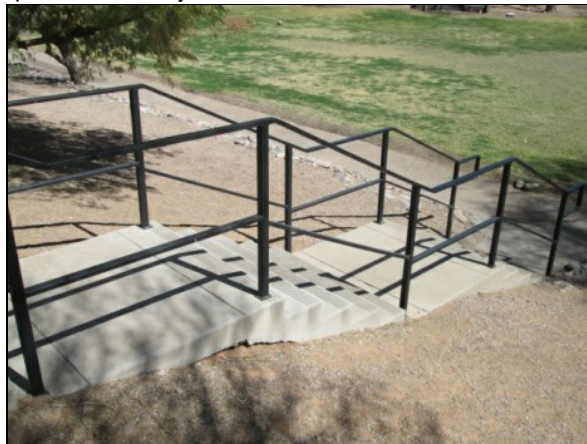
Comp #: 1322 Pet Walk Handrails - Replace

Comments: Iron handrails are mounted along stairways leading down into the grass area. No significant rusting or instability noted. Replacement should be expected eventually.

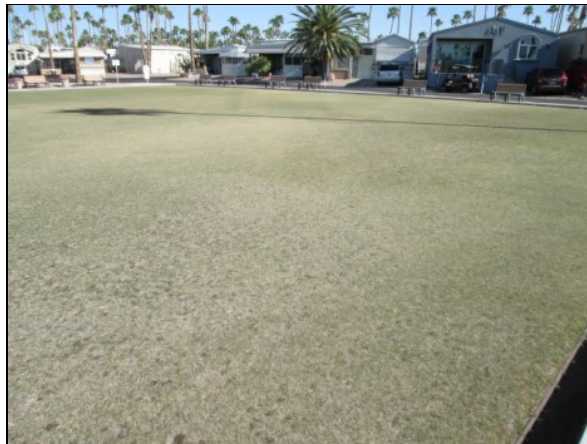
Comp #: 1605 Lawn Bowling Turf #1 - Replace

History: Replaced 11/2009 for \$47,619.

Comments: Turf replacement is reportedly something that will need to be done again in the future. No problems were reported at this time.

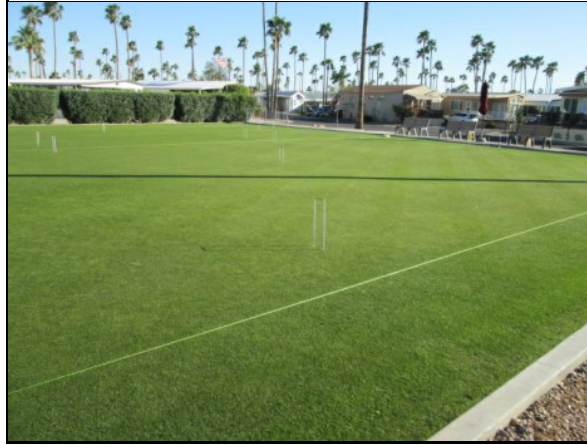
Comp #: 1606 Lawn Bowling Turf #2 - Replace

Comments: This turf area is used for Croquet. There were no problems reported or observed. Actual timing of this project is unknown, but replacement of the turf should be anticipated eventually.

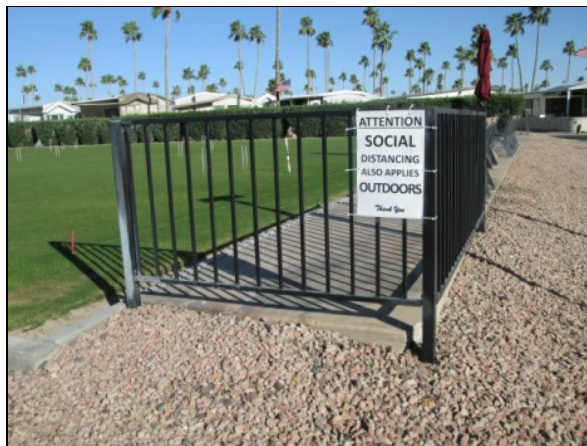
Comp #: 1608 Lawn Bowling Fence - Replace

History: Replaced in 2016-17 for \$7,290. Previous age was unknown.

Comments: Work in 2016-17 involved replacing the metal rails plus repairing some of the block walls. This component accounts for metal handrails and fences bordering both lawn bowling areas. Still in good shape overall. There is irrigation staining on the metal.

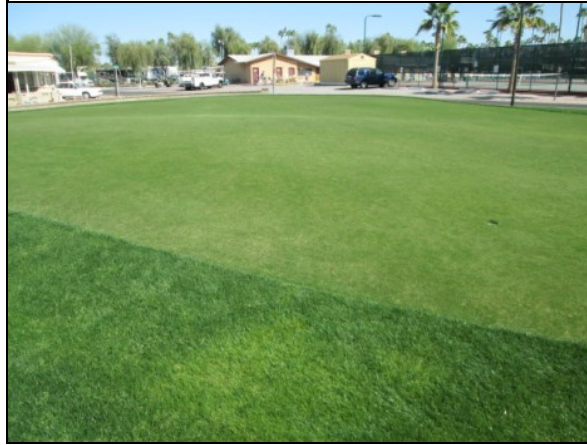
Comp #: 1610 Putting Green Turf - Replace

Comments: Like the lawn bowling areas, replacement of this turf should be anticipated eventually. There were no problems reported or observed.

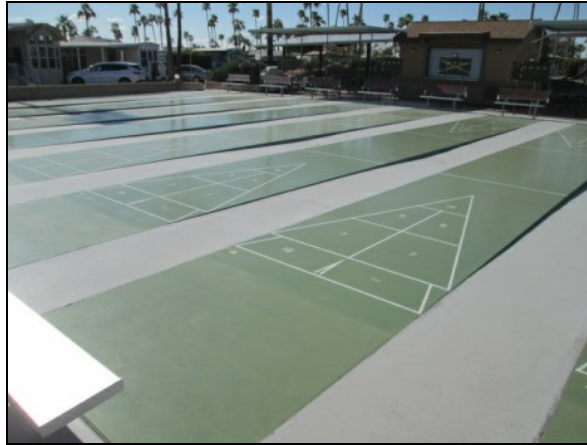
Comments: Shuffleboard courts are concrete with a coating on top. Coating applied reportedly has a lifetime warranty. Despite this warranty, HOA should still budget for resurfacing in the event the coating does not last. Some courts more worn than others. Visible surface wear and some cracks.

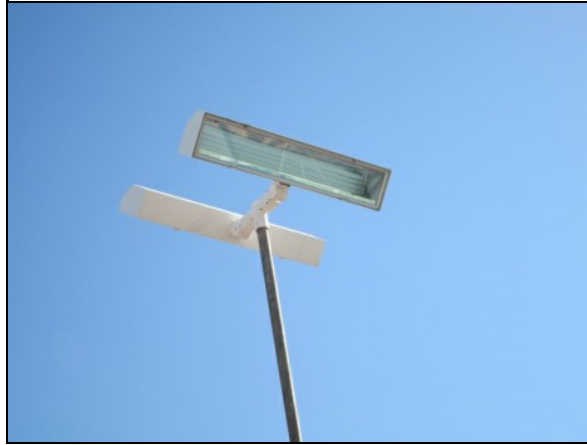
Comp #: 1624 Shuffleboard Lights - Replace

Comments: Light fixtures appear to be in good condition. There was a problem with the lights not staying on, so HOA re-wired the court area in 2013-14. A complete re-wire is not expected again, but replacement of the light fixtures should be anticipated.

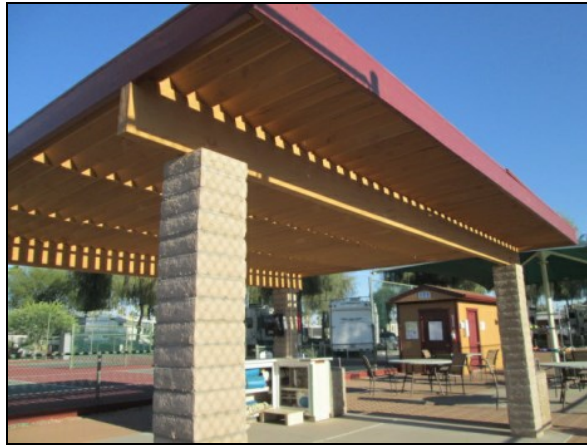
Comp #: 1646 Pickleball Ramada - Replace

Comments: Ramada structure has block columns with a wood cover. Wood cover still appears to be in good to fair condition. Some splits and cracks in the wood noted. Surfaces should be painted more frequently. This component funds for future replacement of the cover.

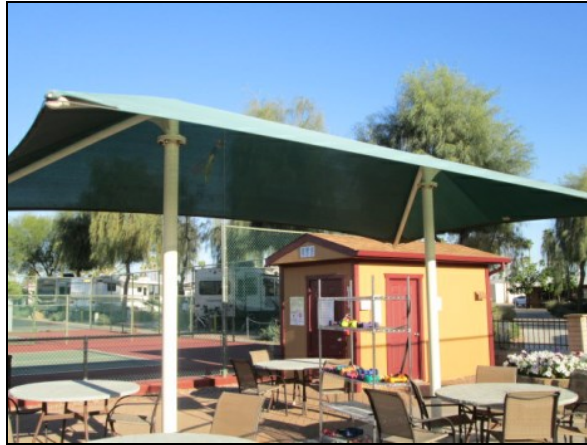
Comp #: 1647 Pickleball Shade - Replace

Comments: Shade screen is manufactured by SunPorts. There is no expectancy to replace the structure under normal circumstances. Periodic replacement of the screen should be expected. Shade looks faded, but it does not have any holes or tears.

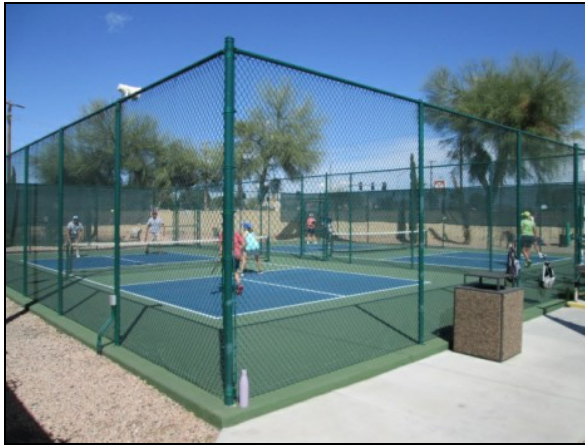
Comp #: 1845 Pickleball Fence (10-11) - Replace

Comments: This is a 10' tall vinyl coated chain link fence. Still in good condition.

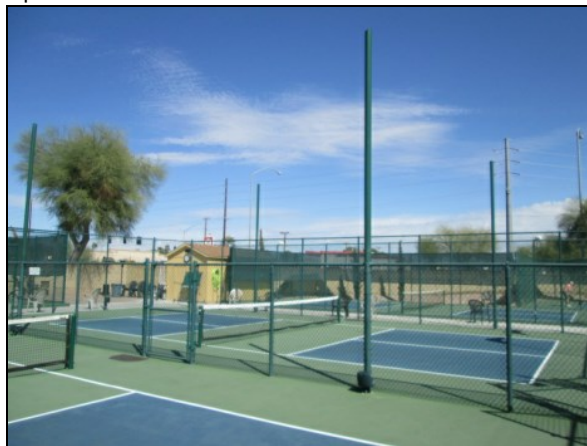
Comp #: 1850 PB Lights (2,8,9) - Replace (A)

Replacement should be anticipated eventually to update and modernize the lighting. Life span varies depending on usage, but the fixtures will not last as long as the poles.

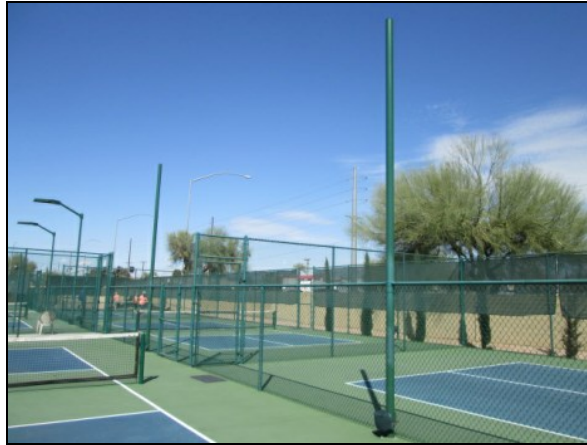
Comp #: 1851 PB Lights (2,8,9) - Replace (B)

Comments: The metal light poles will last longer than the light fixtures, but replacement should still be anticipated eventually. Although poles are not brand new, they are being reflected as new in order to replace them in conjunction with a future light fixture project.

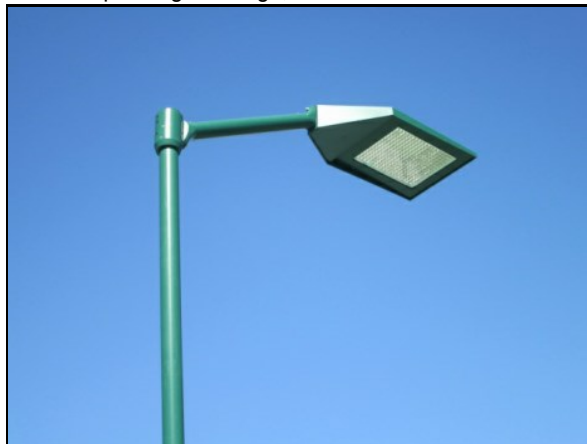
Comp #: 1852 PB Lights (4,5) - Replace (A)

Comments: These are LED light fixtures mounted to metal poles. Replacement should be anticipated eventually to update and modernize the lighting. Life span varies depending on usage, but the fixtures will not last as long as the poles.

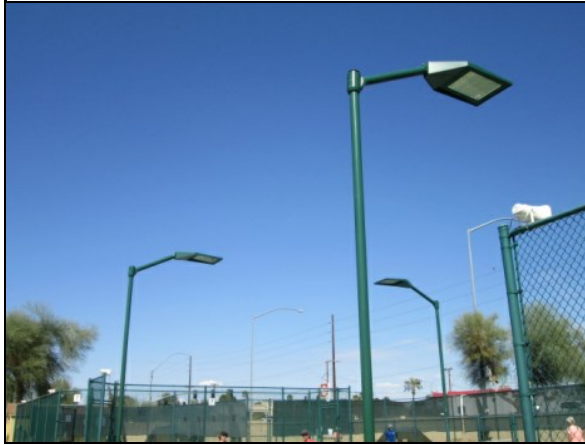
Comp #: 1853 PB Lights (4,5) - Replace (B)

Comments: The metal light poles will last longer than the light fixtures, but replacement should still be anticipated eventually. This component funds to replace the poles in conjunction with a future light fixture project.

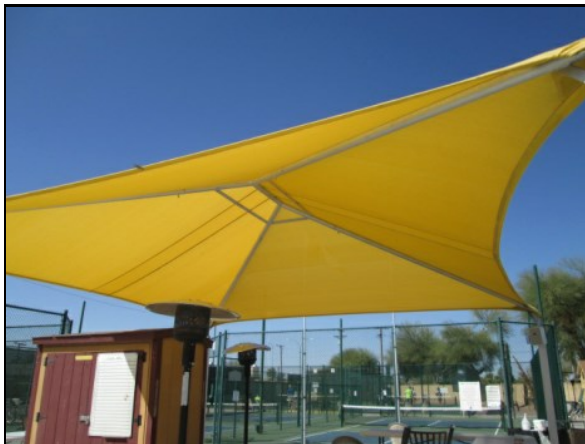
Comp #: 1860 Shade Screens - Replace

Comments: There are (2) 4-post hip/pyramid style structure and (1) tension structure. There is no expectancy to replace the shade structures under normal circumstances. Periodic replacement of the screens should be expected. Material still appears to be in good condition. No visible holes or tears.

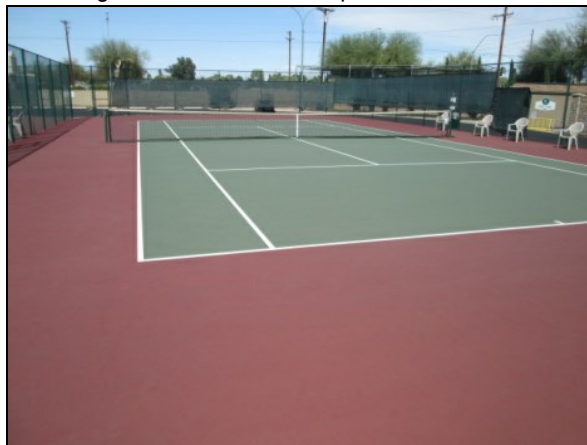
Comments: Tennis courts are not receiving as much use as in the past. Surfaces are holding up longer and still in fair condition.

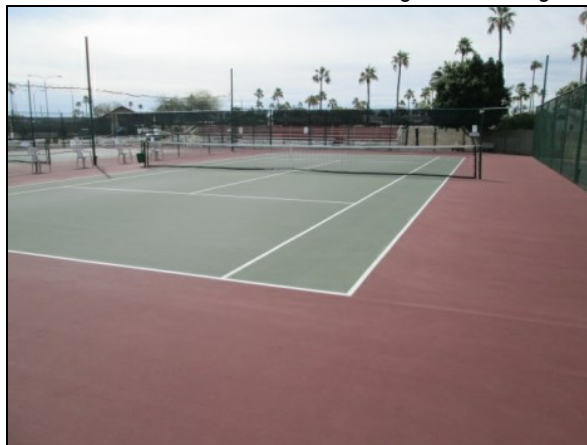
Comments: Good to fair conditions. Some marks and scuffs noted. No signs of cracking.

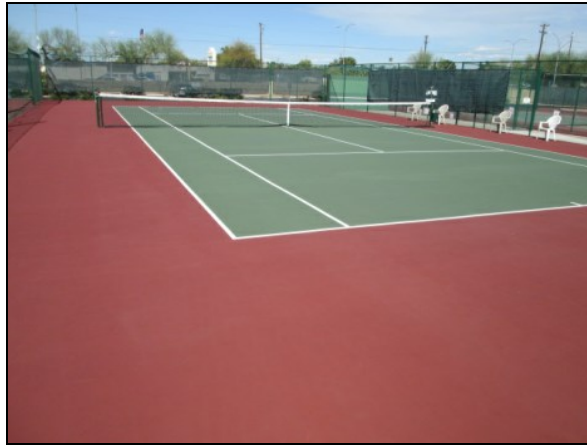
Comments: Good condition. Surfaces still look bright and clean.

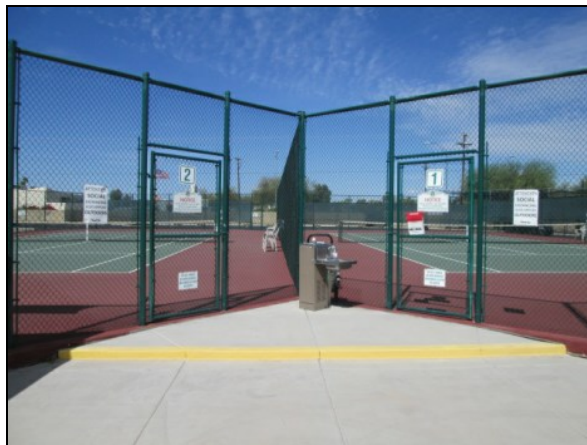
Comp #: 1877 Tennis Fence (1-6) - Replace

Comments: This is 10' tall vinyl coated chain link fence. Some bent spots noted at lower portions of the fence. Still in good condition overall.

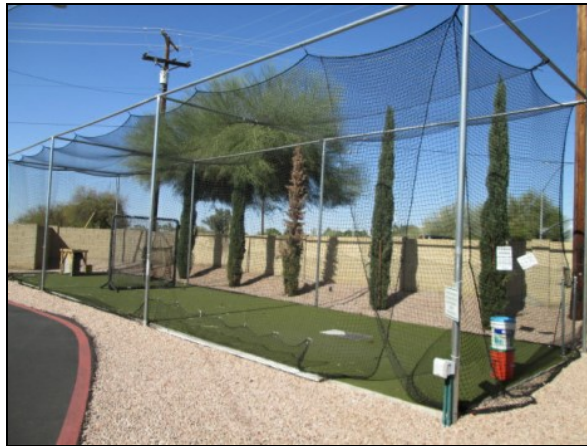
Comp #: 1896 Batting Cage - Replace

Comments: Cage is still intact and in fair shape. It is constructed with chain link fence material. Walls are 14' high and run 150 LF around the perimeter, with a 15' x 60' top. Netting inside the cage is approximately 3,000 sq ft. Treat repairs and replacement of the netting as an Operating expense.

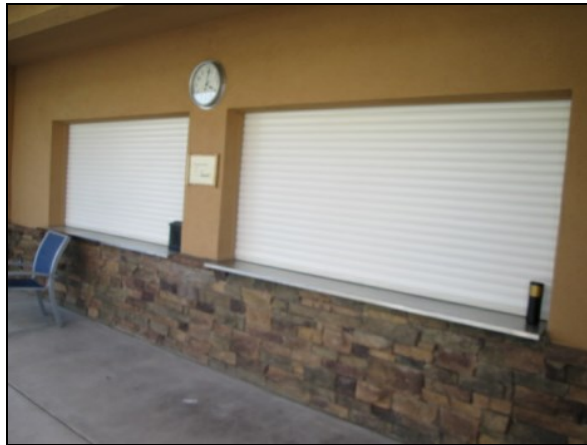
Comp #: 2003 Doors - Replace

Comments: Quantity includes (6) steel access/closet-style doors and (2) roll-up serving doors. Still near new and in good condition. Long life expectancy. It is prudent to plan for eventual replacement. Individual replacements should be treated as an Operating expense.

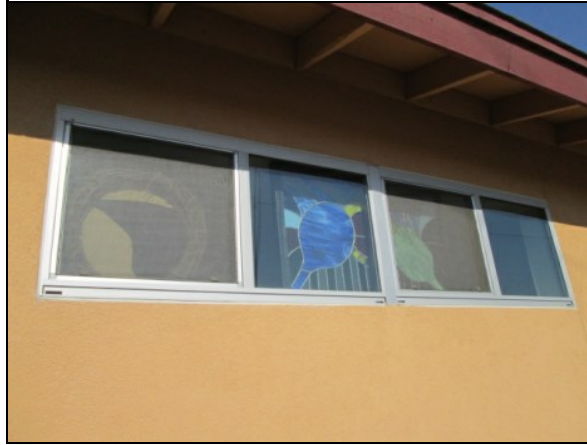
Comp #: 2004 Windows - Replace

Comments: There are (5) windows with a surface area of ~40 sq ft. These are aluminum frame windows. Still near new and appear to be in good condition. Long life expectancy under normal circumstances.

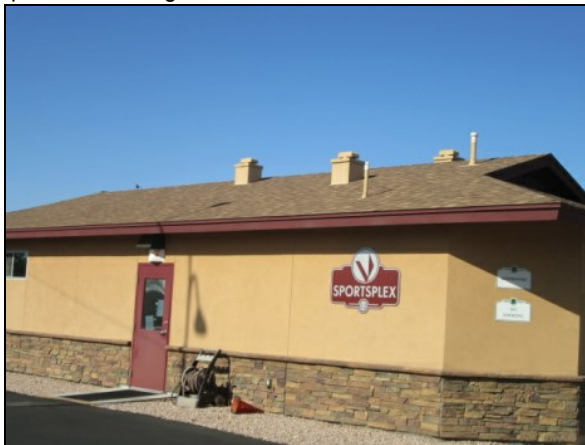
Comp #: 2014 Shingle Roof - Replace

Comments: Roof is newer and expected to be in good condition.

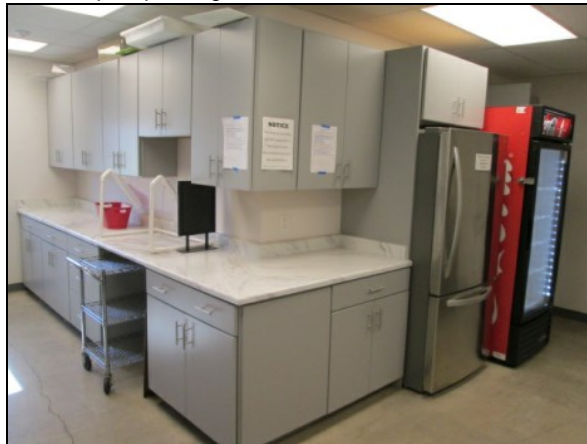
Comments: Interior is still newer and in good condition. This component funds to replace the kitchen cabinetry, (3) refrigerators, (2) freezers, light fixtures, and air curtain, plus painting.

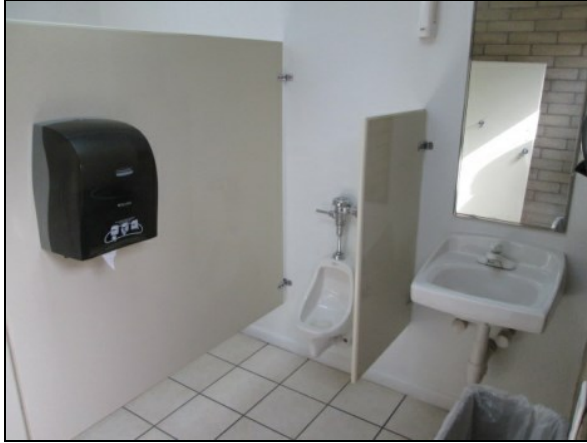
Comments: Restrooms are small and old. Still clean and functional, so remodel is not a priority at this time. This component funds to replace the tile floors, light fixtures, sinks, mirrors, toilets, stalls, etc.

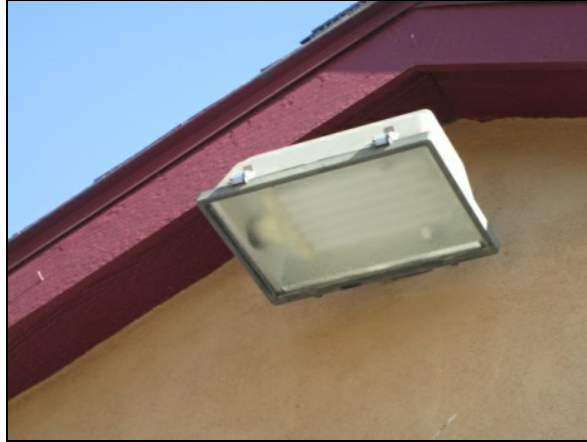
Comp #: 2100 Exterior Lights - Replace

Funded?: No. HOA plans to replace as needed with Operating funds, so no Reserve funding has been allocated.

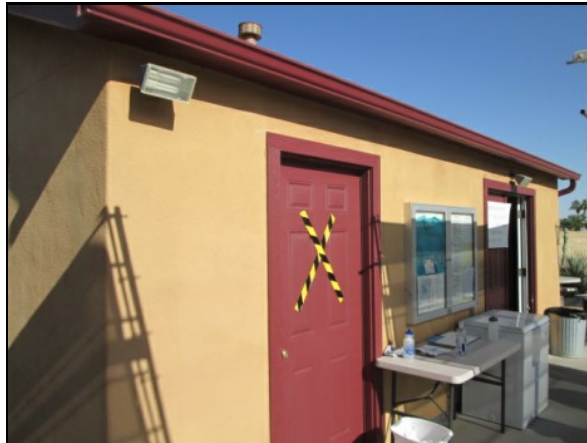
Comp #: 2103 Doors - Replace

Comments: Quantity includes (3) access doors and (1) roll-up serving door. Still in good condition. Long life expectancy. It is prudent to plan for eventual replacement. Individual replacements should be treated as an Operating expense.

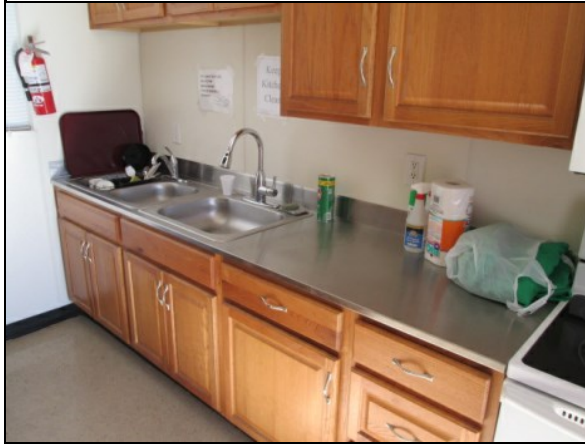
Comments: Interior is still newer and in good condition. This component funds to replace the kitchen cabinetry, (3) refrigerators, (2) freezers, light fixtures, and air curtain, plus painting.

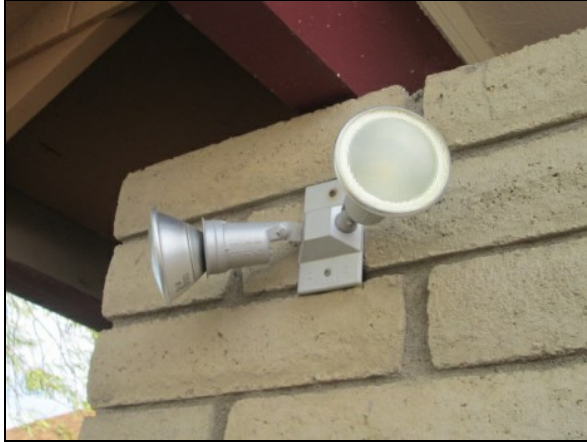
Comp #: 2140 Exterior Lights - Replace

Funded?: No. HOA plans to replace as needed with Operating funds, so no Reserve funding has been allocated.

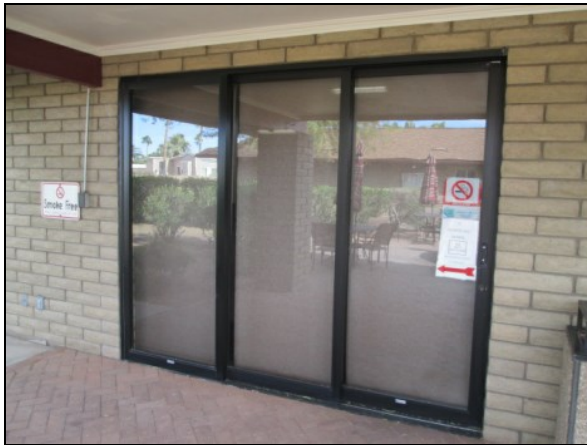
Comp #: 2143 Doors - Replace

Comments: Quantity includes (4) steel closet-style doors and (2) 3-panel glass sliders. These are older doors. Still appear to be in fair condition. Long life expectancy. It is prudent to plan for eventual replacement. Individual replacements should be treated as an Operating expense.

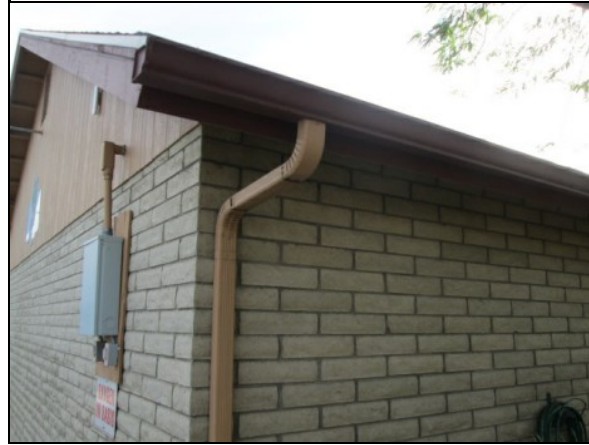
Comp #: 2152 Rain Gutters - Replace

Funded?: No. Cost is below the Reserve expense threshold, so no Reserve funding has been allocated. Repair or replace sections of rain gutters as an Operating expense when needed.

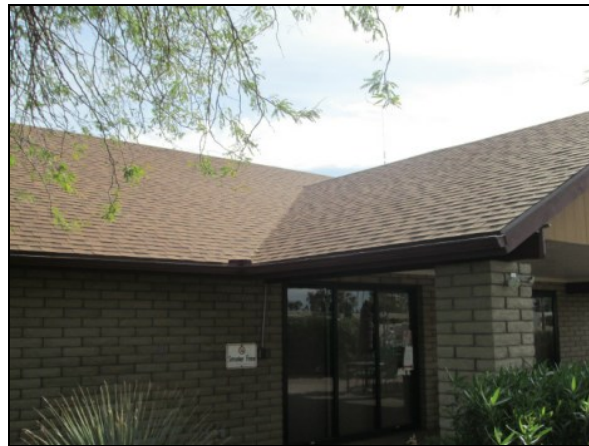
Comp #: 2154 Shingle Roof - Replace

History: Replaced in 2012 for \$10,206. Previously installed in 1994.

Comments: Roof is still in good to fair condition. This is reportedly a 30-year laminate shingle roof. HOA should be prepared to replace sooner than 30-years though. Roof on the Bocce Ball Clubhouse is the same age, so funding is included here to meet the threshold.

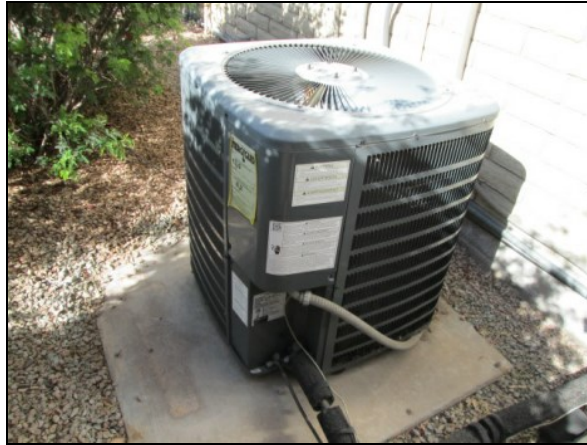
Comp #: 2156 HVAC #1 - Replace

History: Replaced condenser only 6/2014 for \$2,750. Previously installed in 1994.

Comments: This is a split HVAC system. Only the exterior condenser portion of the system was replaced in 2014. The interior air handler is likely still original from 1994. Expect to replace the entire system as one project next time.

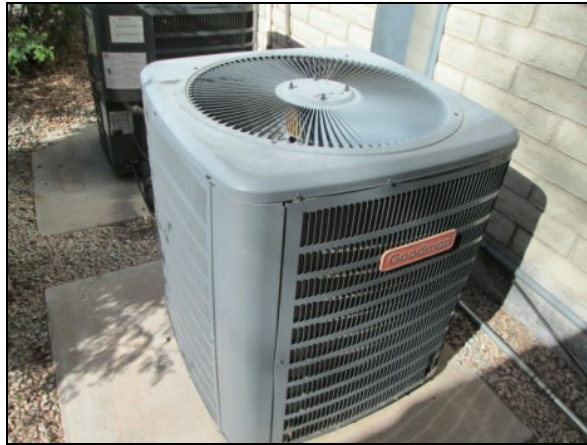
Comp #: 2157 HVAC #2 - Replace

History: Replaced condenser only 6/2014 for \$2,750. Previously installed in 1994.

Comments: This is a split HVAC system. Only the exterior condenser portion of the system was replaced in 2014. The interior air handler is likely still original from 1994. Expect to replace the entire system as one project next time.

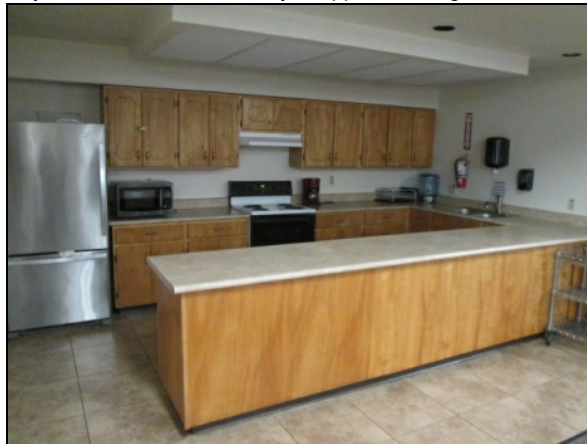
Comments: Interior is older but in fair condition. Remodeling is not a priority at this time, but it should be planned eventually. This component funds to replace the vinyl floors, kitchen cabinetry & appliances, light fixtures, window blinds, plus painting.

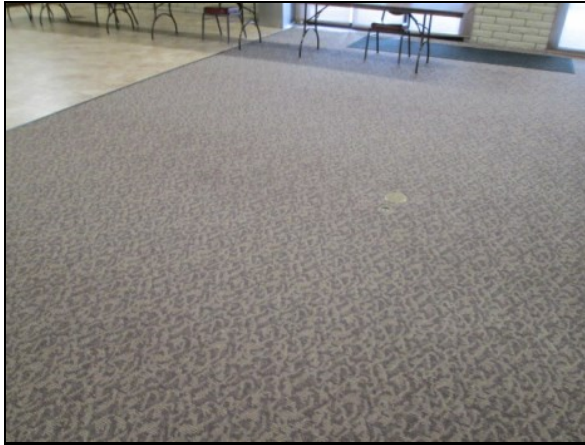
Comp #: 2165 Carpet Floor - Replace

History: Replaced in 2020-21 for \$5,795. Previously replaced in 2008.

Comments: Carpet was recently replaced and is in good condition. Periodic replacement should be anticipated.

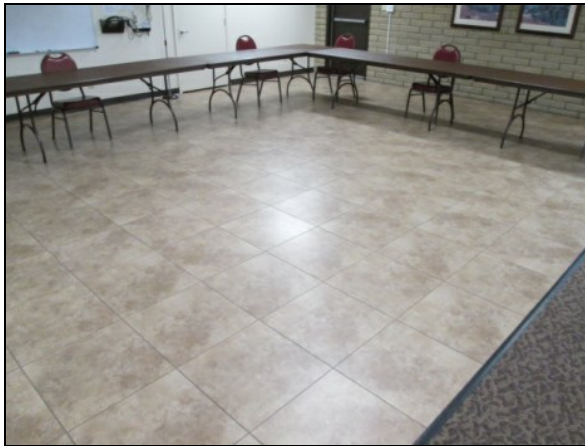
Comp #: 2168 Tile Floor - Replace

History: Replaced in 2008.

Comments: Good conditions observed. Long life component under normal circumstances, however future replacement should still be anticipated.

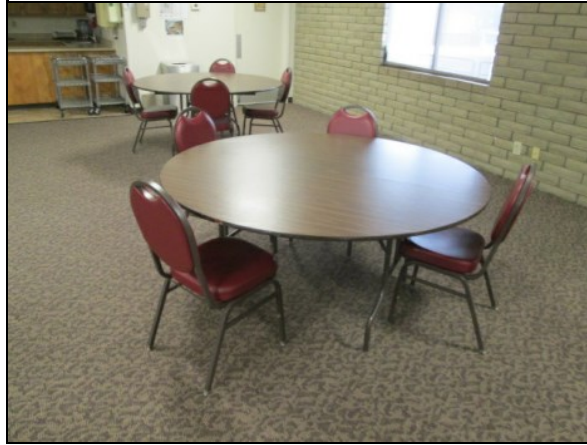
Comp #: 2170 Furniture & Equip - Replace

Funded?: No. Social Club is responsible for replacement, so no Reserve funding has been allocated.

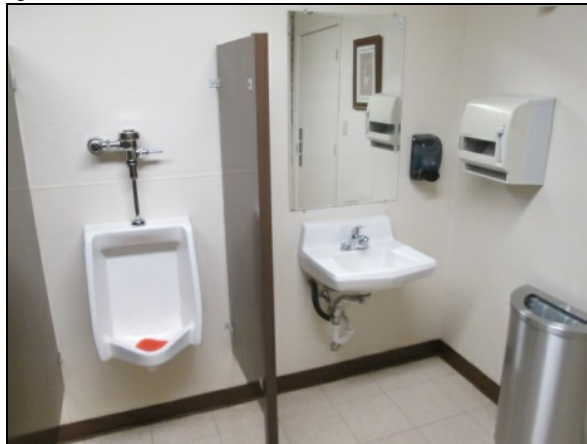
Comments: Restrooms are small and older. Still clean and functional, so remodel is not a priority at this time. This component funds to replace the vinyl floors, light fixtures, sinks, mirrors, toilets, stalls, etc.

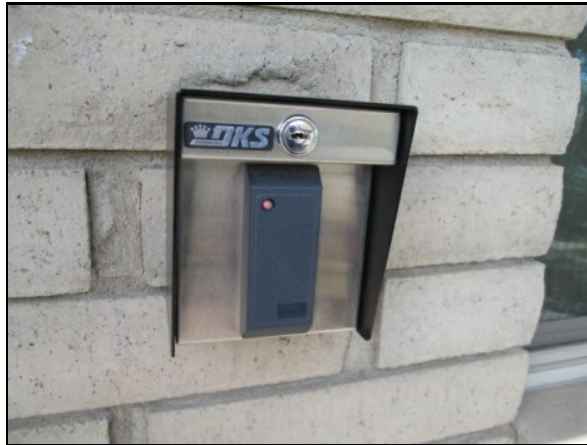
Comp #: 2202 Keycard System - Replace

History: Replaced in 2015-16 for \$4,104.

Comments: This component funds to periodically replace the system. Treat repairs and parts replacement as a maintenance expense.

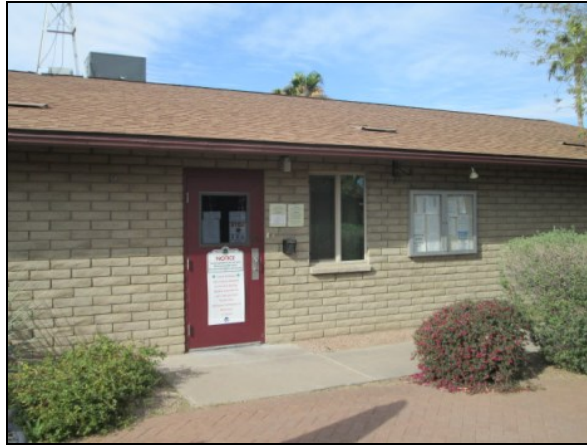
Comp #: 2203 Doors - Replace

Comments: Quantity includes (1) commercial quality, storefront style aluminum & glass door and (3) steel closet-style doors. These are older doors. Still appear to be in fair condition. Long life expectancy. It is prudent to plan for eventual replacement. Individual replacements should be treated as an Operating expense.
