Venture Out RV Resort
Final Drainage Report
5001 E Main Street
Mesa, AZ

For submittal to:
Venture Out RV Association

Prepared by:
Erie & Associates, Inc.
3120 N 24th Street
Phoenix, AZ 85016

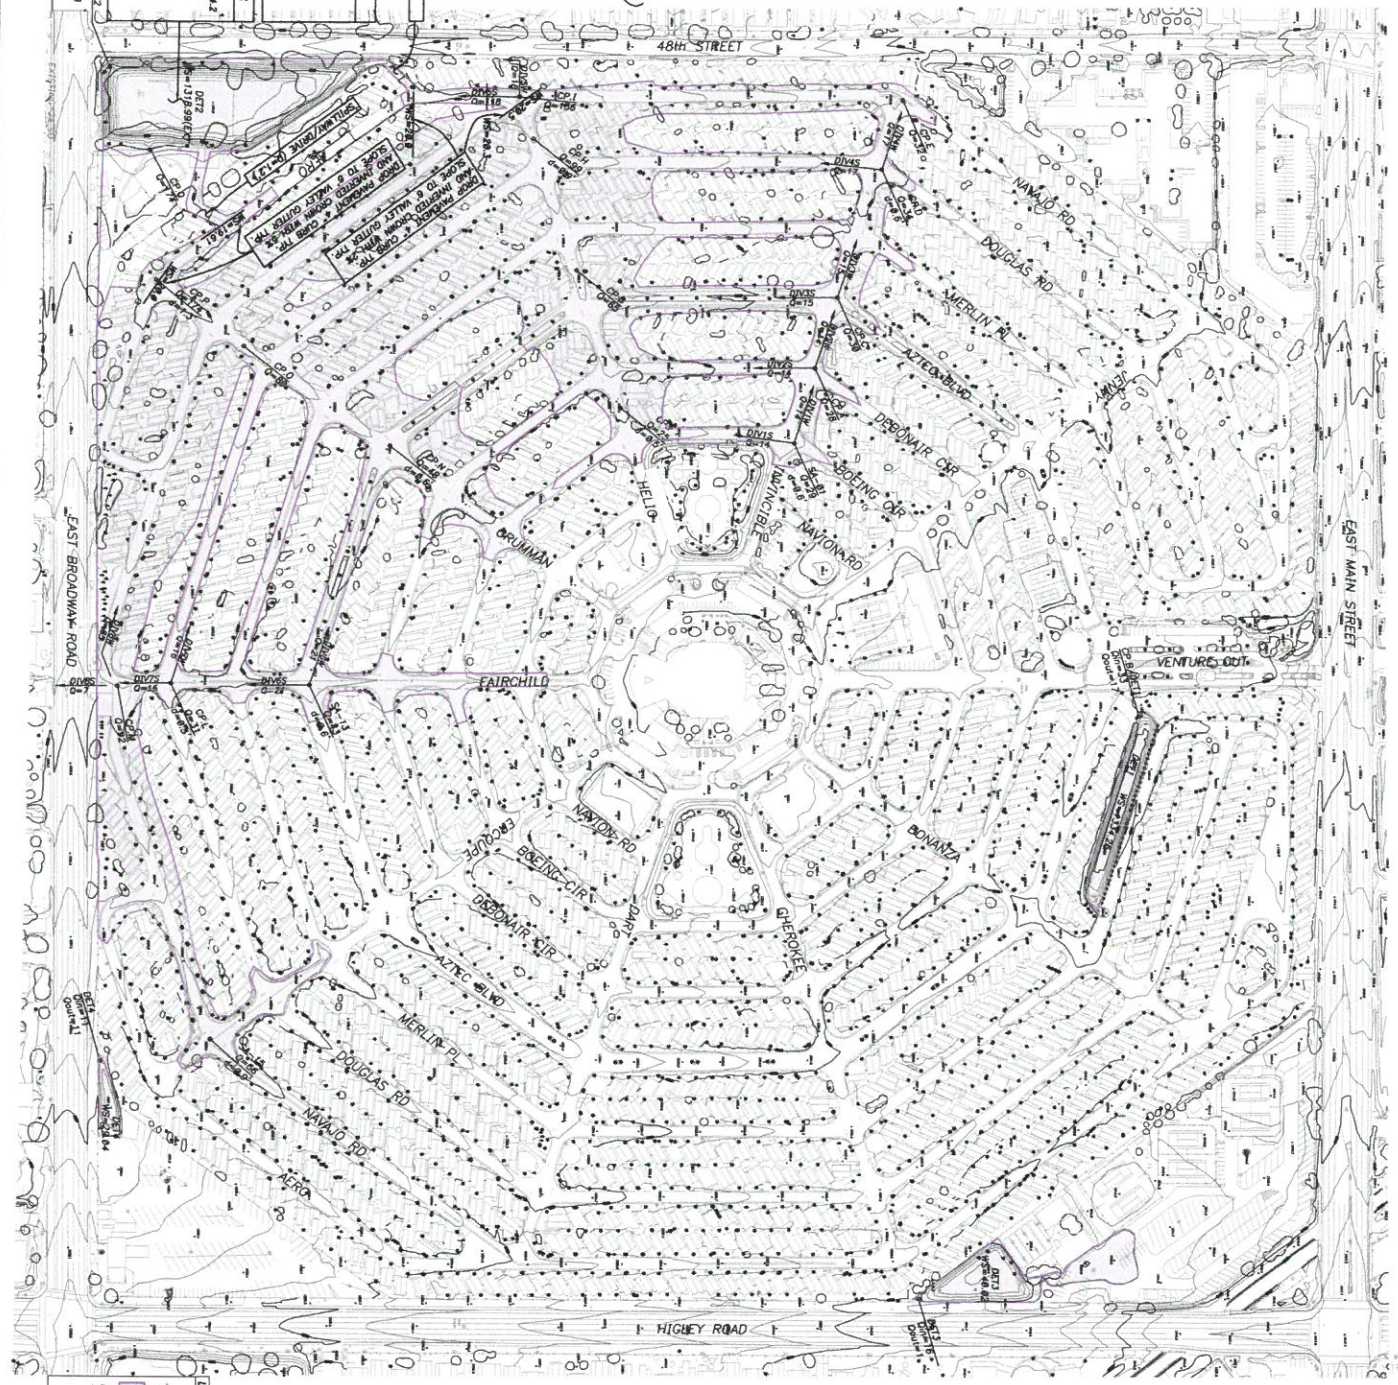
- PROPOSED PONDING ELEVATION
- INDICATES POSSIBLE FLOODING ON 100-YR 2-HR STORM
- NOTE: ANNUAL STREET FLOODING NOT SHOWN

EXISTING CONDITIONS

DEVELOPED CONDITIONS

- LOWERED BASIN BOTTOM TO E.L. 1389.5 EX 12" OUTLET=1314.2
- 80' WALL OPENING AT E.L. 1317.5
- CONSTRUCT SOUTH WEST CORNER OF BASIN
- EXISTING 12" BASIN STORM DRAIN OUTLET TO REMAIN INV=1314.2
- CONSTRUCT SPILLWAYS TO NORTH AND EAST SIDES OF THE BASIN
- LOWER THE PORTION OF ASPG FROM THE EAST SIDE SPILLWAY TO CRUMLAN
- LOWER THE PORTION OF NAWAU FROM THE NORTH SIDE SPILLWAY TO HELLO
- LOWER HELLO AND CRUMLAN

Grumman Road and running northwest approximately 190 feet until reaching the proposed spillway/driveway that empties near the center east side of the basin. *Plate 3* shows an approximation of that condition. This would directly result in a four inch lowering of the resulting water surfaces on the roads approaching the new basin spillways and Aero Road improvements. Some areas would continue to be flooded on extreme flood events unless on lot improvements were raised.

Southeast Triangle Area – The area on the southeast at the Higley/Broadway intersection is also mostly paved. This area drains to a small retention basin on the west. This basin drains out through a fence opening to Broadway Road. The ponding elevation is 1329.04, which is below the nearby units. See *Plate 3* for ponding limits.
